## PRESSURE VESSEL & COLUMN INSPECTION REPORT

LSD: 07-27-051-19W5M

SAP Equipment ID: 66005380

VESSEL STATIC DATA						
Plant	Ansell Gas Plant	Op Unit		System		
Prov. Insp. #	A0436161	CRN	X-0170.2	Equip Tag #	V-102A (equip list). V101B (as per operations)	
Equipment Description		Slug Catcher Separator		Serial #	3625A	
Manufacturer		Vancouver Iron and Engineering		Vessel Class		
Internal Access:	yes	Description: 18" MW		Year Built	1997	
MAWP	400	PSI	@ 650	°F	MDMT	0 °F
CODE :		RT :		PWHT : Yes		
Diameter	78in	Length	(s/s) too high to measure	OAL	mm / in	Vertical
Shell Mat'l		Thickness		in	Corr Allowance	in
Head Mat'l		Thickness min		in	Corr Allowance	in
Nozzle Mat'l		Thickness		in	Corr Allowance	mm
Internal Coating: NO		Internal Clad : NO		Capacity	940 ft3	
Manway : yes		Inspection Port : no		Skirt		
Nozzle Rating	600	lb ANSI	Painted :	YES	Insulated	Yes – Skirt only
PROCESS DATA						
Product Description		Gas,liquids		Sweet		
Operating Pressure		PSI		Operating Temperature		°C
PSV STATIC DATA						
Serial No.	Location	Set Pressure	Capacity SCFM / Lbs/Hr / GPM	Manufacturer	Model / Type	Service Date / Company

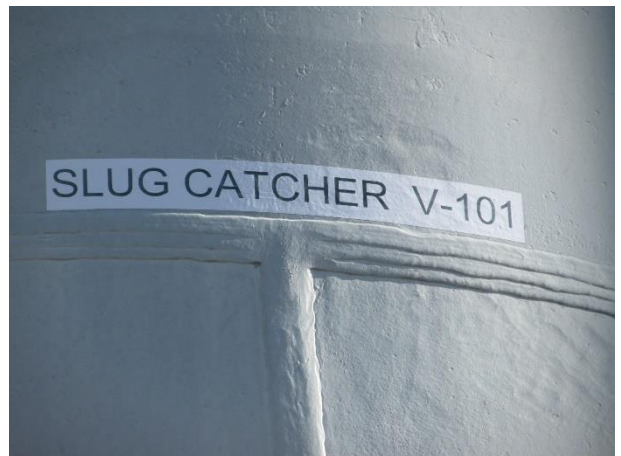
Note: Vessel tagged as V-102A on equipment list and SAP but tagged V-101B on vessel and as per operations.

Vessel labeled V-101

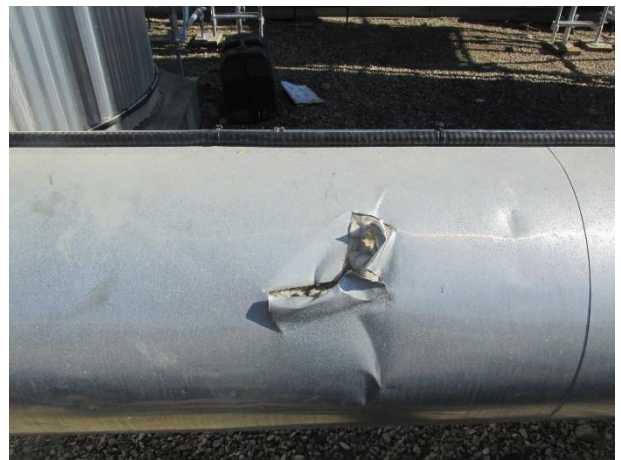
Bottom head piping cladding damage

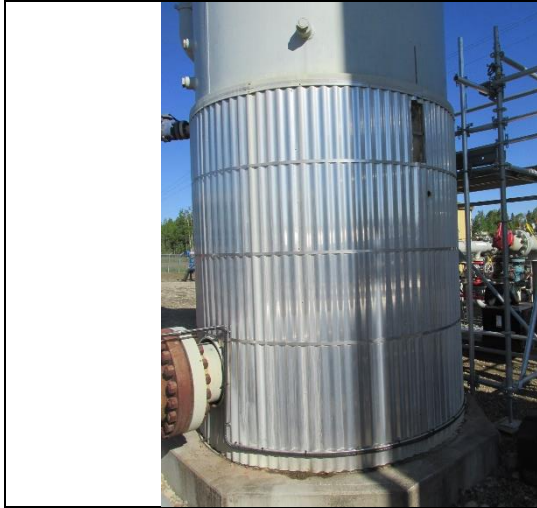
V44	Insulation Jacket	Fair			Tin cladding
V45	Banding	Good			
V46	Seals/Joints	Fair			Some seal failure at top of cladding
V51	Relief Devices Other (Please explain)	Good	Outlet piping		PSV service up to date, set at MAWP, vents to flare
V52	Corrosion	n/a			None noted
V53	Leaks	n/a			None noted
V54	Restricted Inlet/Outlet	n/a			
V55	Manual Operation Lever	n/a

Skirt insulation and cladding

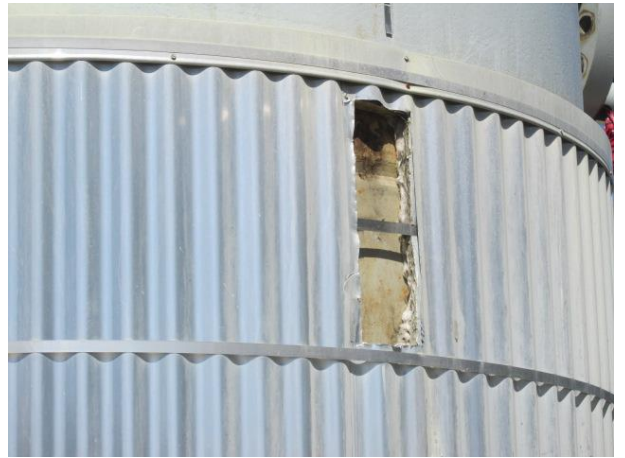
Vessel and piping are in good condition. Vessel and piping are painted, paint in good condition, no damage or corrosion noted. Vessel skirt is insulated and clad. Cladding in fair condition. There is an inspection access port cut in insulation with no coverplate, allowing moisture to get into insulation. Moss was found growing at top and at base of cladding / insulation. No visual access to skirt or anchor bolts as cladding comes down concrete foundation. Concrete foundation was found to be in acceptable condition, no significant cracking or damage noted. Vessel outlet piping is supported with a temporary support post resting on ground. Operations is aware of the poor support system for this section of piping. Manway davit arm appears in good condition, davit is double nutted. Piping off bottom is insulated and clad, cladding in fair condition with some minor damage noted. There is an inspection access under skirt to UT bottom head and drain elbow. This is considered a confined space. Some minor surface rusting noted on bottom head. Dataplate is securely attached to vessel, and is legible. Ground cable securely attached directly to skirt. PSV service is up to date, set at MAWP and vents to flare header. UT survey done 2014 by Streamline Inspection.

No coverplate on skirt cladding inspection cut out

Review UT survey results.  
Install coverplate over insulation cut out, and seal.  
Improve piping support for outlet piping – Pillings and structural steel supports

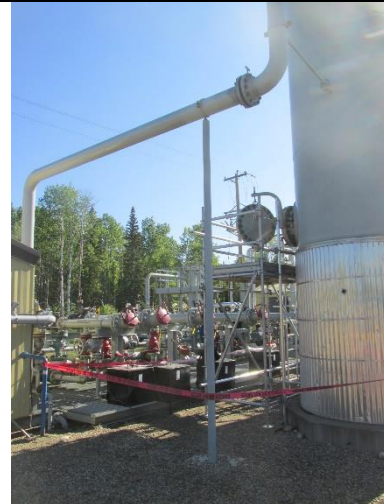
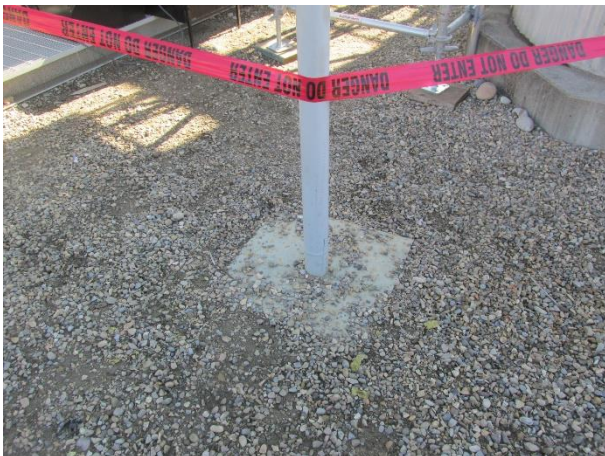
Temporary support for gas outlet piping, support post resting on ground

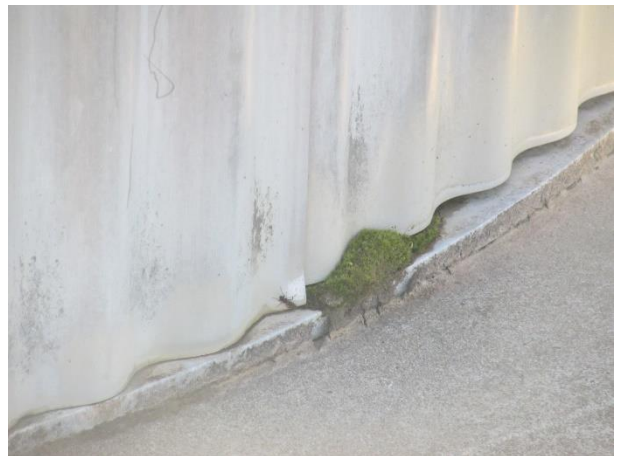
V23	Anchor Bolts	n/a			No visual access to anchor bolts
V24	Saddle/Skirt	Good	Skirt		Visual limited to ID surface
V25	Davit	Good			Double nutted, no damage noted
V26	Fireproofing	n/a			
V31	Connections Other (Please explain)	Good			All connections secure
V32	Small Branches	n/a			
V33	Nozzles	Good			No corrosion or damage noted
V34	Manways	Good			No corrosion or damage, gasket surfaces acceptable
V35	Reinforcing Pads	Good			Weepholes present, free of debris, no evidence of leaks
V36	Inadequate Thread Engagement	Good			Adequate thread engagement
V37	Bolting	Good			Bolting tight and secure. No corrosion of threads noted
V38	Flanges	Good			No leaks or corrosion noted
V39	Leak Clamps	n/a			
V41	Insulation Other (Please explain)	Fair	Skirt and bottom outlet piping		Insulated and clad
V42	Damage	Good	Bottom outlet piping		Minor cladding damage
V43	Penetrations	Poor	No coverplate on skirt insulation cutout		No coverplate on skirt insulation cutout. Moisture has access under skirt. Moss growing on top and bottom of cladding, suggesting that the insulation behind cladding is moist.

Moss growing at base of skirt cladding

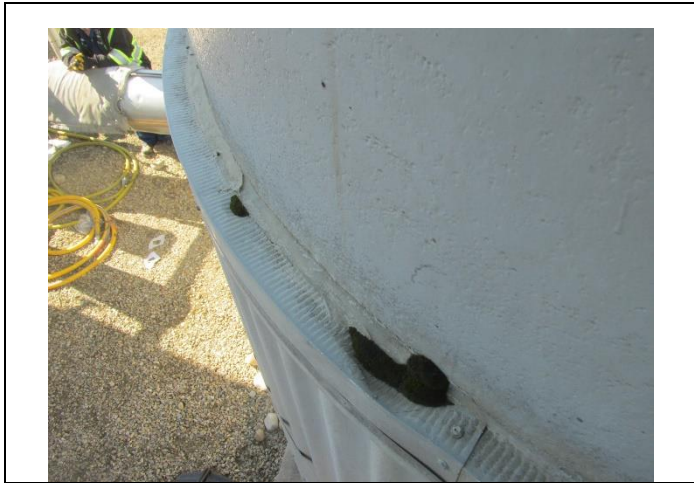
Moss growing at top of skirt cladding

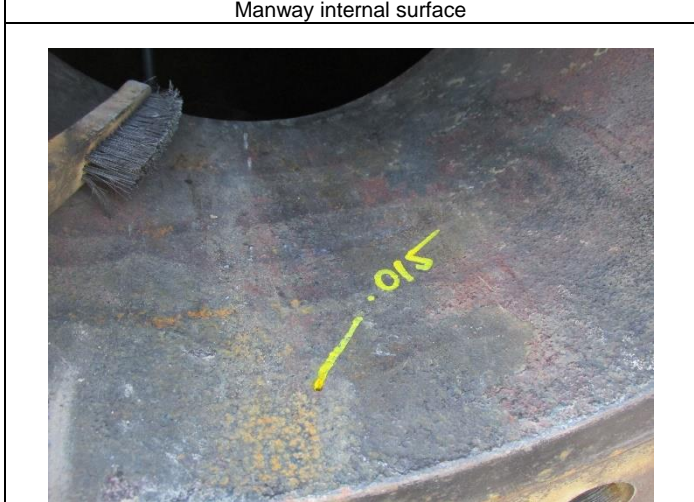
Internal inspection was done after vessel was aired out. Internal access is through 18" manway. Manway flange gasket surface in acceptable condition, no corrosion or damage noted. Minor surface corrosion noted on bottom of manway nozzle throat, approx. 0.015" deep. Scaffolding was set up within vessel to visual access upper portions of shell and top head. General corrosion was found throughout bottom shell course. There is no evidence that the general corrosion found is active. General corrosion depths average 0.015" to 0.025". Some small areas of hard black deposits found on bottom shell. No under deposit corrosion noted when areas scraped clean. No significant corrosion noted on circs, longseam, nozzle or attachment welds. Bottom head was found to be in good condition, no significant corrosion or damage noted. Bottom nozzle vortex breaker was found to be in acceptable condition and securely attached. Inlet deflector plate and nozzle cover attachments are all securely attached. There is a ring welded around top shell below top head for a demister. However there is no demister currently installed or in use in vessel. There was a large loose nut found laying on top of demister ring. Loose nut was removed from vessel. Half way up the shell there

General corrosion on bottom of manway nozzle throat

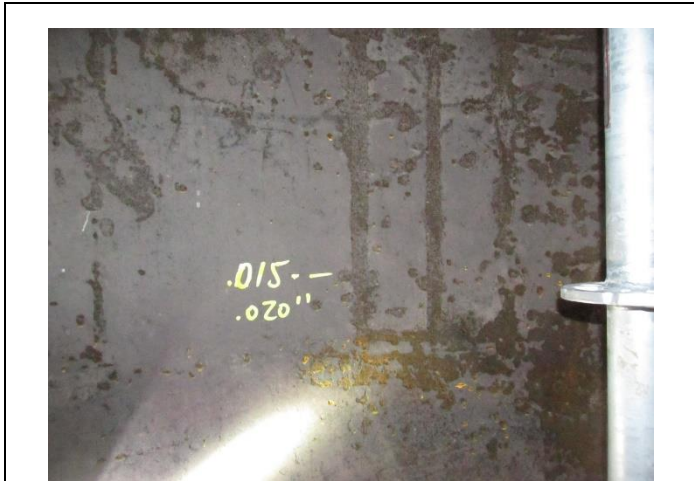
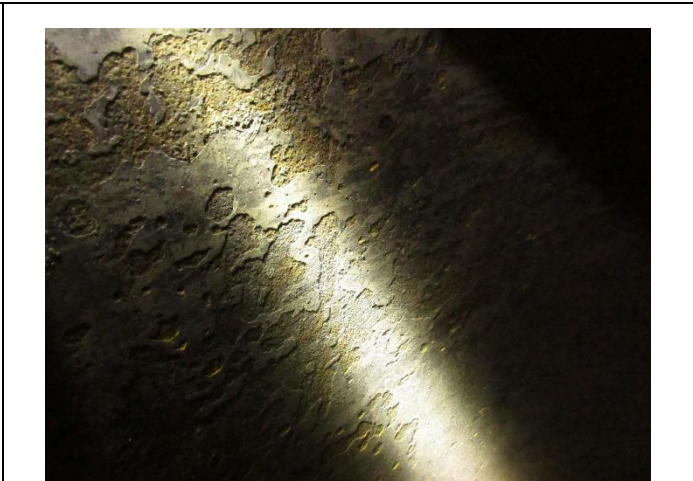
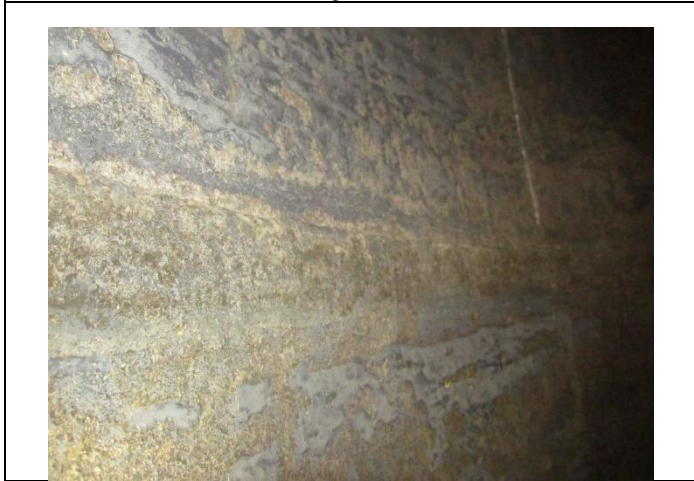
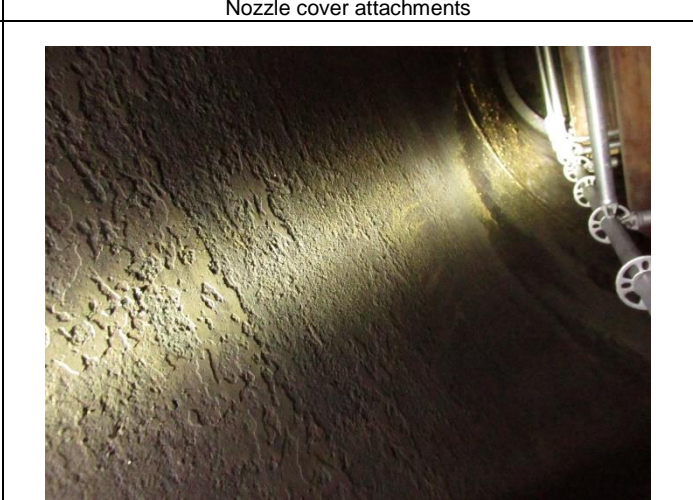
ID	Description	Condition	Location	NCR	Comments
V1	General Other (Please Explain)	Good			Overall
V2	Corrosion (depth, length, width)	Fair	Bottom shell		General historic corrosion, 0.015" to 0.025" deep average bottom shell
V3	Erosion	n/a			No erosion noted
V4	Distortion	n/a			No distortions noted
V5	Blisters	n/a			No blisters noted
V6	Deposits	Fair			Waxy buildup on top half of shell and top head. Bottom half of shell was mostly clean. Some small areas of hard black deposits noted on bottom shell.
V7	Heads	Good			No significant corrosion or damage noted
V8	Welds	Good			No corrosion, damage or visible defects noted
V9	Nozzles	Good			No corrosion, damage or obstructions noted
V10	Shell	Fair	Bottom shell		General historic corrosion, 0.015" to 0.025" deep average bottom shell
V11	Gasket Surfaces	Good	manway		Acceptable condition, no corrosion or damage
V21	Internals Other (Please explain)	Good	Inlet deflector plate, vortex breaker, nozzle cover attachments		Securely attached

Bottom shell general corrosion

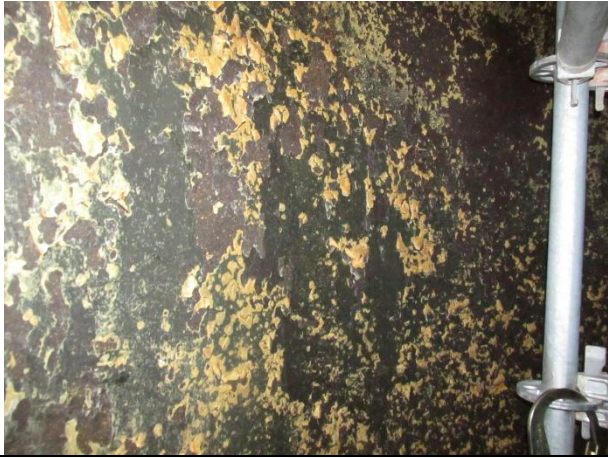
was some waxy product buildup remaining of shell and top head. This wax buildup was easily scraped off to allow visual access to shell and top head surfaces. No significant corrosion or damage noted underneath wax buildup on areas where it was removed via scraping on mid, or top shell, or on top head. No corrosion noted on top head or mid shell. No corrosion, damage or obstructions noted within inlet, top outlet or bottom outlet nozzles. No nozzle obstructions noted.

Mid shell waxy buildup

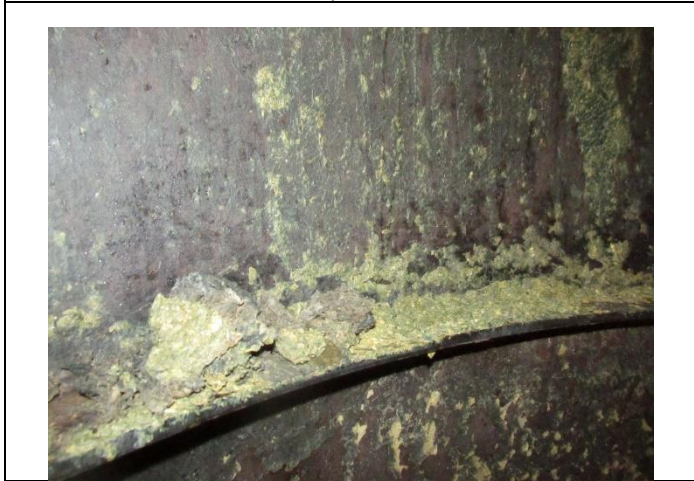
Top demister ring, no demister in use within vessel

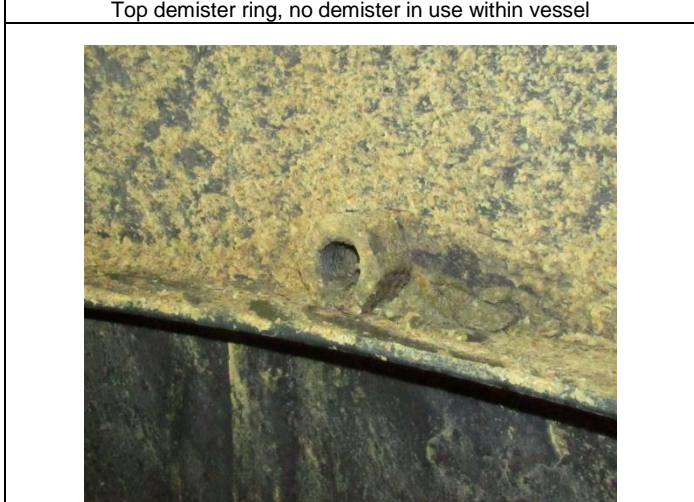
Loose nut found laying on top demister ring

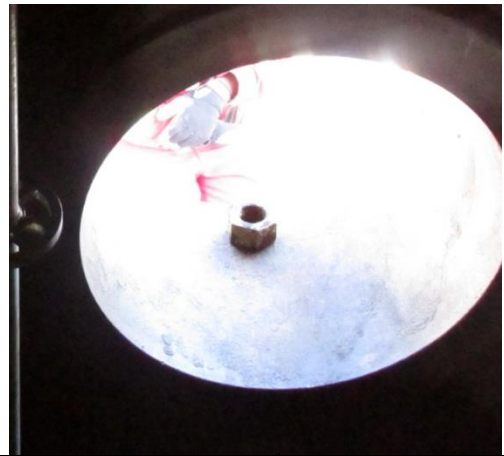
Loose bolt found on top of demister ring removed from vessel

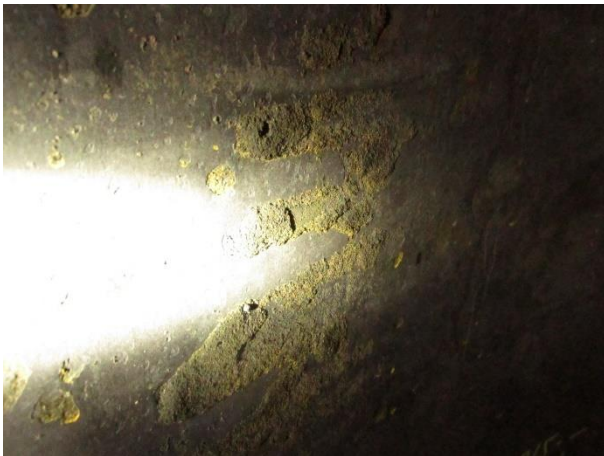
Bottom shell hard black deposits
