API 653 ABOVE GROUND STORAGE TANK OUT OF SERVICE INSPECTION FINAL REPORT

HUSKY ENERGY

UNWIN SALT WATER DISPOSAL

TANK # T-101

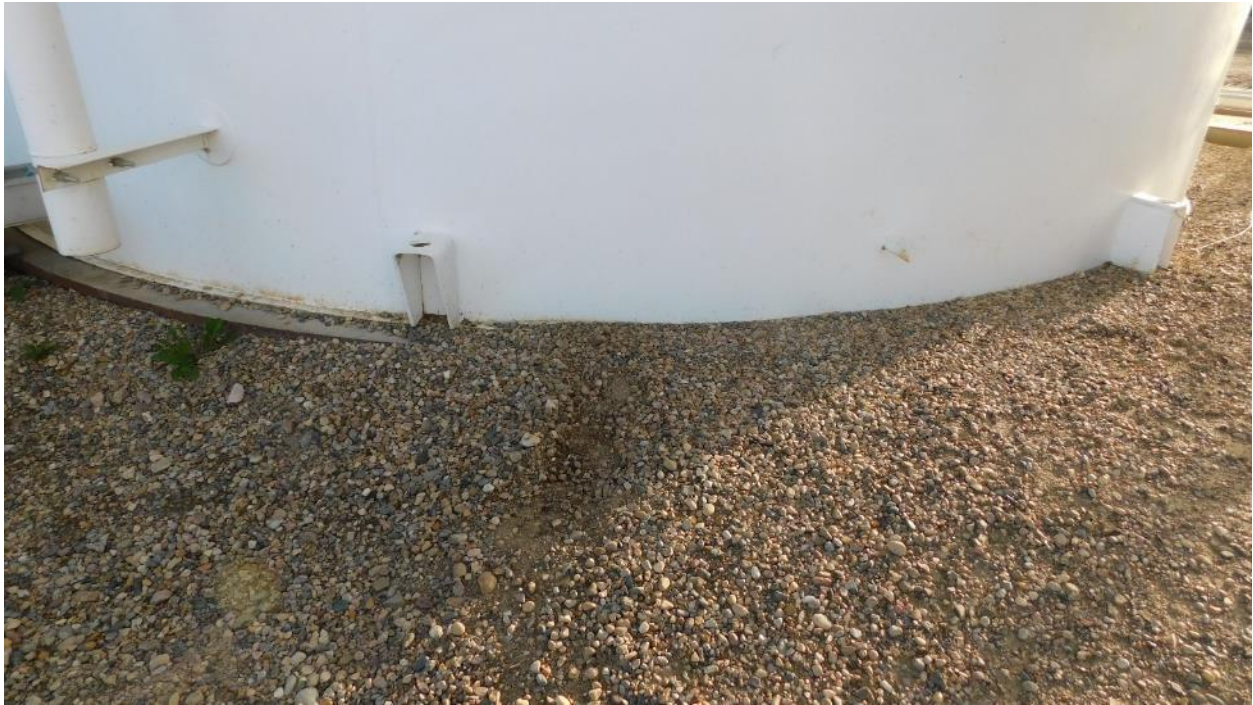
Photograph 6: Foundation Overview

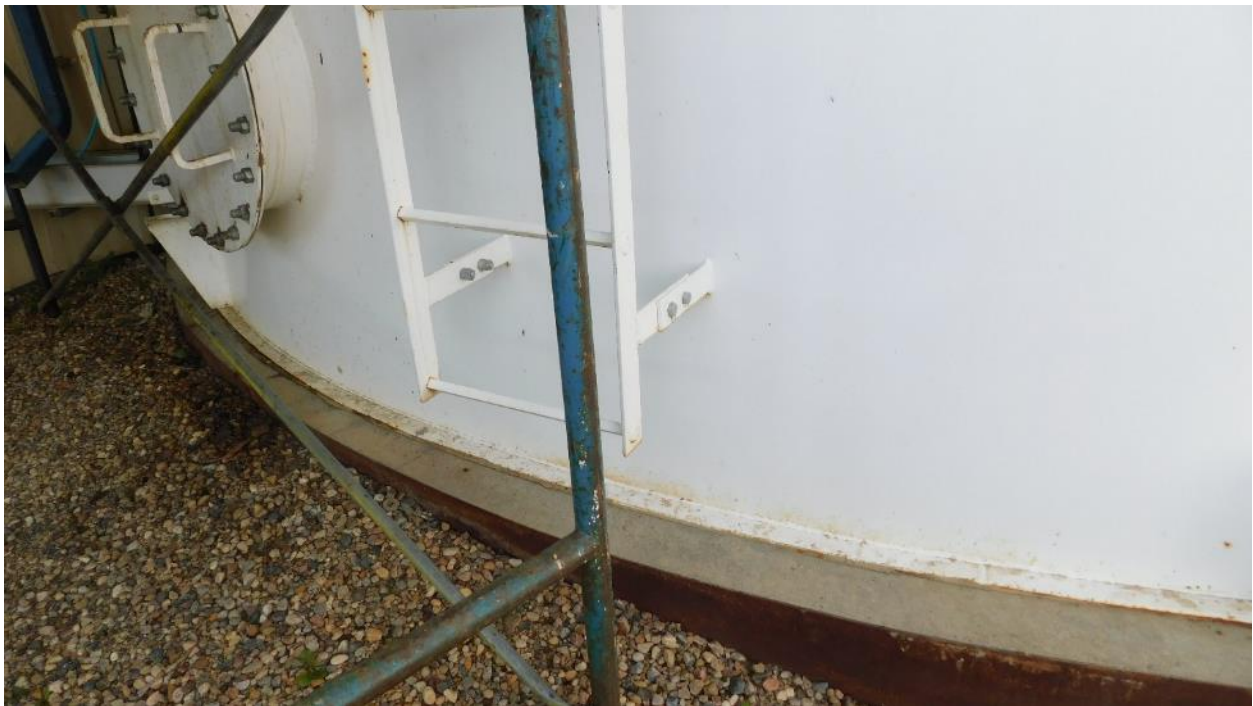
Photograph 7: Foundation Concrete Ring Wall

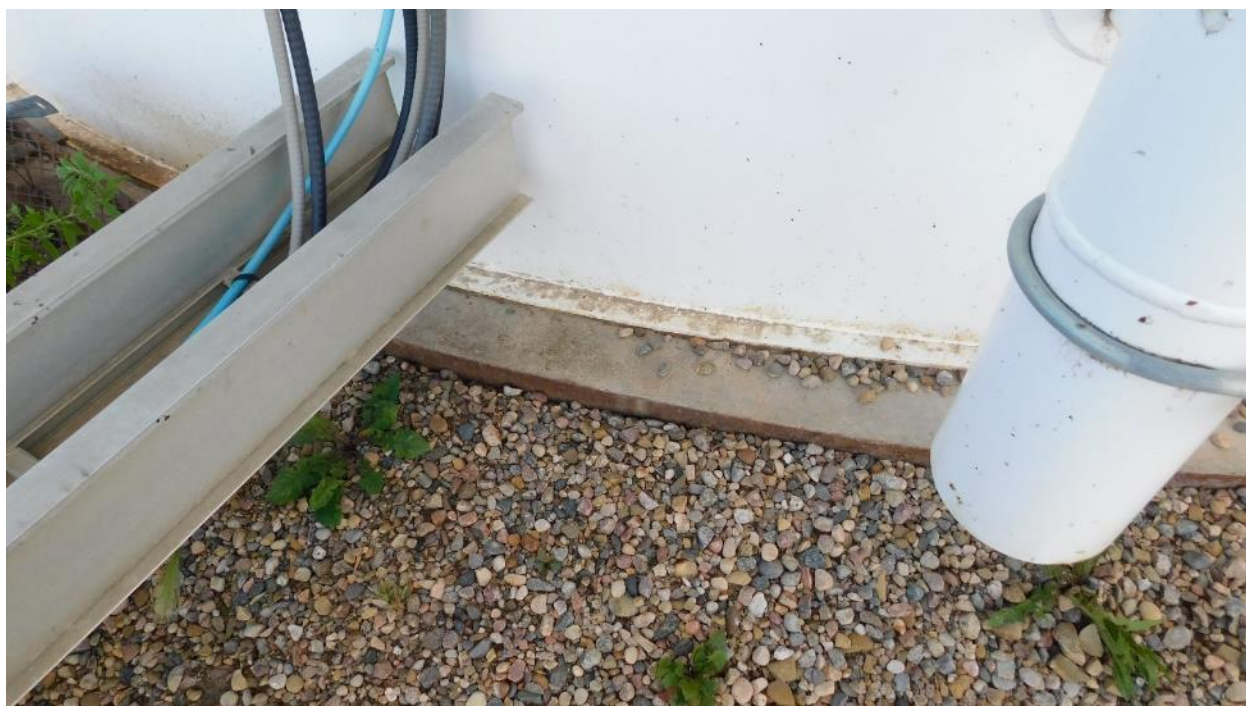
Photograph 8: Foundation Concrete Ring Wall

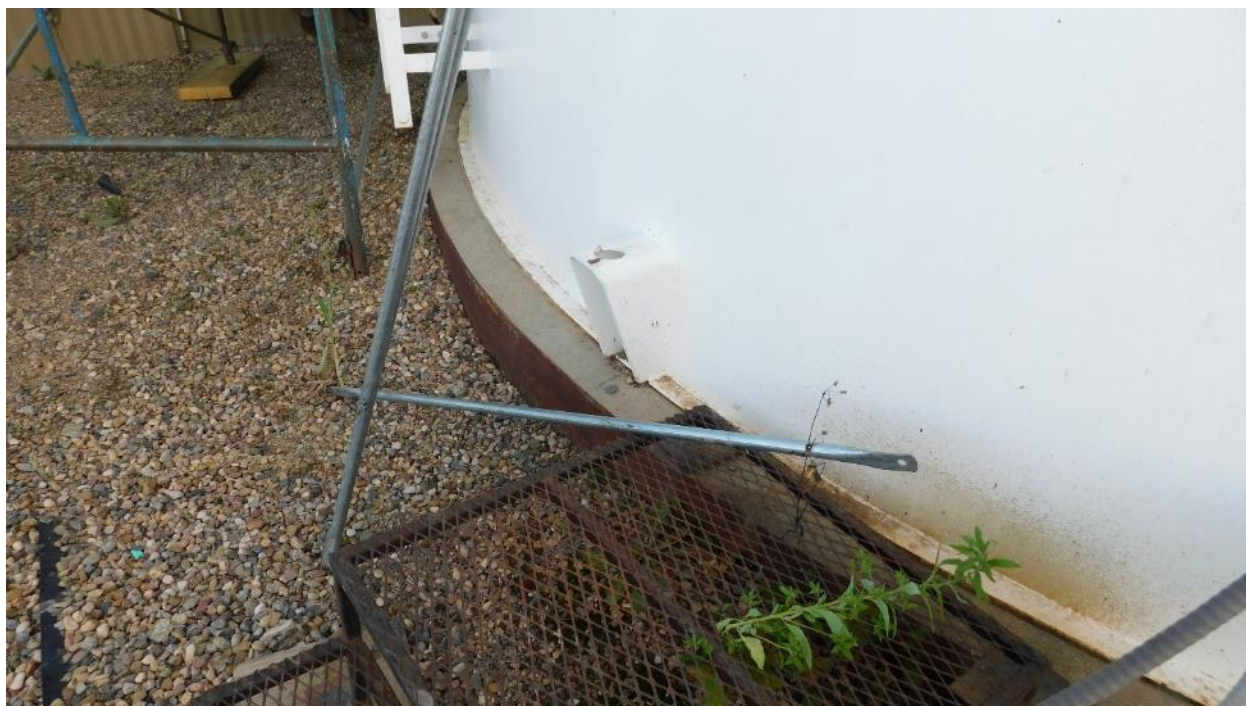
Photograph 9: Foundation Concrete Ring Wall

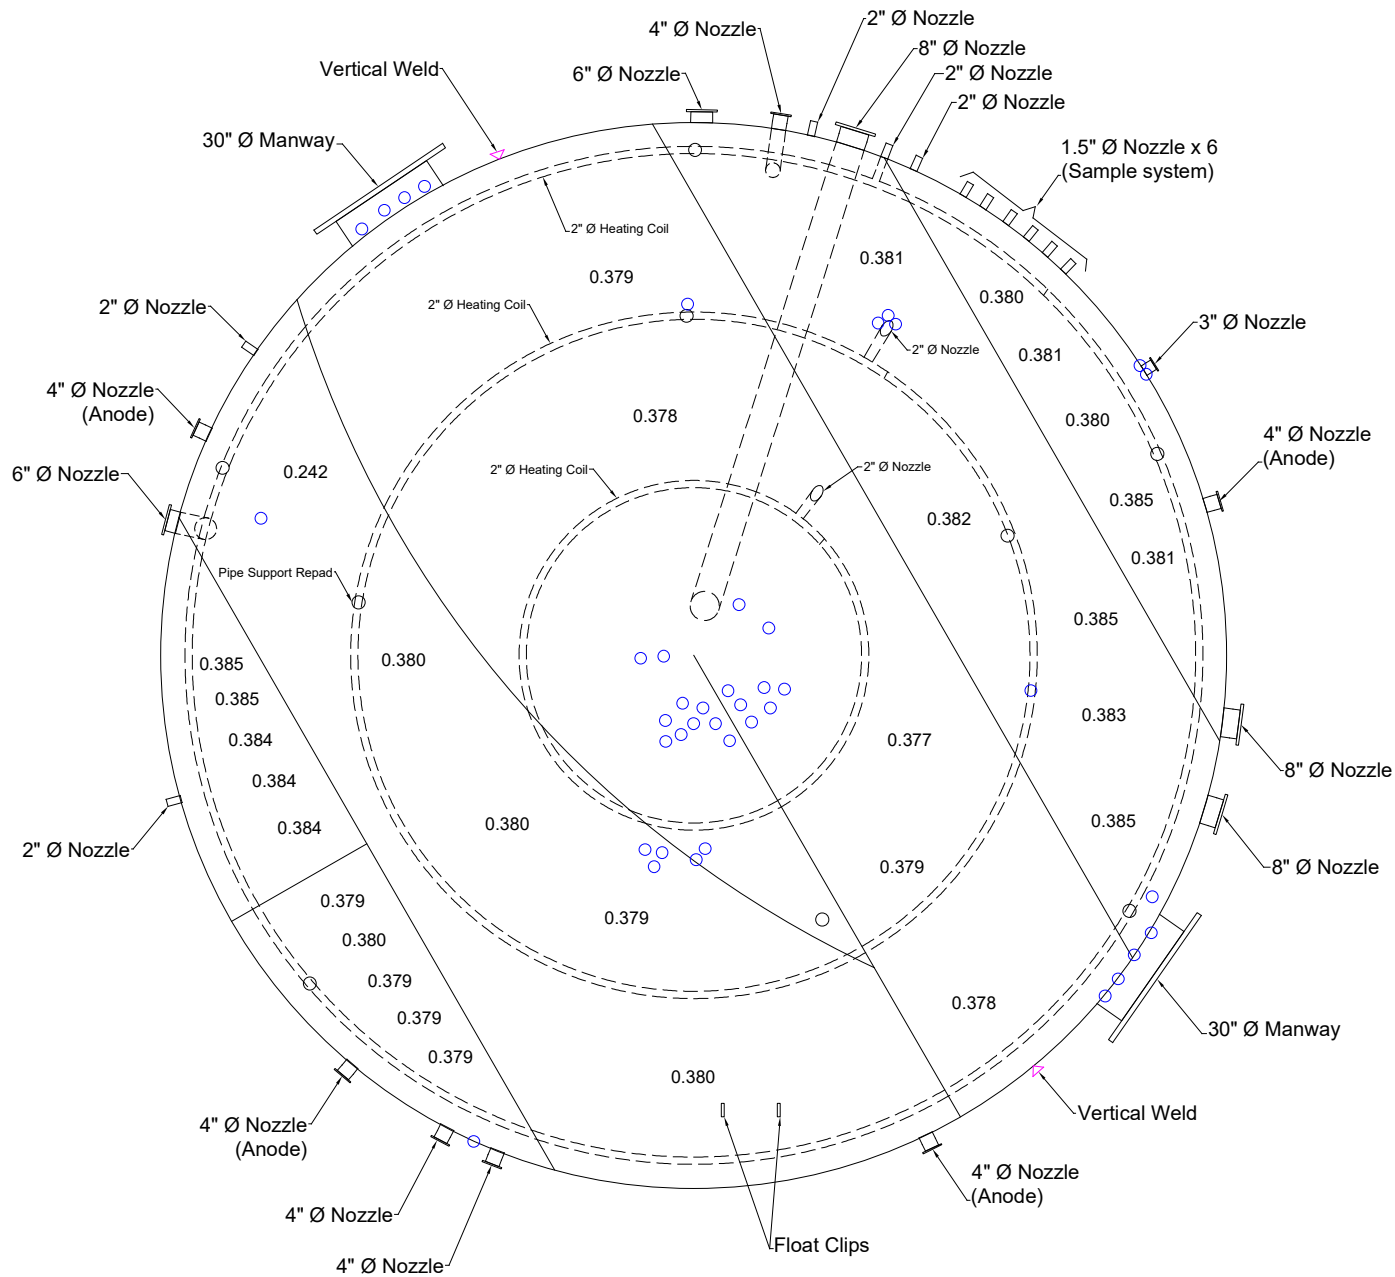
BOTTOM PLATE LAYOUT

- 1.1.5 Coating failures were observed on the bottom plate particularly around the centre of the tank. Refer to Bottom Plate Layout drawing for additional details.

○ Coating Failures

- 10.1.1 It is recommended to repair the coating failures observed on the bottom plate and the shell-to-bottom weld.

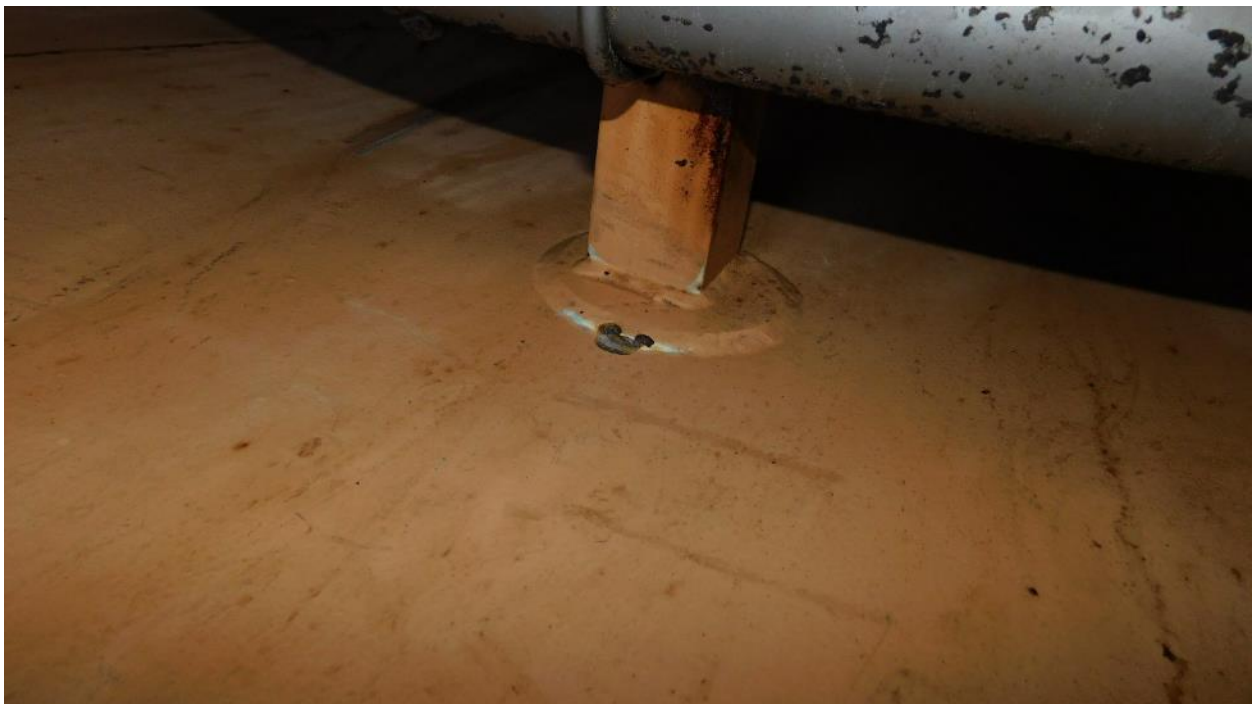
Photograph 13: Coating Failure on Pipe Support Reinforcing Pad

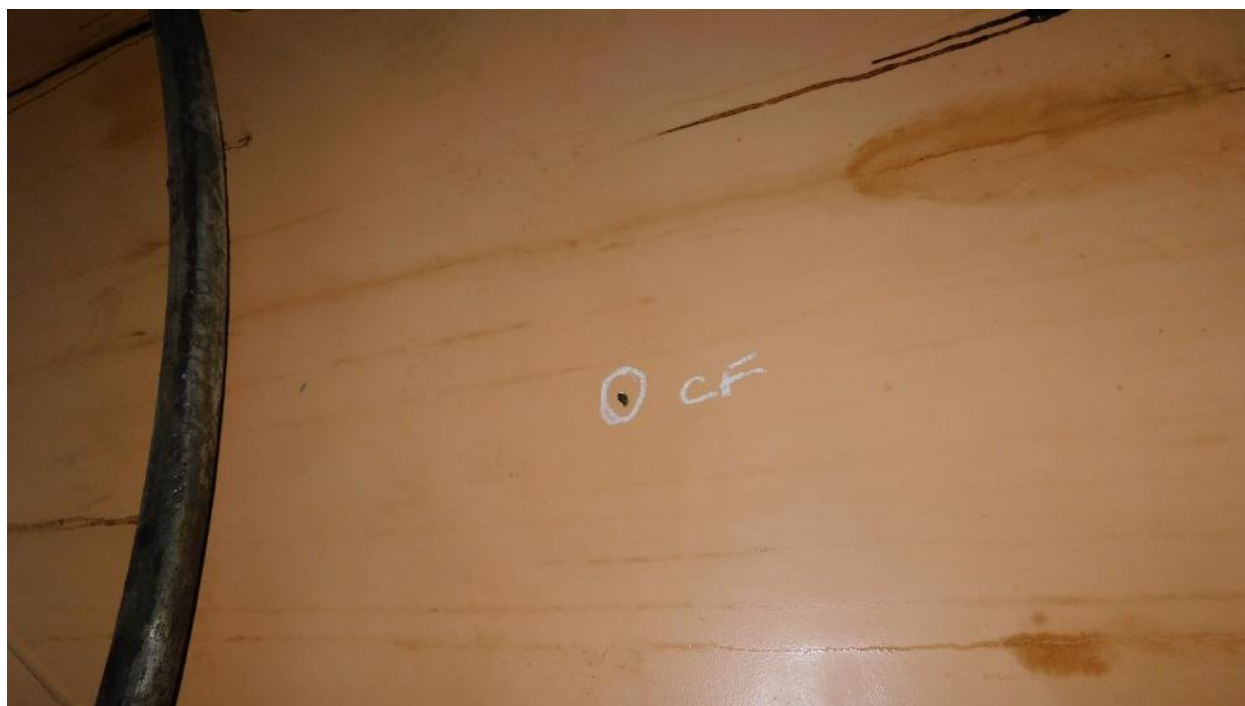
Photograph 14: Coating Failure on Bottom Plate

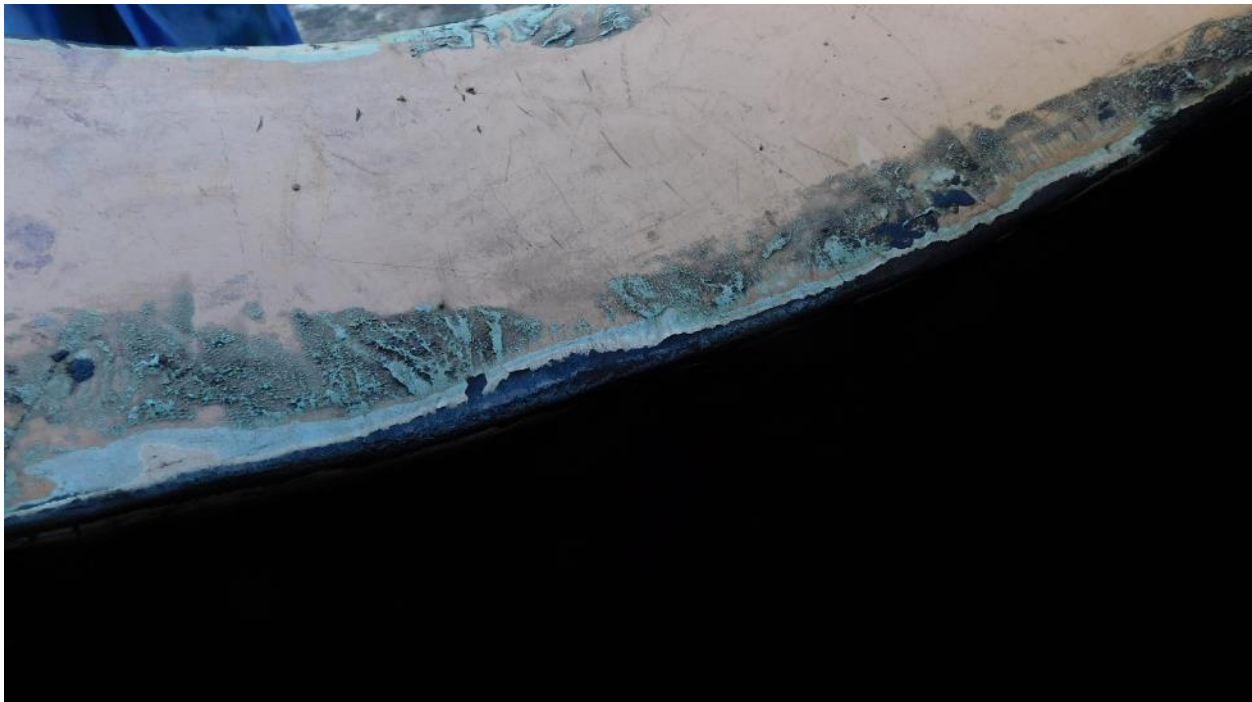
- 1.4.1 Nozzle interiors were visually inspected where possible. No indication of corrosion was observed in the accessible areas.
- 1.4.2 No corrosion was observed in the nozzles externally.
- 1.4.3 Coating failures were observed and marked for repair on the internal nozzles.

Photograph 21: Coating Failures on Entrance Manway

- 10.4.1 It is recommended to repair the coating failures observed on the internal nozzles.

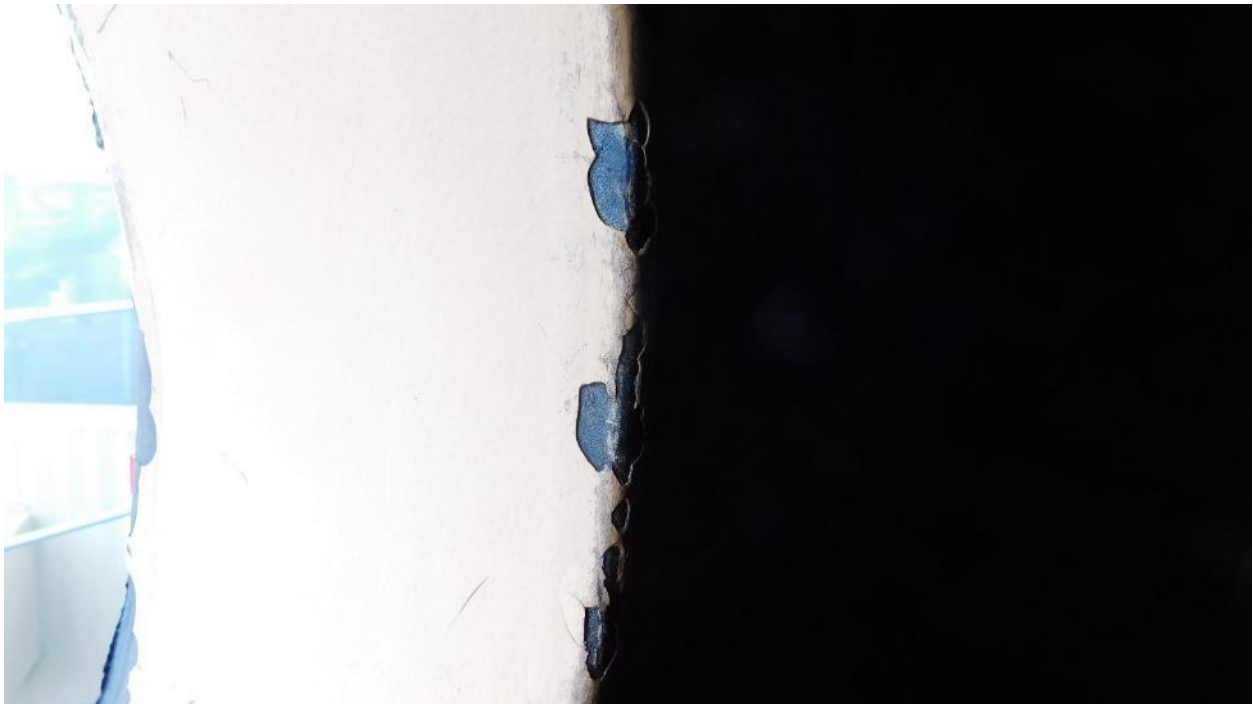
Photograph 27: Coating Failure on Manway

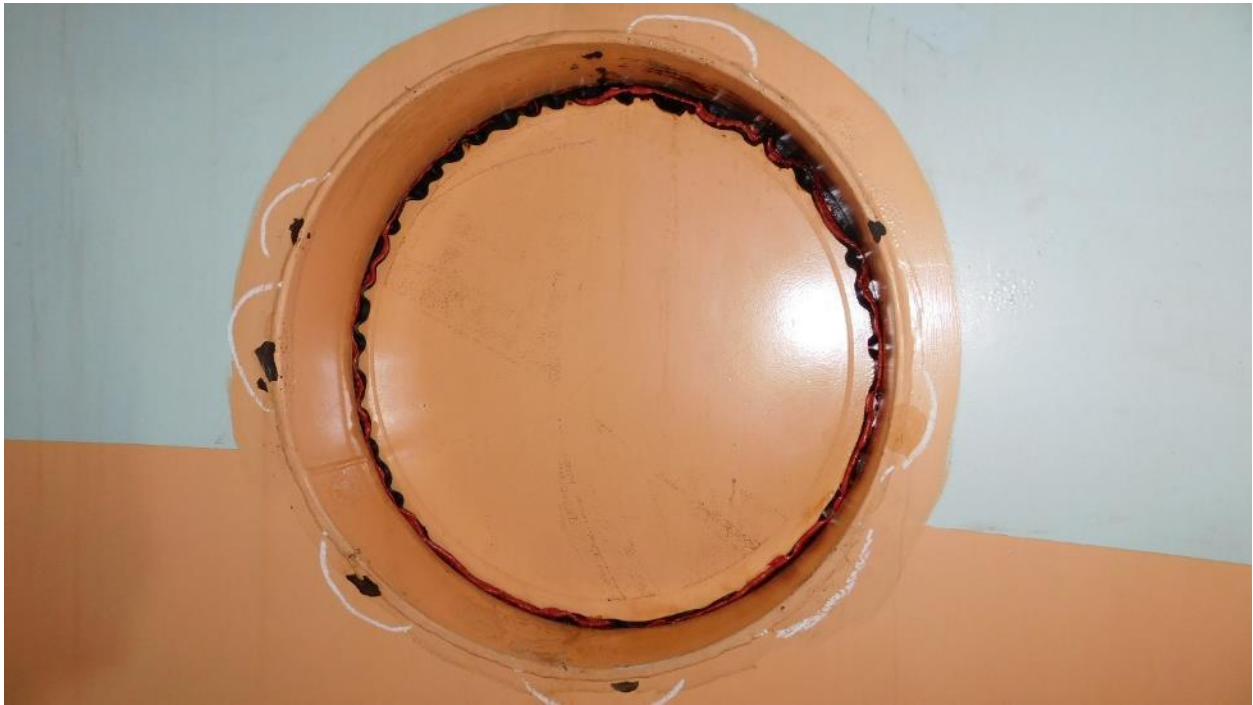
Photograph 28: Coating Failures Around Internal Manway

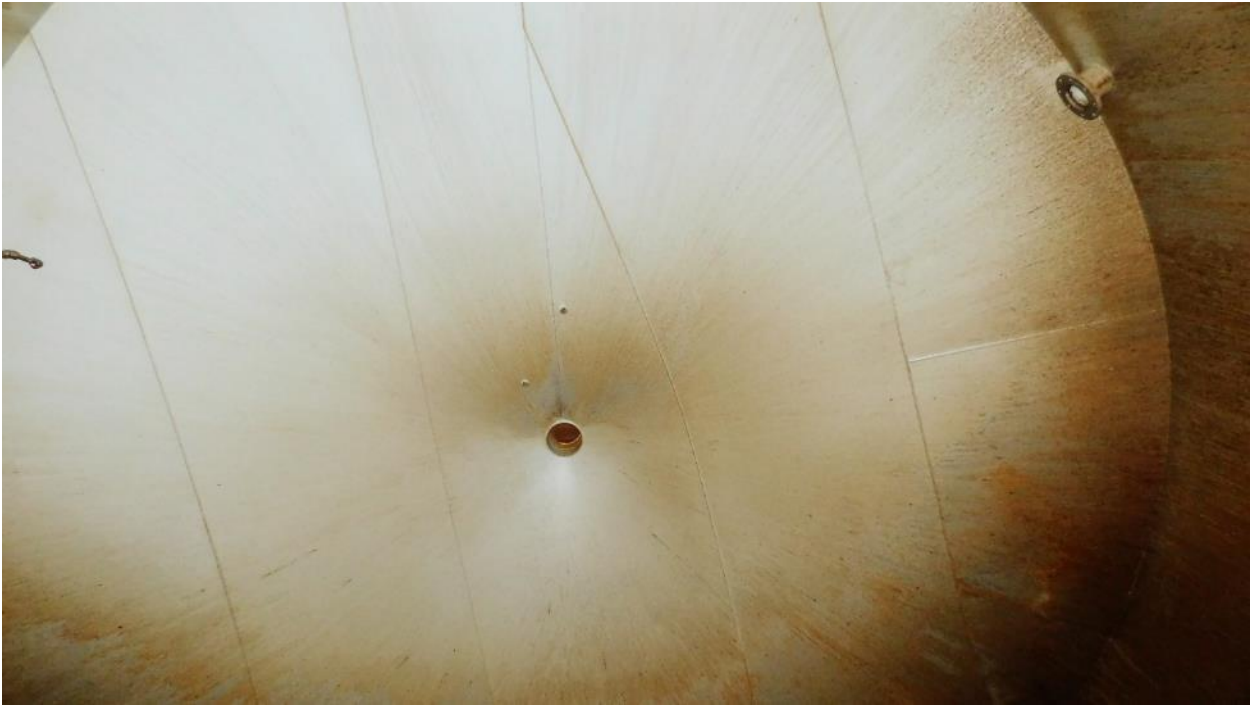
- 1.5.1 The fixed roof was visually inspected from the bottom plate internally. No corrosion or coating failures were observed.

Photograph 36: Fixed Roof Internal Surface

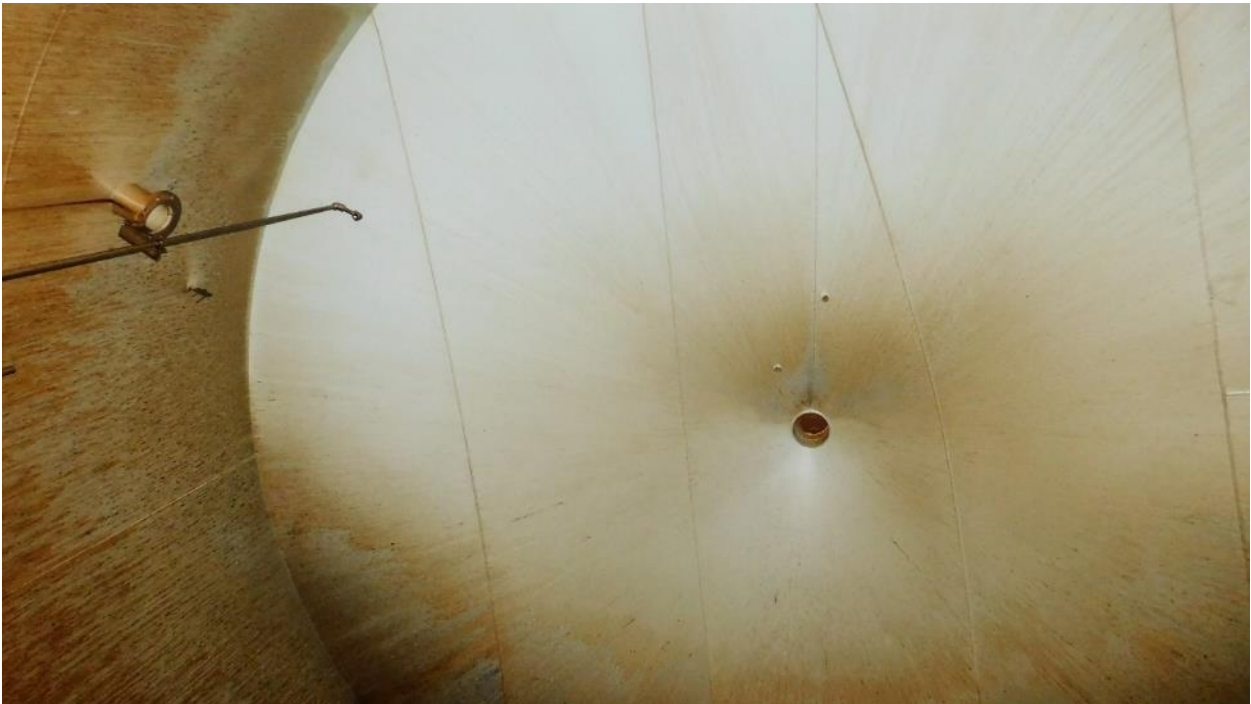
Photograph 37: Fixed Roof Internal Surface

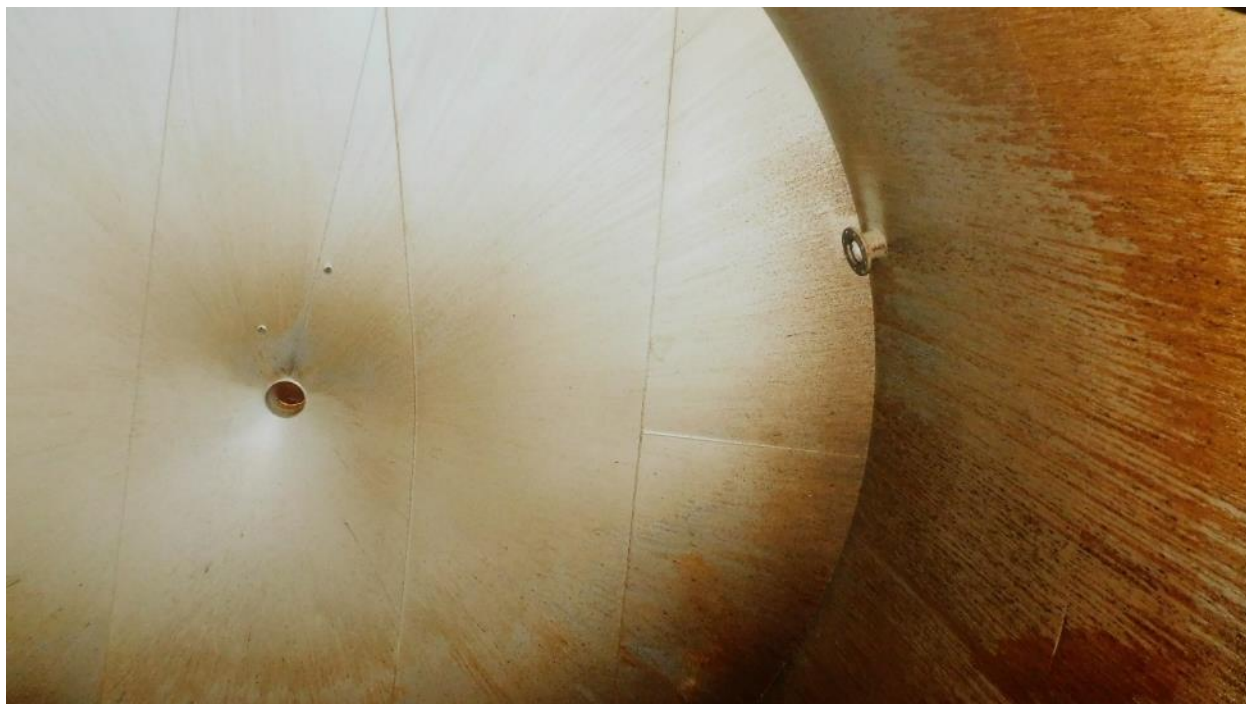
Photograph 38: Fixed Roof Internal Surface
