API 653 ABOVE GROUND STORAGE TANK OUT OF SERVICE INSPECTION FINAL REPORT

HUSKY ENERGY

UNWIN SALT WATER DISPOSAL

TANK # T-102

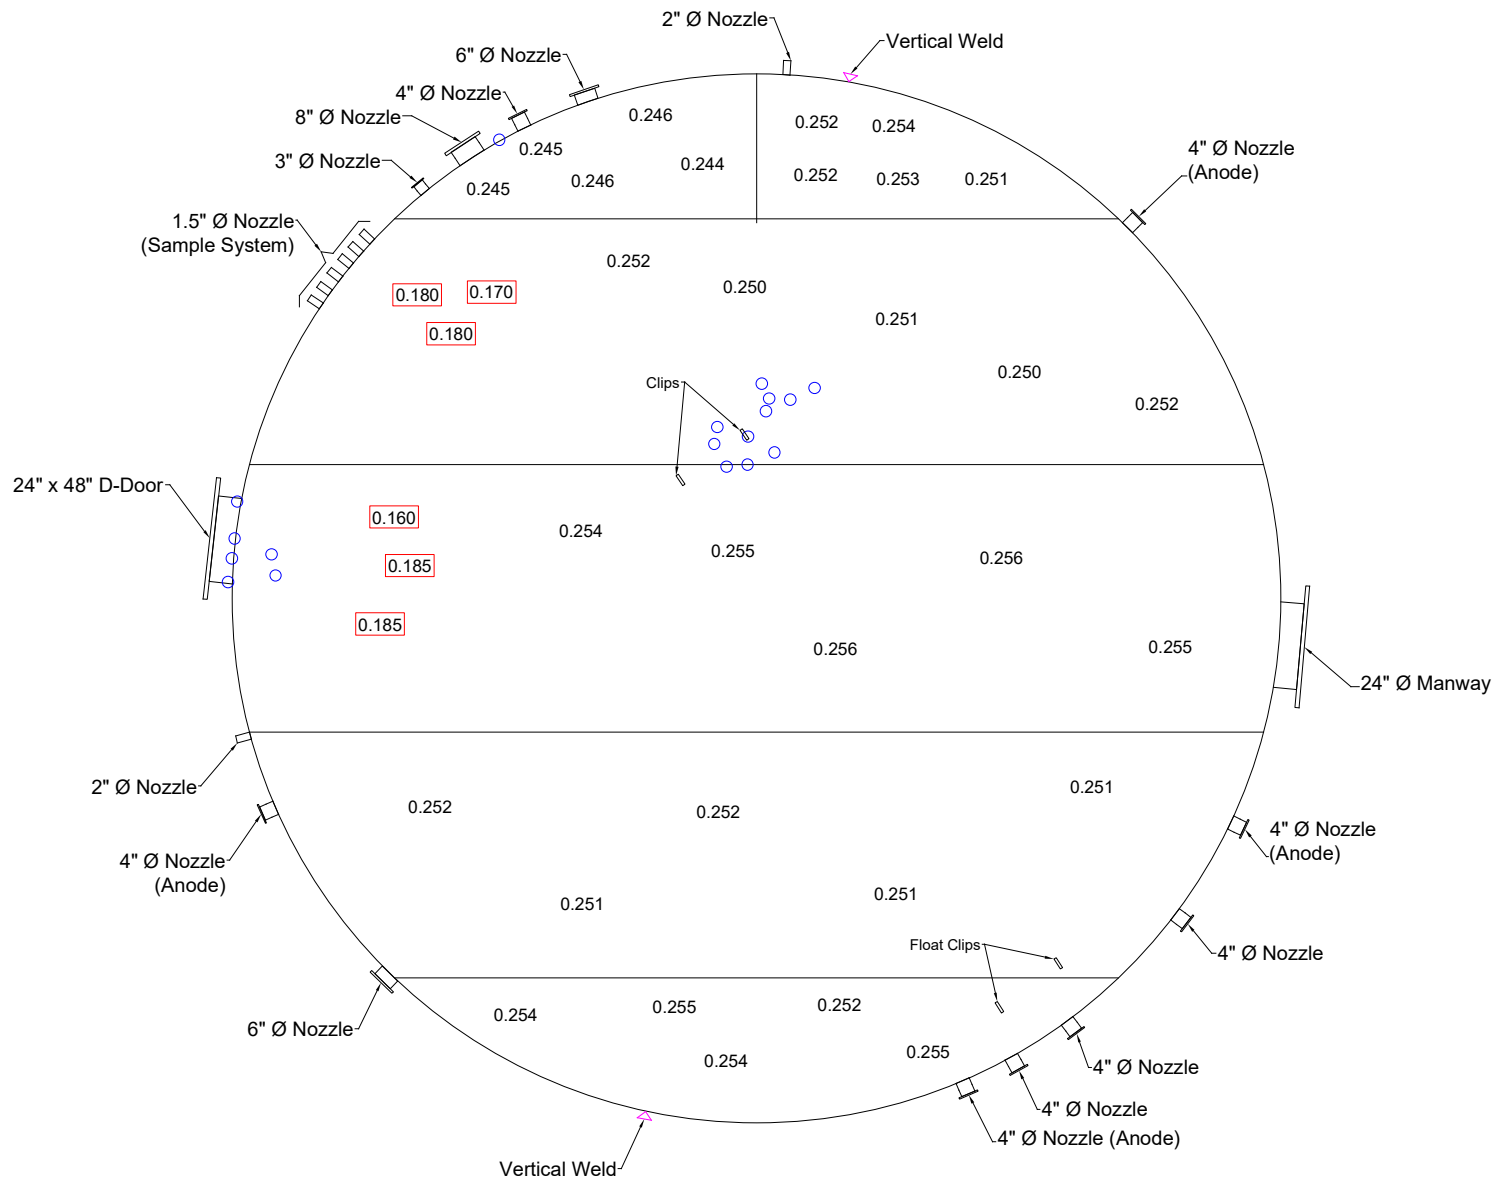
TITLE:
BOTTOM PLATE LAYOUT

- 1.1.1 A Magnetic Flux Exclusion (MFE) scan was performed on all accessible areas of the tank bottom plate. Six (6) MFE indications from underside corrosion were found. The minimum thickness found with ultrasonic examination was 0.160 inch utilizing the echo to echo technique with a nominal plate thickness of 0.250 inch.

Based on remaining life calculations, no bottom plate repairs are recommended at the time of this inspection.

- Coating Failures
- 0.252 Random UT Readings (Echo to Echo)
- 0.170 MFE Indications

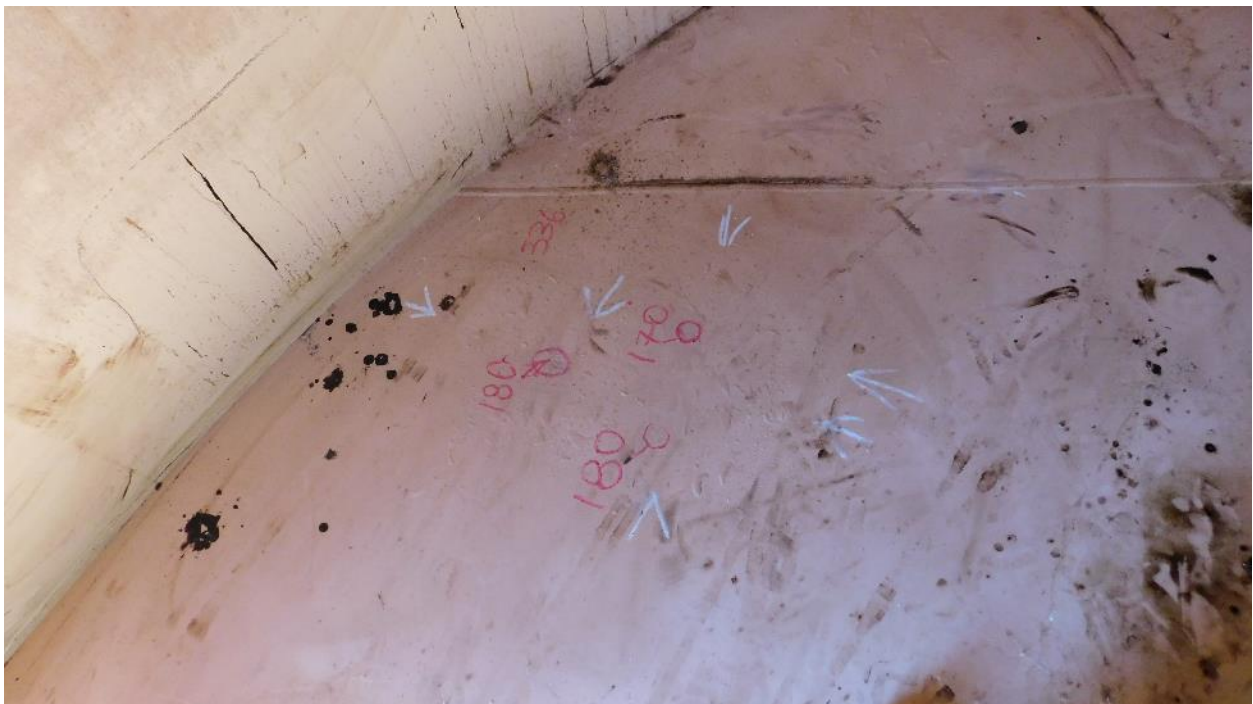
Photograph 12: MFE Indications

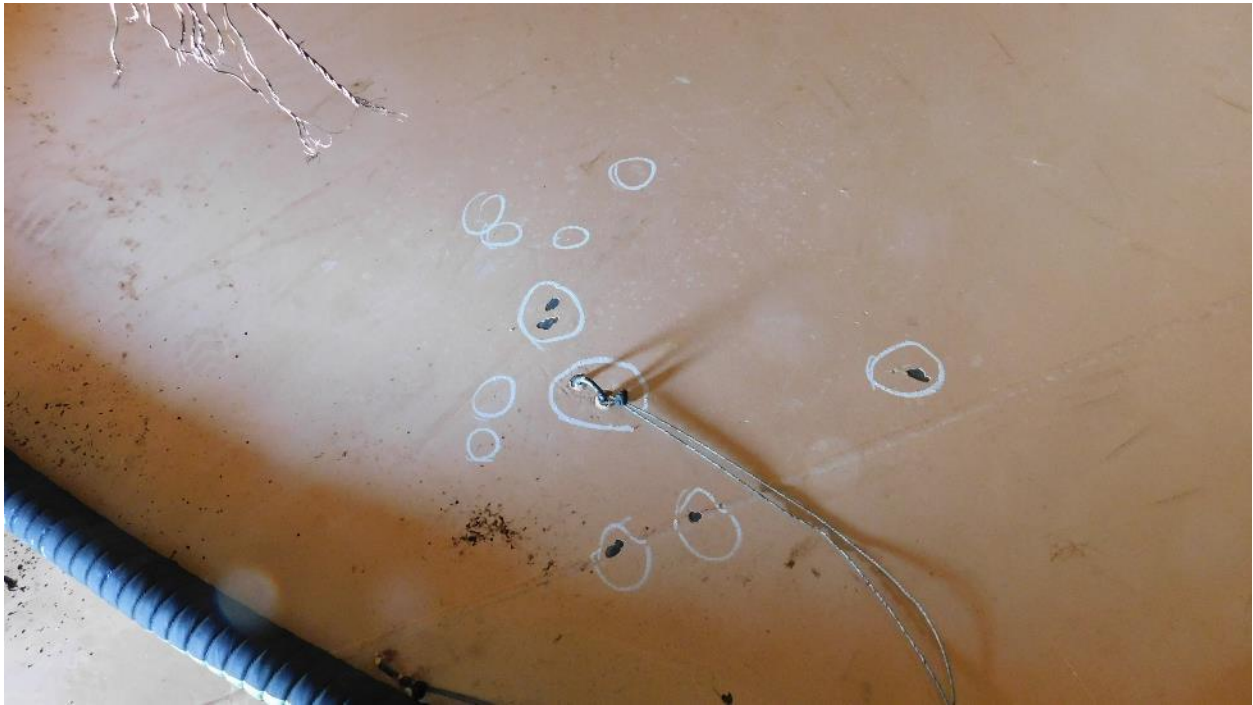
- 1.1.4 Coating failures were observed on the bottom plate and around the float clips.
- 1.1.5 Areas of coating failure were observed on the internal shell-to-bottom weld.

Photograph 13: Coating Failures on Bottom Plate

10.1.1 It is recommended to repair the coating failures observed on the bottom plate and the shell-to-bottom weld.

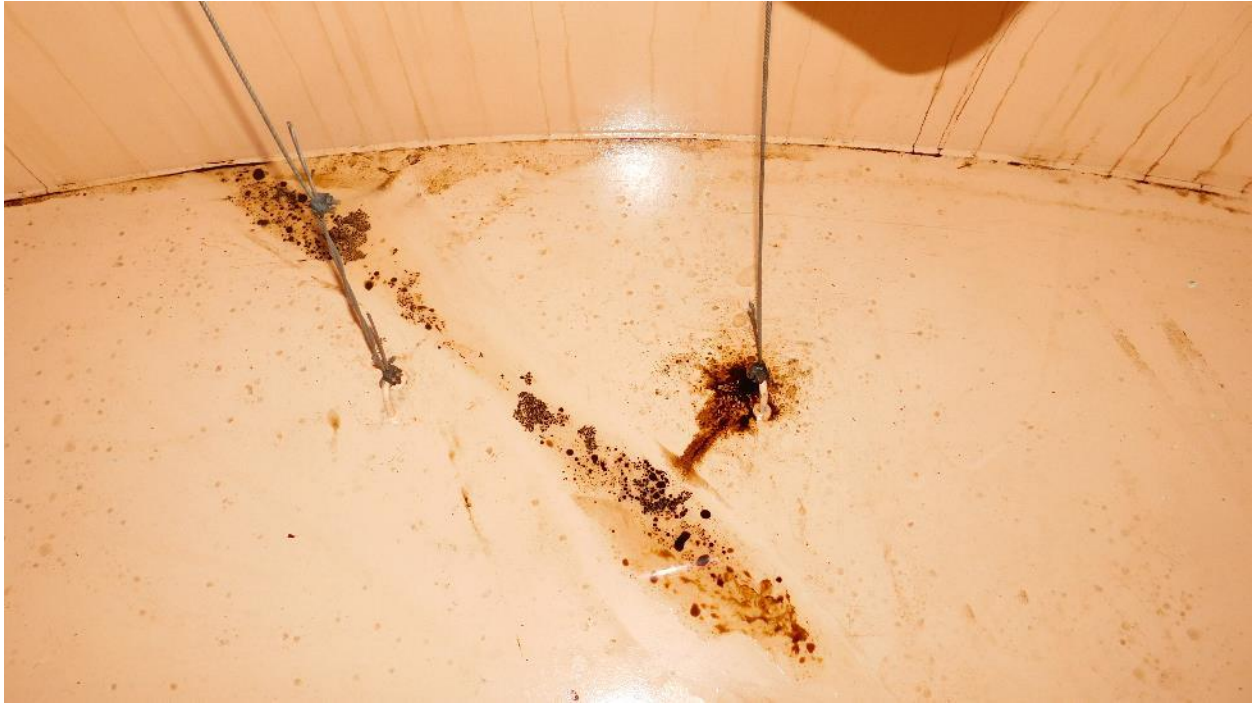
Photograph 27: Float Clips

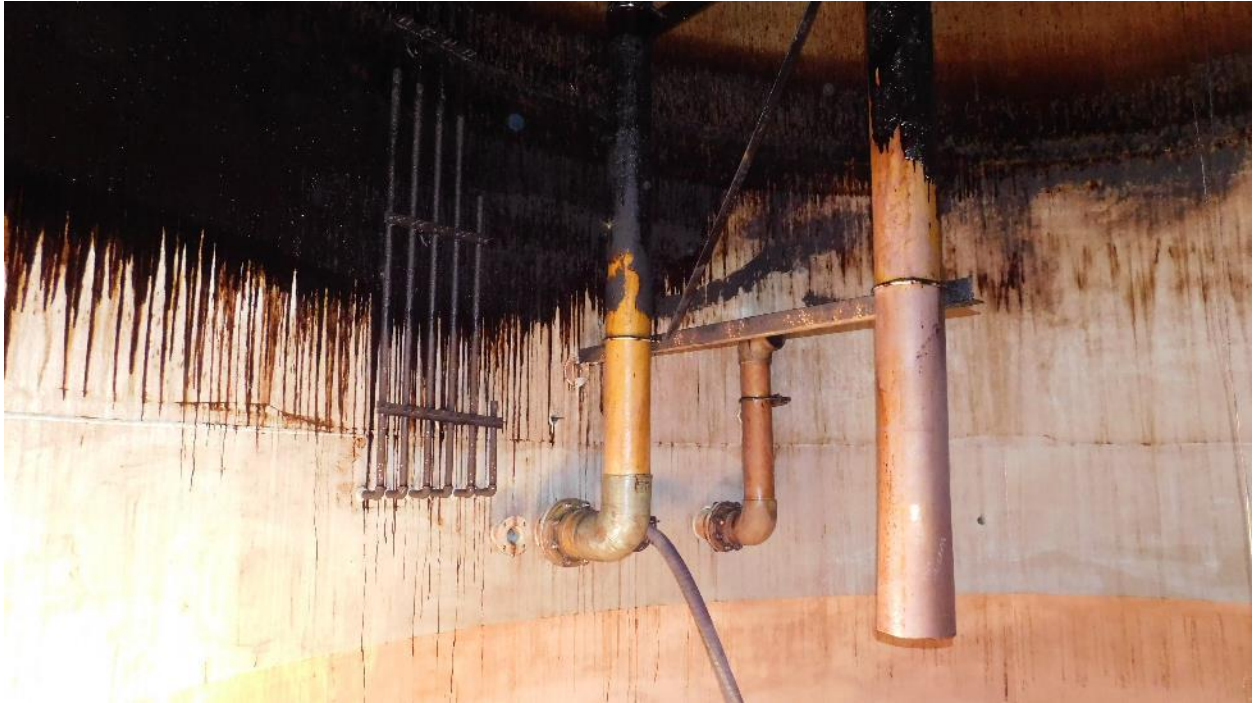
- 1.4.1 Nozzle interiors were visually inspected where possible. No indication of corrosion was observed in the accessible areas.
- 1.4.2 No corrosion was observed in the nozzles externally.
- 1.4.3 Coating failures were observed and marked for repair on the internal nozzles.

Photograph 29: Internal Nozzles

10.4.1 It is recommended to repair the coating failures observed on the internal nozzles.

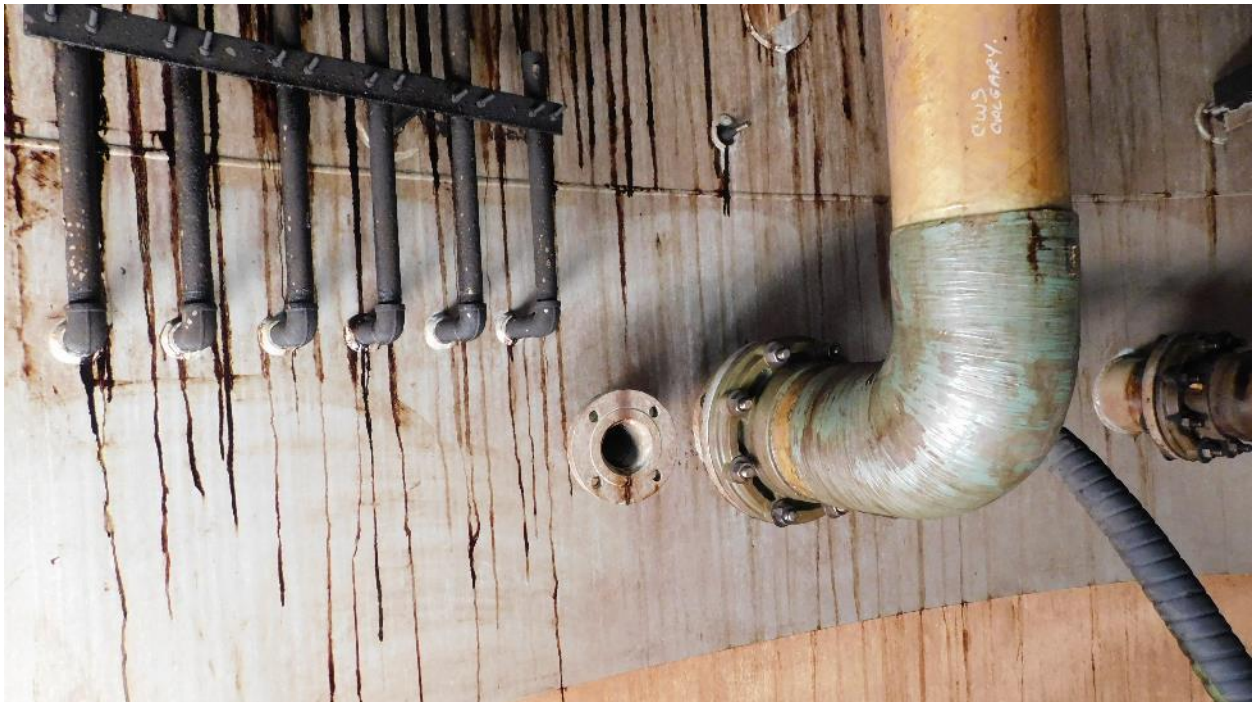
Photograph 30: Internal Nozzles
