Pressure Vessel Inspection Report

Equipment #: 62037651

Description: South Inlet Separator (North Building)

Inspection Date: July 23, 2009 Inspected by: Les Deverill

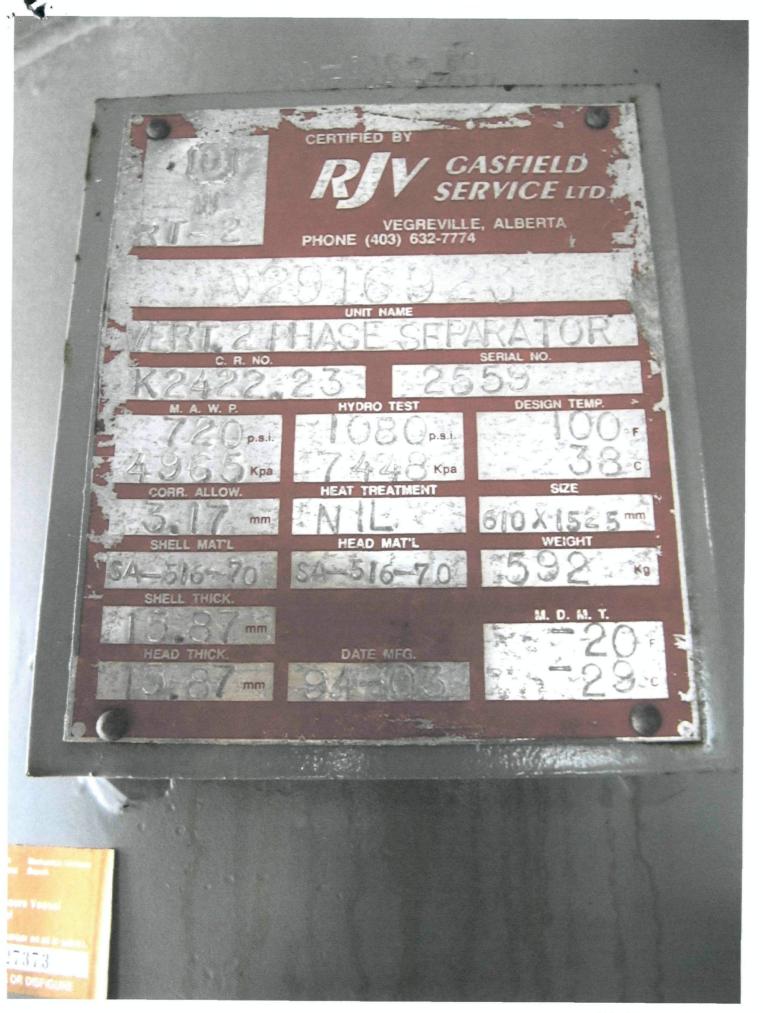
#5 - Mid Shell	0.625"	0.637" (16.2 mm)	0.634" (16.1 mm)
#6 - Bottom Knuckle	0.625"	0.809" (20.5 mm)	0.841" (21.4 mm)
#7 - Bottom Head	0.625"	No Access	NA
#8 - Outlet Drain El	0.436"	0.177" (4.5 mm)	NA
#9 – Inlet El	0.436"	0.161" (4.1 mm)	NA

Data Assessment indicates no major changes in wall thickness measurements since 2004, however the outlet drain elbow (2") and inlet elbow (2") are thin. There could be a spec break at the valves, but the measurement is low even for Schd 40 -- 2" piping fittings.

BY____OF____ SUBJECT PROJECT_ 6-34.50.27 NONTA BLDS - SOUTH INCEL SER 533 # 27373. A# 29/6923 TMUS # TOP N KNUCKEE #1 769 TOP OUT NOZZ #2 462 FLOOR CURPURE 708 WEST KNUCK#3 751 FROM FLOOR IP PSV OUGLET NOZZ #4 480 PLACES UPPER SHELL HJ. 637 5888CIALLY NEAR BOTT KHUCK #6 809 BOTT HO # 7. NO ACCESS CARMS TO FAT BOH DRAW SL #8 177 18856 ONLINE INUST 20 49

- The foundation & building in which the vessel is located, really needs to be repaired, to maintain a suitable operating environment & to ensure no one steps through the floor.
- Conduct an engineering review to ensure adequate thickness of associated piping.
