Pressure Vessel Inspection Report

Equipment #: 62019555

Description: Inlet Separator

Location: 6-34-50-27 W3 (Cost Center # 72325)

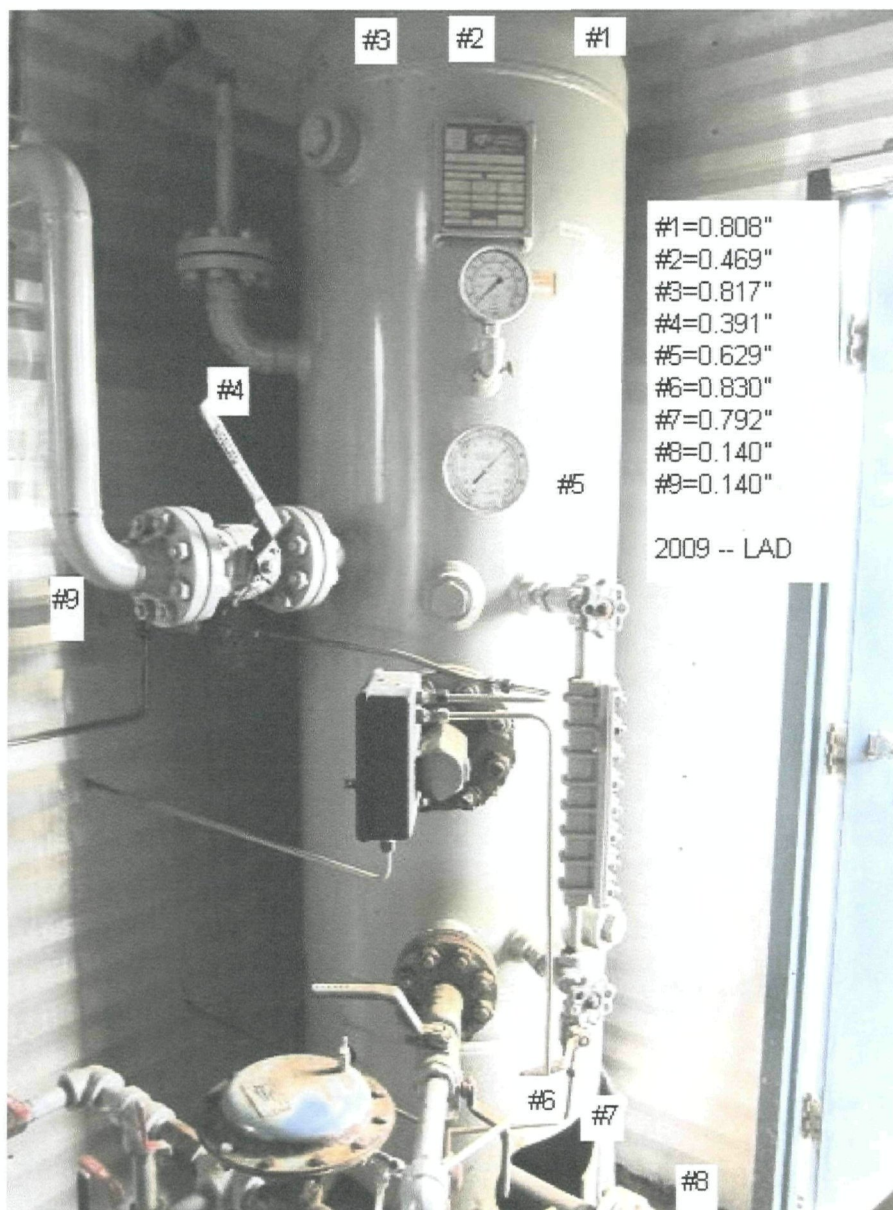
UT – TML's Description	Nominal Thickness	2009	2004
#1 – Top South Knuckle	0.625"	0.808" (20.5 mm)	0.793" (20.1 mm)
#2 – Top Outlet Nozzle	0.436"	0.469" (11.9 mm)	NA
#3 – Top West Knuckle	0.625"	0.817" (20.8 mm)	NA

#4 – PSV Elbow	0.436"	0.391" (9.9 mm)	NA
#5 – Mid Shell	0.625"	0.629" (16.0 mm)	0.626" (15.9 mm)
#6 – Bottom Knuckle	0.625"	0.830" (21.1 mm)	0.820" (20.8 mm)
#7 – Bottom Head	0.625"	0.792" (20.1 mm)	NA
#8 – Outlet Drain El	0.436"	0.140" (3.6 mm)	NA
#9 – Inlet El	0.436"	0.140" (3.6 mm)	NA

Data Assessment indicates no major changes in wall thickness measurements since 2004, however the outlet drain elbow (2") and inlet elbow (2") are very thin. There could be a spec break at the valves, but the measurement is low even for Schd 40 -- 2" piping fittings.

- The foundation & building in which the vessel is located, really needs to be repaired, to maintain a suitable operating environment & to ensure no one steps through the floor.
- Conduct an engineering review before restarting this vessel to ensure adequate thickness of associated piping.

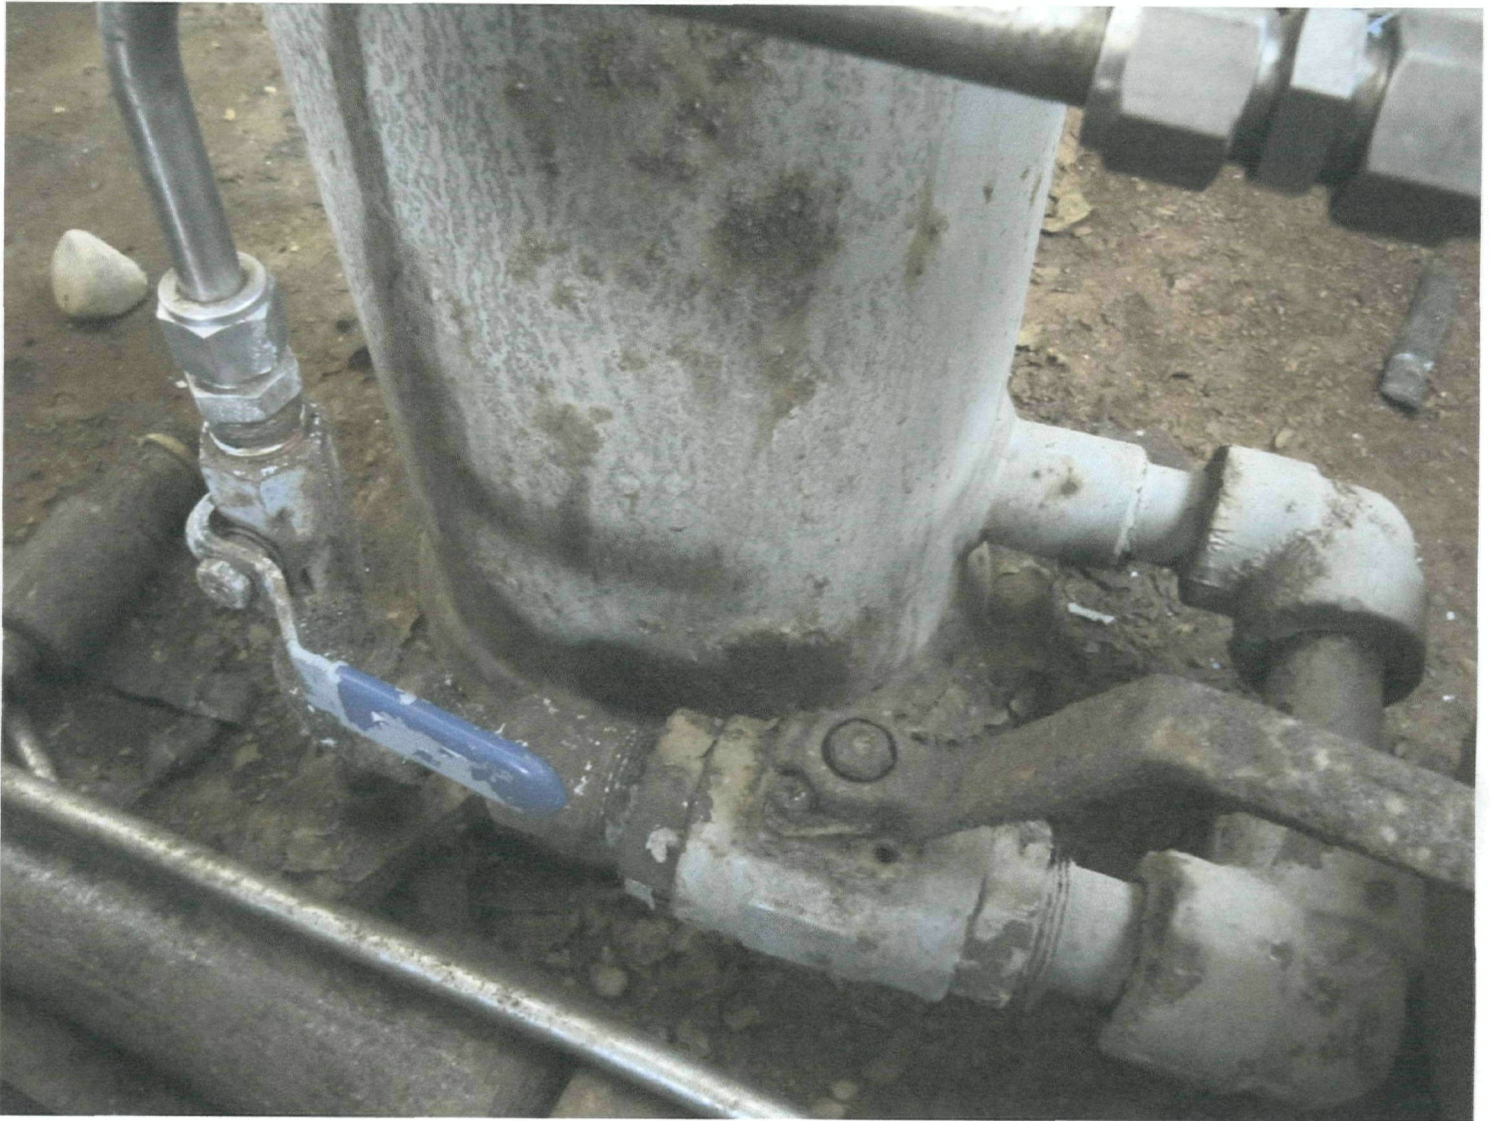
BLDG FLOOR

- Vessel in fair condition with no changes to previous inspection.
- The vessel building is deteriorating quickly, the wall where the door frame is contained is corroded away from the floor and the floor is extremely corroded. Floor perforations may be the next order of business.
- Inlet & Outlet Drain Elbows are exhibiting low measurements on the outside radius of the elbows (both @ 0.140"). Unless there is an engineering spec break, the design thickness for these elbows should be 0.436" (XXS). (Nozzles on drawing indicate XXS)
