# Tank Inspection Report

Location: 8-33-48-27 W3

Tank Type: Heavy Oil Storage

S/N: 05.05.24.13885 CAP: 1000 bbl

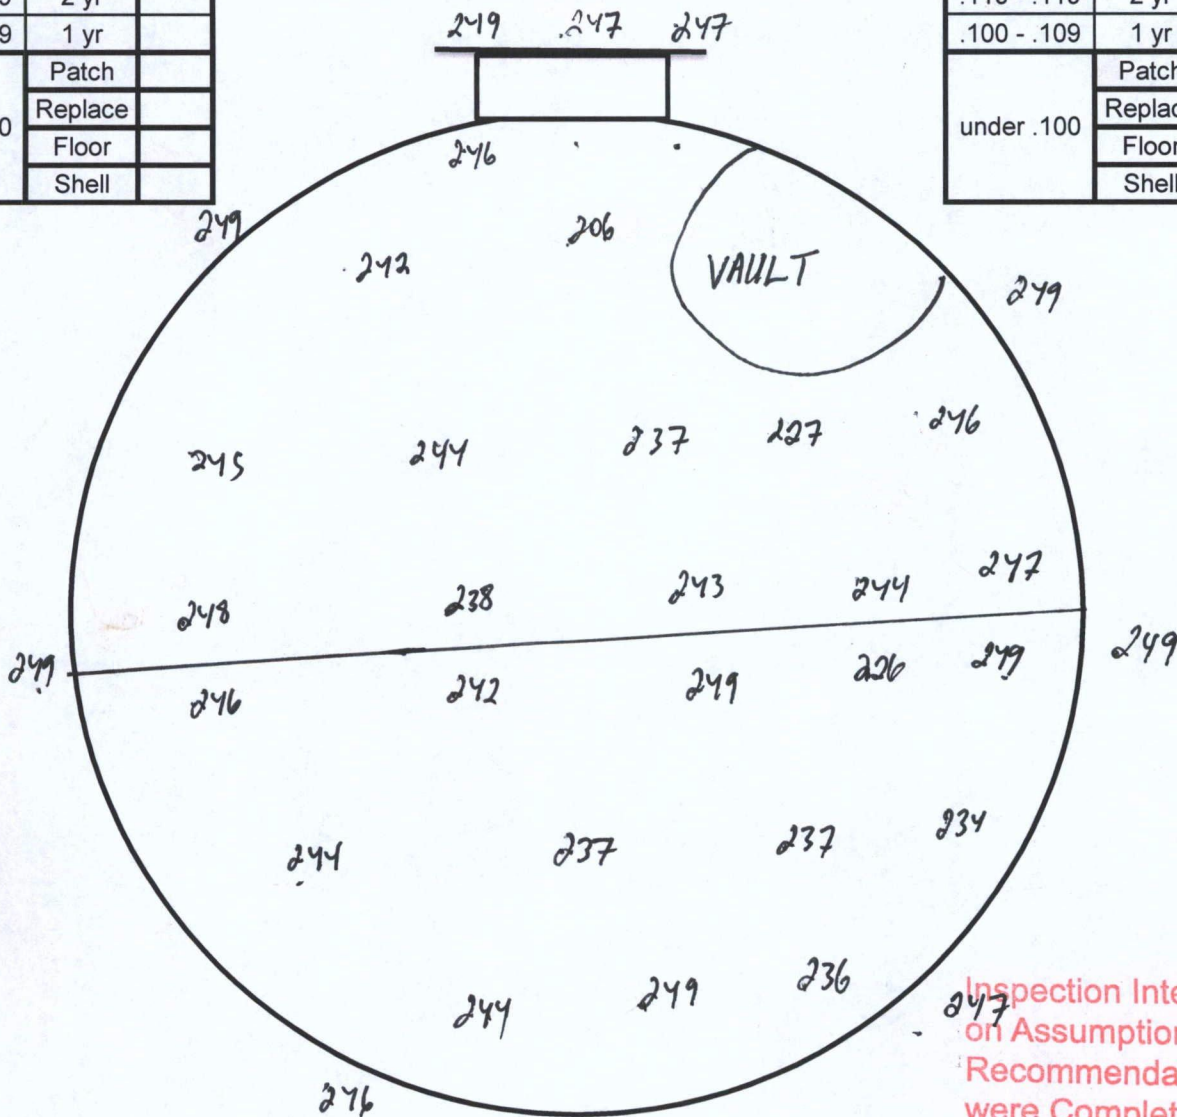
347 Inspection Interval Based  
on Assumption that  
Recommendations  
were Completed

oily patches/drops on Areas of the Floor at the time of Inspection.

UT Readings Consistent with Good Floor and Shell For a 5 yr Turnaround  
As per Husky UT Requirements.

Firetube Does Appear to be bowed AND Need to be Replaced. Visibility Is Limited Due to burner Assembly. Remove Burner Assembly AND Re-evaluate before Pulling Tube.
