## Tank Inspection Report

Location: 121/B14-11-49-27W3

Client: HUSKY OIL OPERATIONS LIMITED  
IRISNDT #: LYN1801173  
Location: 121/B14-11-49-27w3  
Item Inspected: 1000BBL Tank

**Tank sn# G00 297 S1**

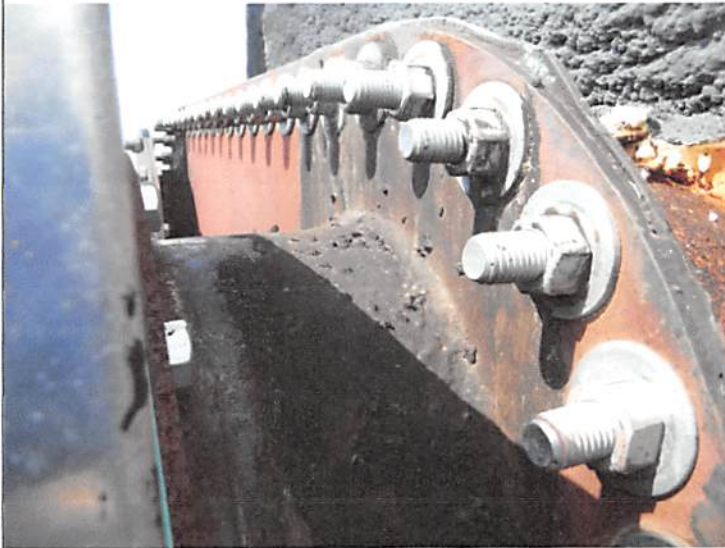
Firetube bolts seeping Heavily

- Moderate leaking evident at firetube flange - area of oil appeared to be seeping from firetube throat - area was stripped and no sign of hole / corrosion was evident in area - Heavy leaking evident from gasket area - Recommend new gasket and monitor area
- Fill/Grind sting gouges in floor
- Brace 1" Vault riser

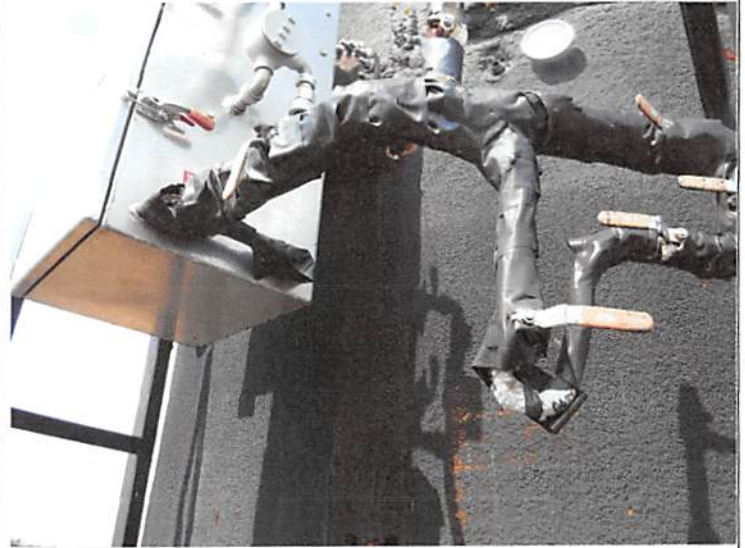
Area of oil running down shell

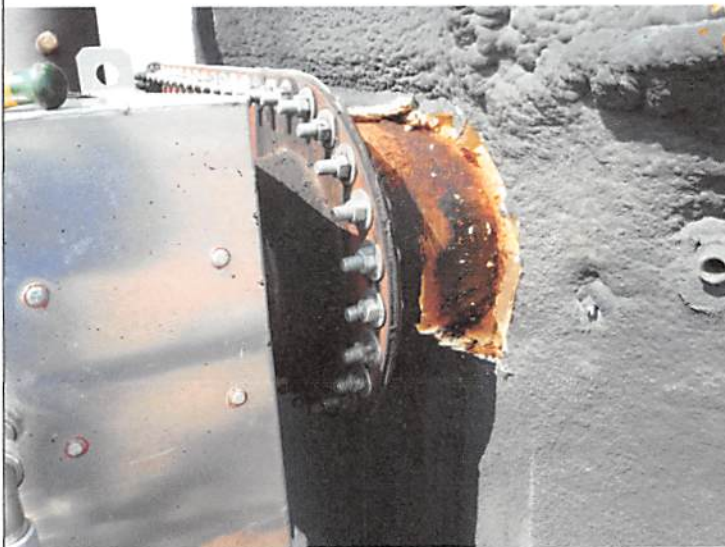
Area of insulation stripped - No corrosion / hole evident - insulation oil soaked

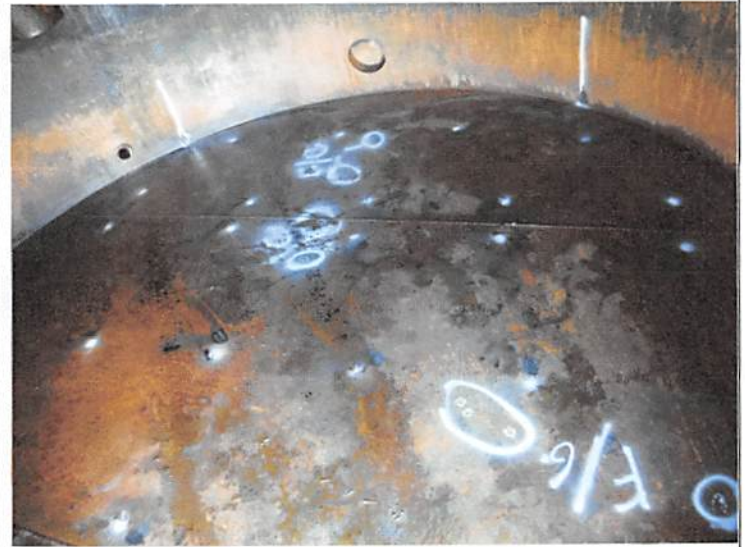
Areas of fill / grind sting gouge marks in floor

| ID | Notes |
|---|---|
| 2 | * Fill / grind sting gauges in floor |
