<h1 style="margin:0;">IRISNDT</h1>	<h2 style="margin:0;">MAGNETIC PARTICLE INSPECTION REPORT</h2>	<p><b>CA1091-MT-279</b> Page 1 of 1</p>
------------------------------------	--	---

<b>Procedure:</b> 5.0 <b>Technique:</b> MT-2V <b>Code / Standard:</b> Crack Detection <b>Other:</b> N/A	<b>Rev:</b> 3.0	<b>Client:</b> HUSKY OIL OPERATIONS <b>IRISNDT #:</b> LYN1801205 <b>Location:</b> 141/11-16-49-27W3M <b>Item Inspected:</b> Tank Lifting lugs	<b>Date:</b> 08-Aug-18 <b>WO #:</b> 81300610 <b>PO #:</b> 8401273069 <b>Appr#</b> 2Z-0149311
--	-----------------	--	---

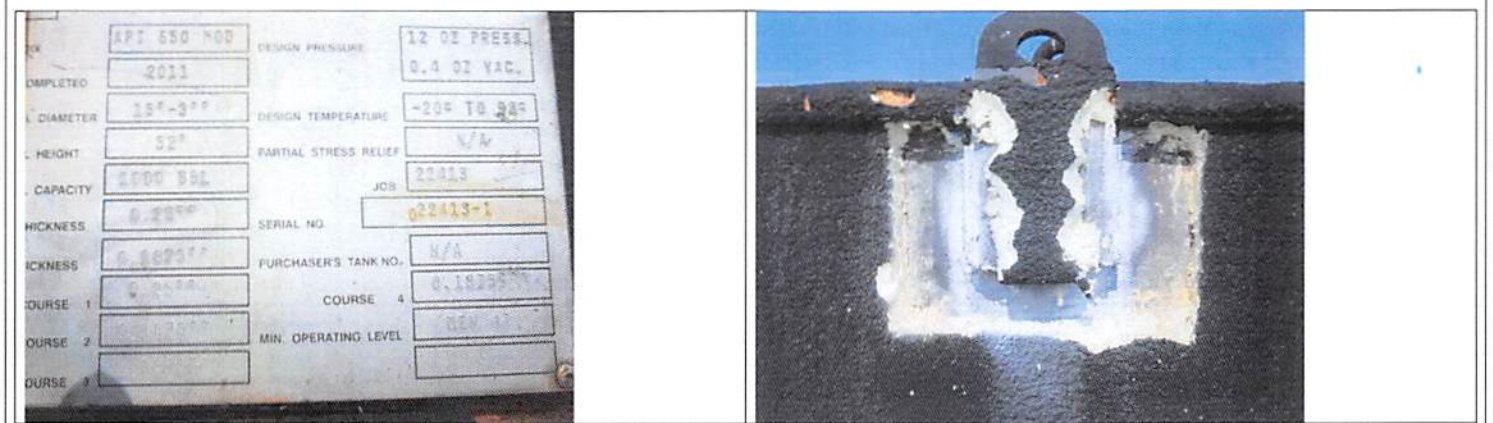
Photo Typical for all 4 lugs

Inspection results: Acceptable no cracking evident
