Storage Tank External Visual Inspection Report

Organization: Husky	Inspection Date: 23/07/2015 12:00:00AM
Plant: Lloydminster Production	Equipment ID: 62037429
	Asset No: 62037429
	System: 00006 HUSKY VERMILION BATTERY 14-
	Operating Unit: H1-01-004 MANNVILLE/SWIMMING

Description:	TANK, UNIVERSAL 160M3
--------------	-----------------------

Storage Tank Internal Visual Inspection Report

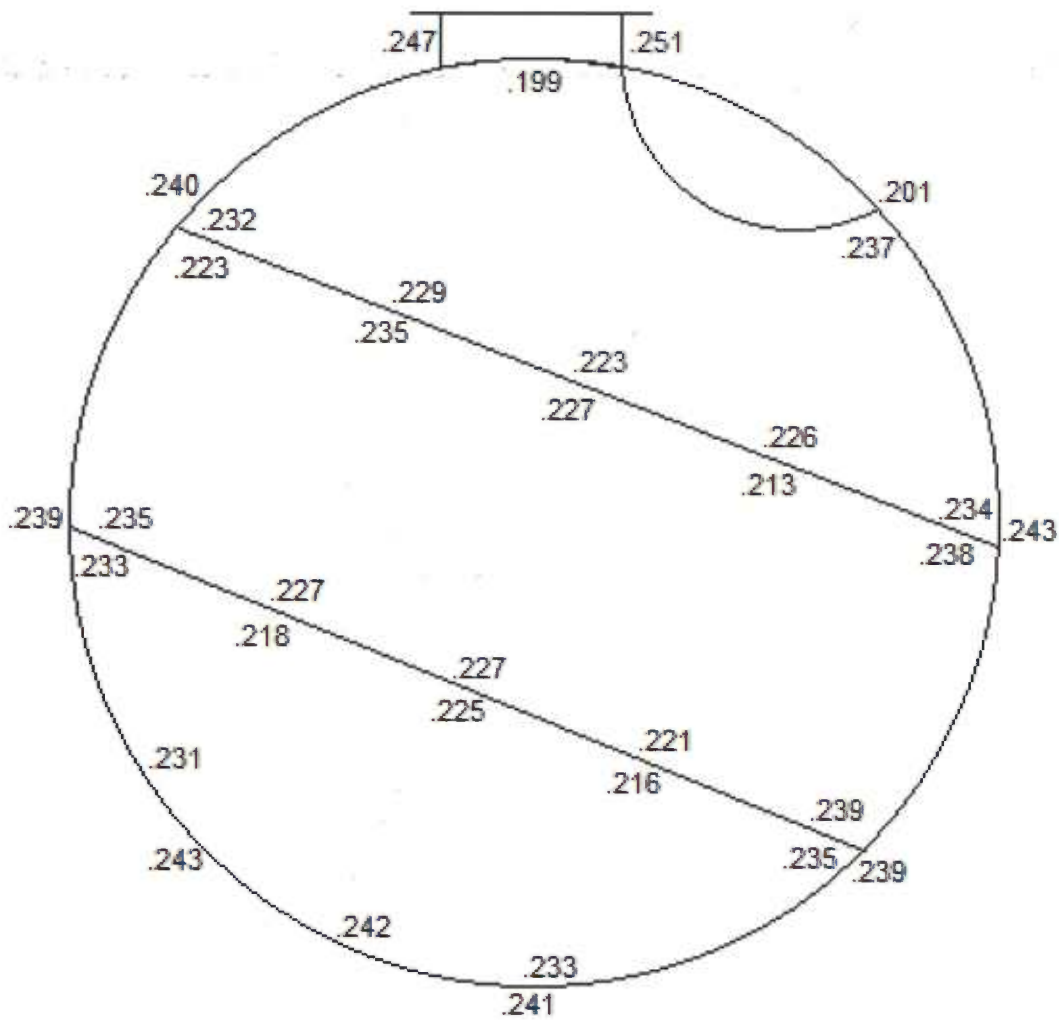
LOCATION Vermilion
14-18 Battery DATE 2015-07-23 MFG UIL
YEAR 2002 S/N 02-03-19-11697 CAP 1000 BBL AFE/CC 80025575
FLOOR THK 1/4" SHELL THK 1/4", 3/16" ROOF THK 3/16"
SAP # 620374329

Random locations of the tank's floor and lower shell were UT thickness tested with some minor metal loss identified. The lowest thickness identified was found to be 0.199". See attached sketch for thicknesses found and approximate locations of tests.

Continue the UT thickness survey on the tank floor and lower shell at next scheduled inspection.
