PRESSURE VESSEL INSPECTION SUMMARY REPORT

FACILITY: Sylvan Lake Gas Plant DATE: SEP. 20/01 REPORT #: 09-20-01-KG-F

Client: Husky Energy
 Location: Sylvan Lake Processing Facility 01-21-38-02-WSM
 Item Examined: Internal welds of Butane Bullet S/N 80028-005

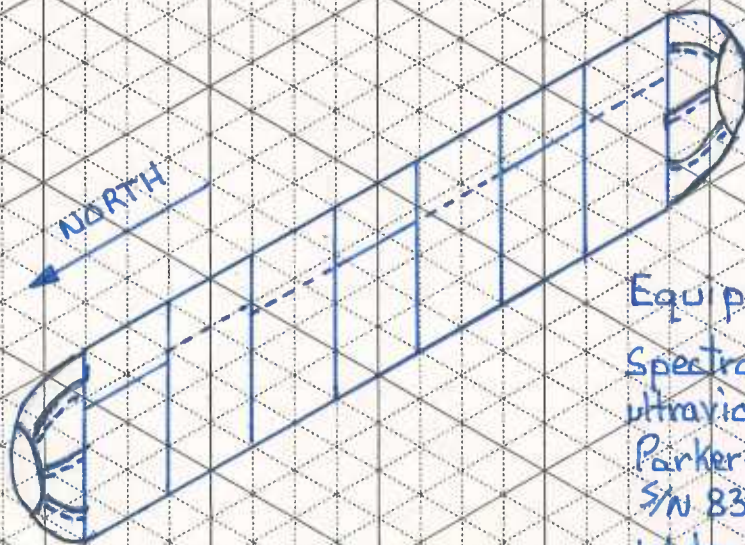
As per client's request wet fluorescent magnetic particle testing was carried out on 100% of all accessible internal welds of the above noted Butane Bullet with results noted below. The magnetic particle testing was performed on all circ. seams, long seams, north & south head segment seams, nozzles, manway and the outside portion of the head stiffener ring attachment fillet welds. Several relevant linear indications were observed throughout the vessel shell, heads and welds with all being shallow and easily removed by grinding to a depth no greater than .045". All grinding locations were re-tested with WF MPI and were found acceptable.
