PRESSURE VESSEL & COLUMN INSPECTION REPORT

LSD: 07-27-051-19W5M

SAP Equipment ID: 66130683

VESSEL STATIC DATA						
Plant		Ansell Gas Plant		Op Unit		System
Prov. Insp. #		A0571635		CRN		U0833.2
Equipment Description		NGL Bullet		Serial #		H0700289
Manufacturer		Trinity Industries de Mexico		Vessel Class		
Internal Access: no		Description:		Year Built		2007
MAWP 250		PSI		@ 125		°F
CODE : U		RT : 4		PWHT : No		
Diameter 131.875 in O.D.		Length (s/s) in		OAL 1080.875 in		Horizontal
Shell	Mat'I	SA-516-70		Thickness	0.828 in	Corr Allowance mm
Head	Mat'I	SA-516-70N		Thickness	0.487 in	Corr Allowance mm
Nozzle	Mat'I			Thickness	in	Corr Allowance mm
Internal Coating: YES NO		Internal Clad : YES NO		Capacity		m3
Manway : no		Inspection Port : no		Saddle		
Nozzle Rating 150		lb ANSI		Painted : yes		Insulated no
PROCESS DATA						
Product Description		NGLs		Sweet		
Operating Pressure		70		PSI		Operating Temperature 68 °F
PSV STATIC DATA – East PSV						
Serial No.	Location	Set Pressure	Capacity SCFM / Lbs/Hr / GPM	Manufacturer	Model / Type	Service Date / Company

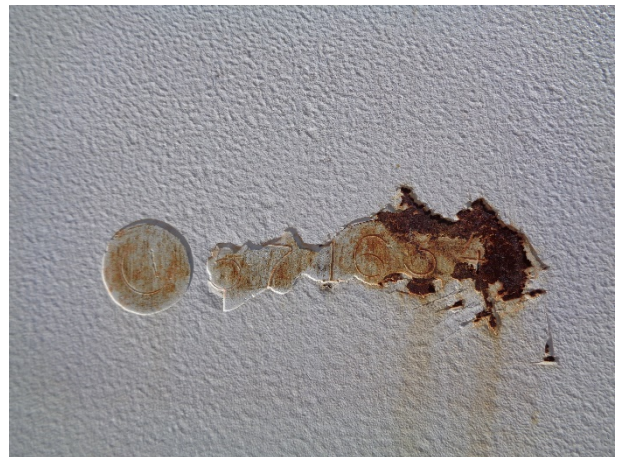
A visual external inspection was conducted on vessel while in operation. Beside plant 2 refridge building. Dataplate secure and legible. A# stamped in vessel shell above d/p. Vessel and piping are in good condition, piping well supported. Paint in good condition, no significant deterioration noted. Ground cable securely attached directly to saddle support. Saddles seal welded, supports securely bolted down, no play for thermal expansion. Ladder and platform in good condition and securely attached, safety gate present at platform opening to ladder. There are 2 PSVs on top shell. No access to west PSV. East PSV service up to date, set below MAWP, vents to atmosphere. There is a weather cap present at end of vertical PSV discharge pipe and a drill hole at bottom of 90 elbow. Inlet isolation valve on both PSVs carsealed open. UT inspection performed 2014 by Streamline Inspection.

A# STAMPED ABOVE DATAPLATE

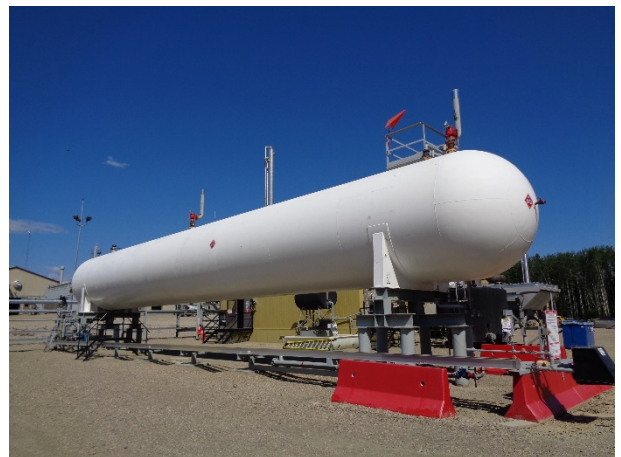
VESSEL OVERVIEW

Vessel was found to be in good condition and fit for continued service.

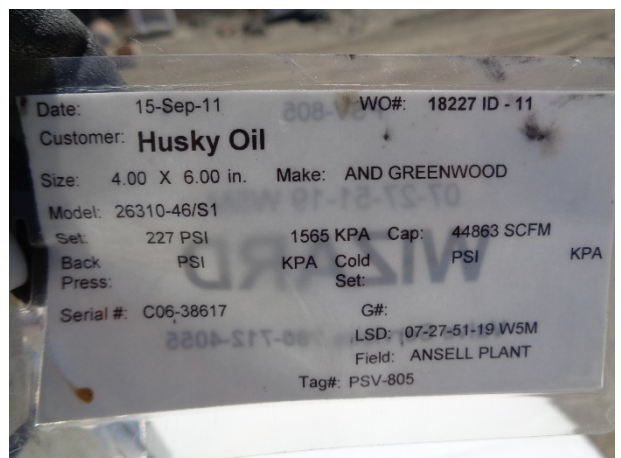
EAST PSV SERVICE TAG

C06-38617	Off top east shell	227psi	44863scfm	Crosby	26310-46/S1	15-Sep-11. Wizard. Tag PSV-805
PSV DETAILS						
	Type (Thread/Flange)		ANSI Rating		Size (in)	
PRD Inlet	Flanged				4"	
PRD Outlet	Flanged		150		6"	
NDE Equipment records						
Procedure#	Description	Manufacturer	Model#	Serial#	Due Date

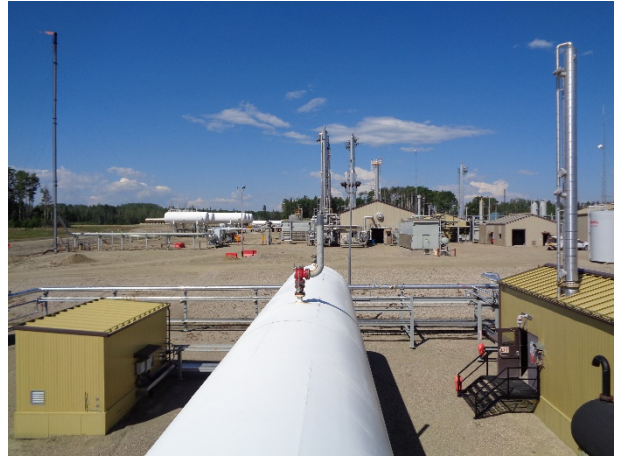
WEST PSV – NO ACCESS

Review UT survey results.
Check PSV records for set pressure / service date of second PSV.
