PRESSURE VESSEL & COLUMN INSPECTION REPORT

LSD: 08-02-050-07W4 **Date:** 2017-01-30 **SAP Equipment ID** 62068385

DISTRICT:	ALBERTA NORTH	FACILITY:	MANNVILLE/ SWIMMING	LOCATION/LSD:	08-02-050-07W4
EQUIP NAME:	GLYCOL CONTACTOR			PROV REG No.:	0244337
SERIAL No.:	LS-3771	Equip No.:		National Board No.:

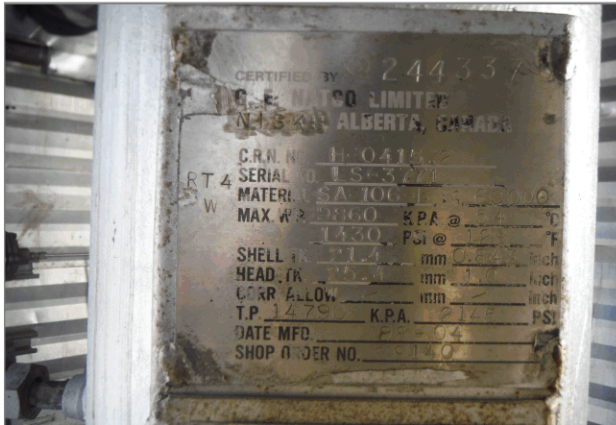
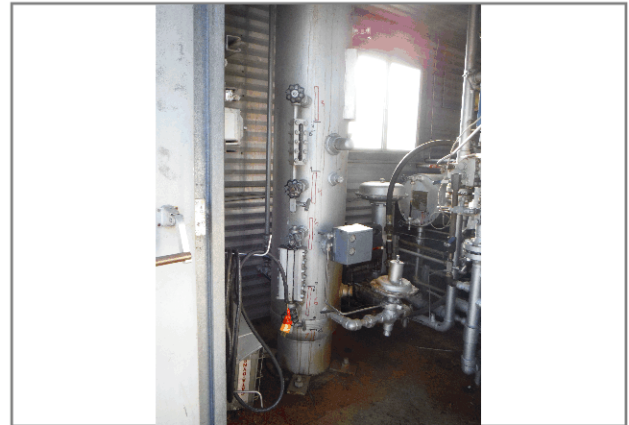
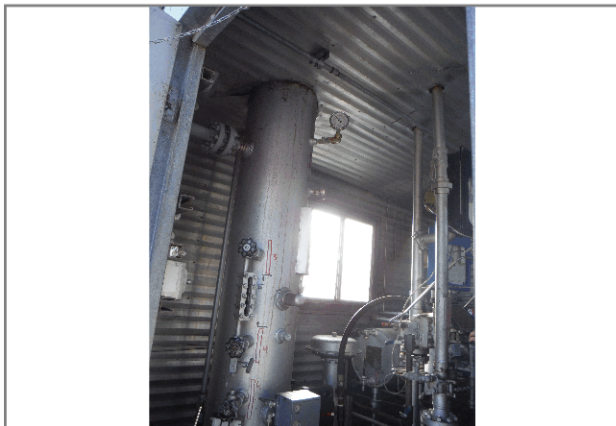
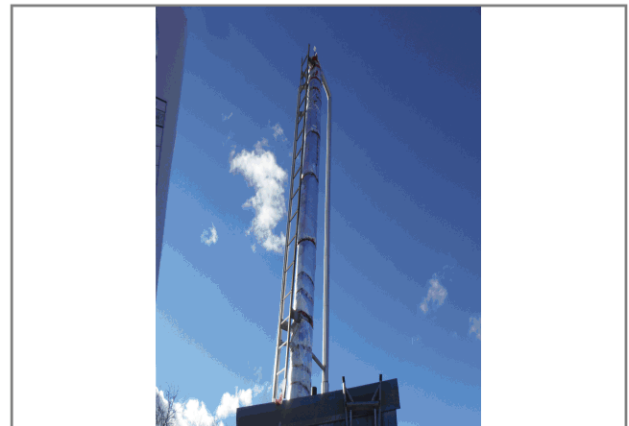
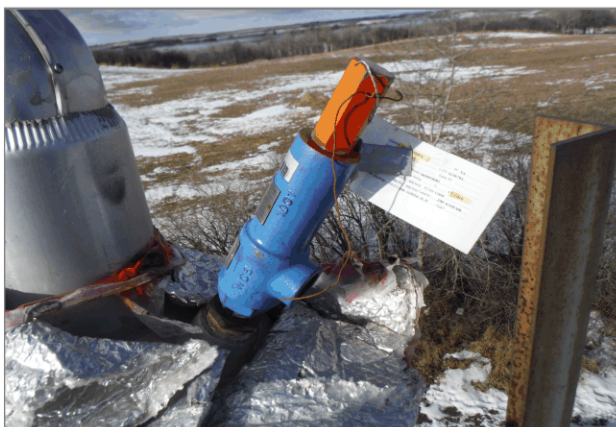
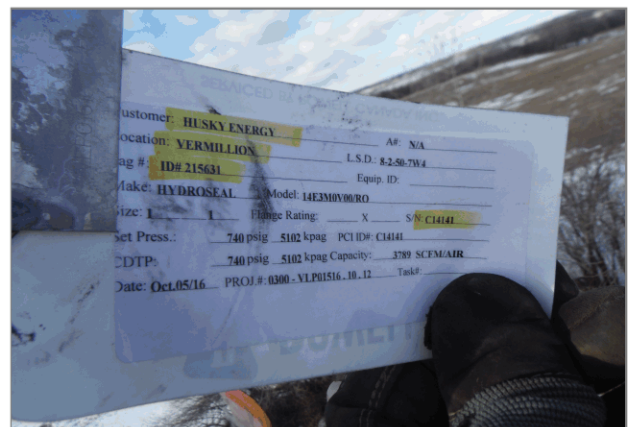
PSV DOES NOT HAVE OUTLET PIPING ATTACHED. IDR ATTACHED
 PSV IS NOT POSITIONED VERTICALLY APPROX-45 DEGREE ANGLE.

PSV HAS NO OUTLET PIPING PRESENT. PSV IS NOT IN THE VERTICAL POSITION (APPROX 45 DEGREES).

INSTALL OUTLET PIPING ON PSV TO DISCHARGE IN A SAFE LOCATION. RE-INSTALL PSV IN THE VERTICAL POSITION OR OBTAIN PERMISSION TO OPERATE PSV IN NON-VERTICAL POSITION FROM MANUFACTURER.

INSTALL OUTLET PIPING ON PSV TO DISCHARGE IN A SAFE LOCATION. RE-INSTALL PSV IN THE VERTICAL POSITION OR OBTAIN PERMISSION TO OPERATE PSV IN NON-VERTICAL POSITION FROM MANUFACTURER
