# Pressure Vessel External Visual Inspection Report

Equipment ID: 62066206

Description:	TREATER, H-100
Asset Type:	Treater

# Pressure Vessel Internal Visual Inspection Report

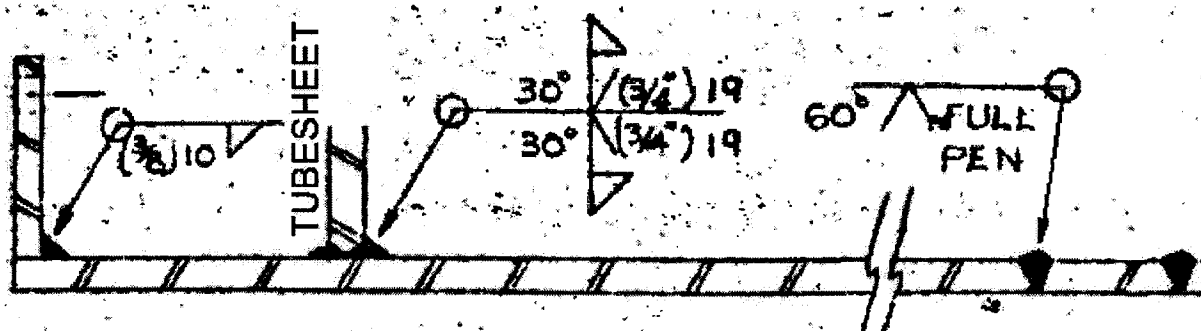
**Weld Joint Design**

The treater was down for turnaround. The firetube was sandblasted and brought to L&L Oilfield Maintenance. The burner leg was bowed with hot spots and will be replaced through the flange to 1" past an existing circ weld. IRIS NDT is scheduled to perform 100% MPI on welds. If cracking is found stop the repair and contact Marie to reassess.

Weld joint design for replacement shall be in accordance with the original detail and dimensions:

- 1) Remove the firetube from the tubesheet weld by suitable methods such as air-carbon arc gouging, and cut out the degraded area of pipe 1 inch beyond the existing circ weld repair on the leg.
- 2) Bevel dress the firetube and tubesheet per original detail. Parent material to be cleaned to shiny metal at weld and adjacent 50mm minimum. Perform MPI on prepared surfaces (below).

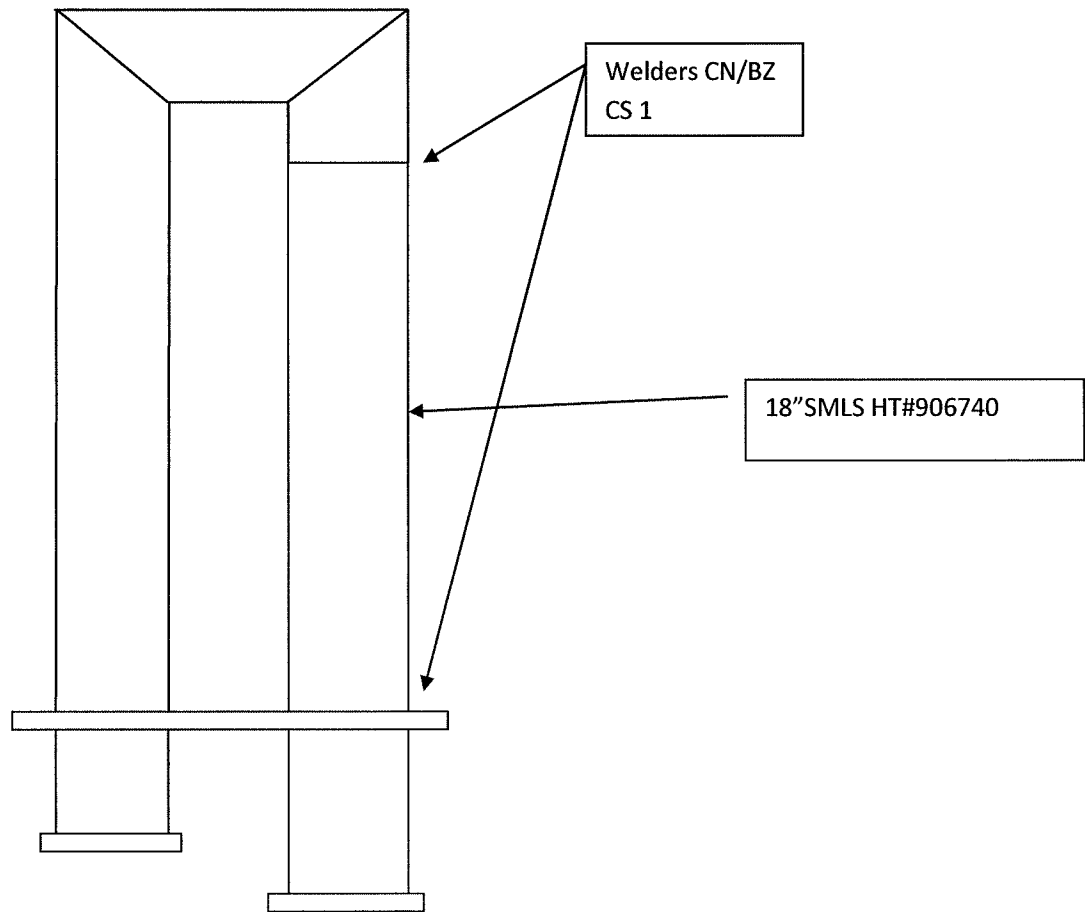
**10-34-51-4W4M MORGAN BATTERY 18" FIRE TUBE REPAIR**

Generally the internal surfaces and components of the Flash Treater were found to be in fair condition although one leg on the firetube was found to be badly bowed and required immediate repairs. The leg was replaced by L& L Oilfield of Lloydminster prior to recommissioning the Flash Treater.
