Tank Inspection Report

Location: Morgan Battery 10-34-51-4w4 Tank Type: T-106B Sales tank Date: June.17.2016
 Mfg: Universal Year blt: 1993 S/N: 97 06 0310384 CAP: 3000 bbl
 Floor Thk: 1/4" Shell Thk: 3/16" Roof Thk: 3/16"
 Requisitioned by: RAY TRACHUK Approver: MARC CASE Approver Code: 2Z-02018989
 WO #: 60263746 PO#: 8401063456 CC: _____ SAP #: GL#6160051

MFL FLOOR SCAN REPORT

Report #: LYD1600687-ST-001rev1
Date: June. 17. 2016

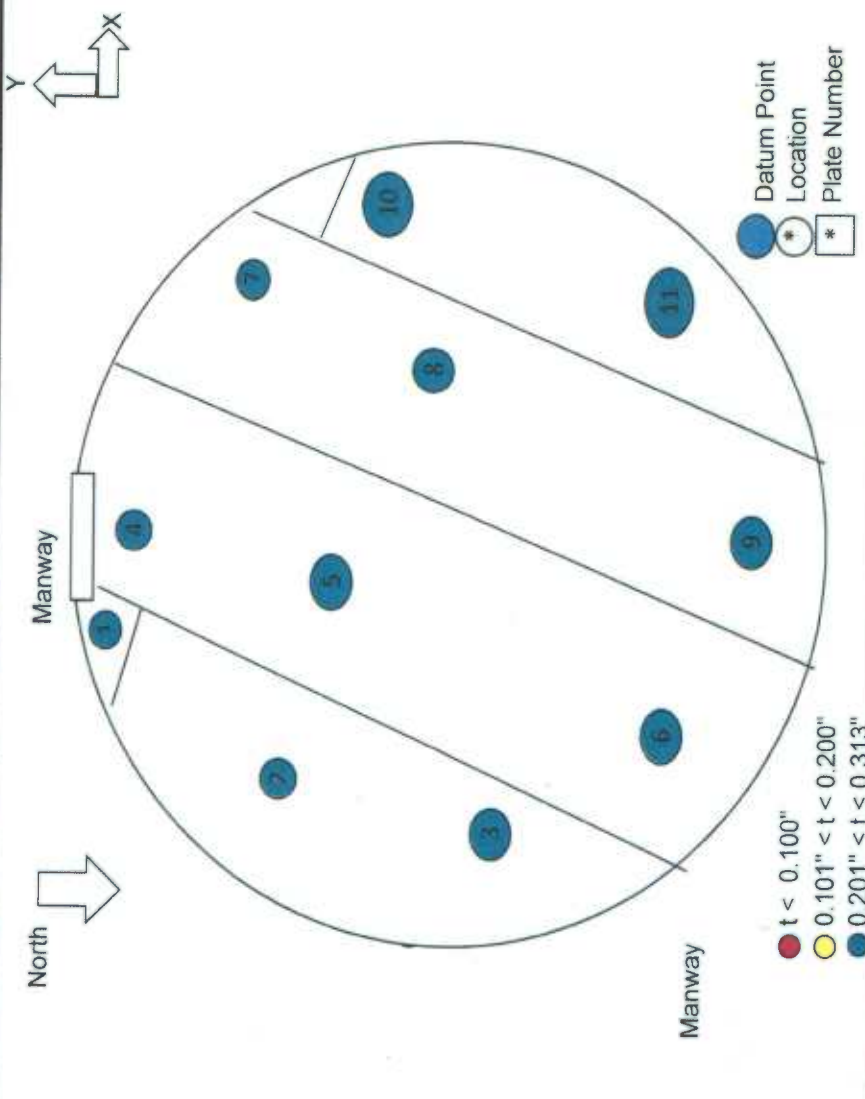
FLOOR PLATE LAYOUT AND BACK-UP UT LOCATIONS

Results: A MFL floor scan was performed on TK-106B sn# 97 06 0310384 to determine the condition and integrity of the tank bottom. No significant soil side indications of corrosion/pittings were found with remaining wall thickness ranged from 0.270" to 0.298" for 0.250" nominal thick floor plates (Plus coating thickness) MFL floor scan not representative of overall condition of tank, for additional inspection results see report# CA0325-NDT-12

Random UT	thickness
	1 0.292"
	2 0.270"
	3 0.288"
	4 0.287"
	5 0.281"
	6 0.292"
	7 0.281"
	8 0.275"
	9 0.298"
	10 0.280"
	11 0.282"
