# Storage Tank Visual Inspection Report

**ABOVE GROUND STORAGE TANK  
API STANDARD 653  
OUT-OF-SERVICE  
FINAL INSPECTION REPORT  
RANGER INSPECTION™  
JOB # 22669  
(Revision 1)**

**HUSKY ENERGY**

**TANK # T-107A**

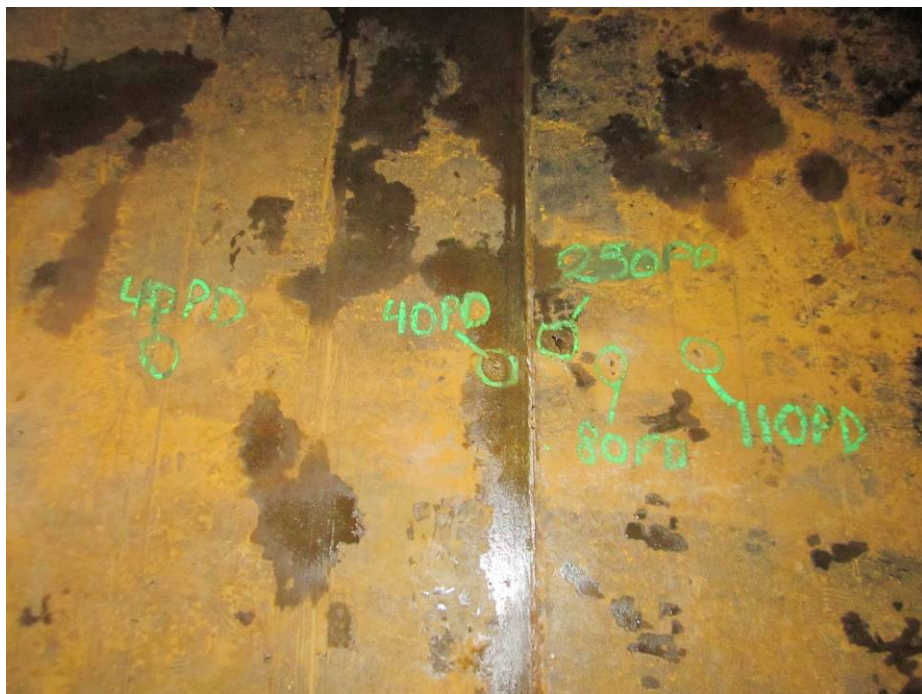
**Photograph #11: Topside Pitting (Suspect Mechanical Damage)**

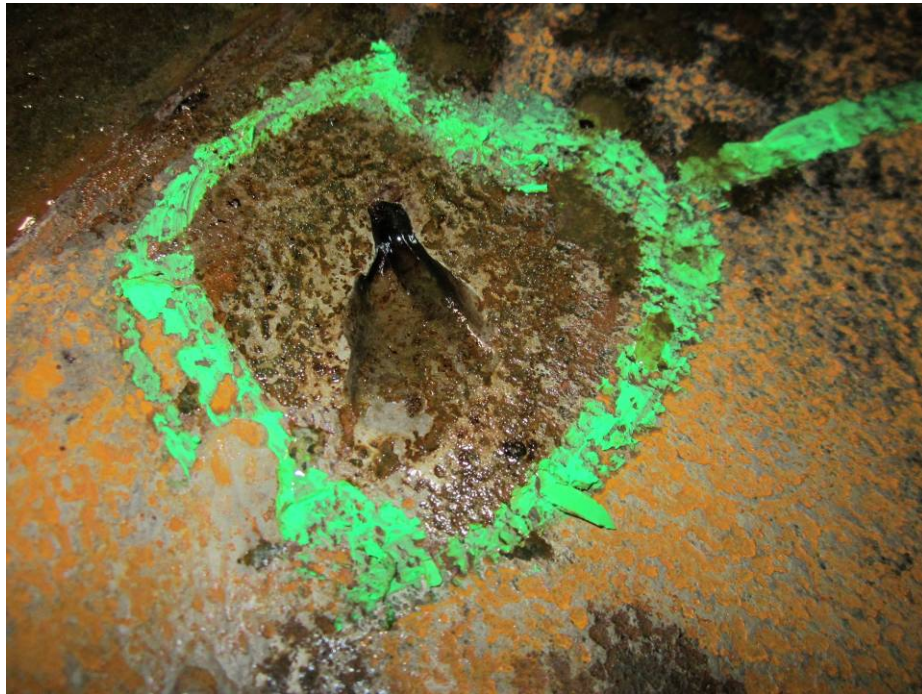
Photograph #12: 0.250 inch Deep Pit

- 1.) The following is recommended to allow the tank to return to service for a 5 year run:
  - a.) 18 inch \* 8 inch patch covering topside pitting (0.250, 0.110, 0.080, 0.040 inch)
  - b.) 9 inch round patch covering topside pitting (0.150 inch)
  - c.) 6 inch round patch covering topside pitting (hole through, 0.050 inch)
  - d.) Lace weld topside pitting (0.090 inch)
  - e.) 3 separate puddle welds (0.050, 0.040, 0.040 inch)

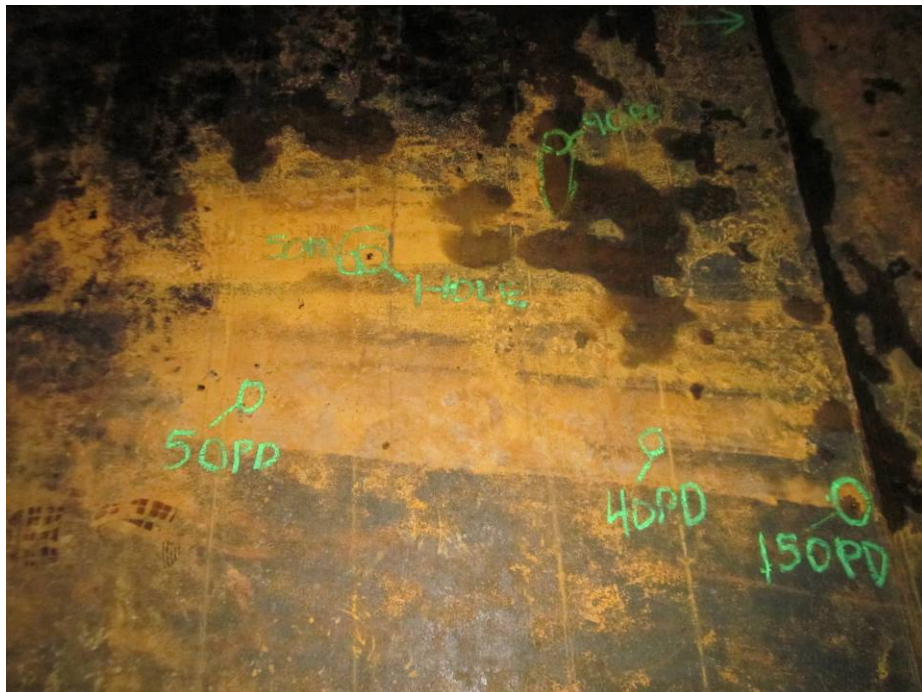
Photograph #13: Topside Pitting (Suspect Mechanical Damage)

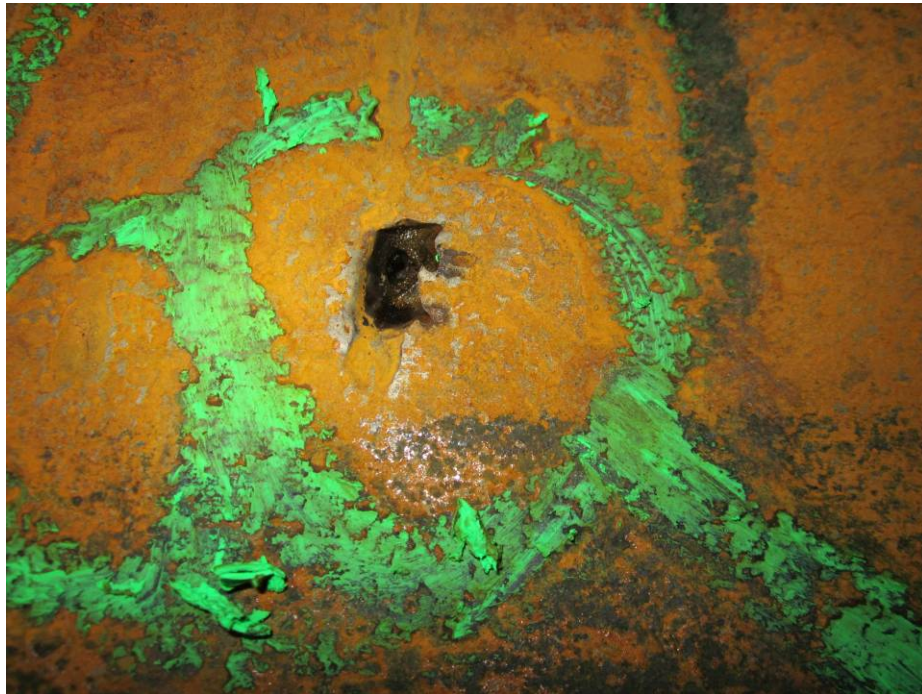
RESULTS WITHOUT REPAIRS			RESULTS AFTER RECOMMENDED REPAIRS	
$RT_{BC}$	0.131	inch	0.131	inch
$RT_{ip}$	Hole through	inch	0.250	inch
$O_r$	5	years	5	years
$StP_r$	Hole through	inch/yr	0	inch/yr
$UP_r$	0.00567	inch/yr	0.00567	inch/yr
$MRT$	Hole through	inch	0.103	inch
Required Thickness at $O_r$	0.100	inch	0.100	inch

Photograph #14: Hole Through

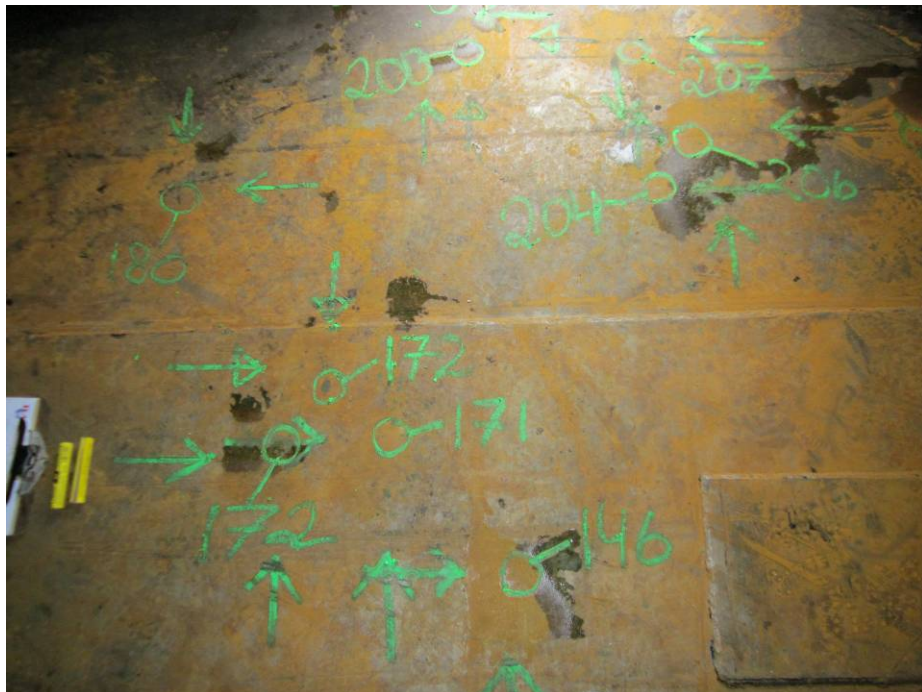
- 1.) A Magnetic Flux Leakage (MFL) scan was performed on accessible areas of the tank bottom plate. Twenty two (22) indications of underside material loss were identified.
- 2.) Resulting MFL indications were additionally evaluated with ultrasonics (UT). The minimum thickness found was 0.131 inch. The nominal thickness is 0.250 inch.
- 3.) The bottom plate was visually examined for topside pitting. Ten (10) pits up to 0.250 inch deep and one (1) hole were observed throughout the tank bottom. This material loss is believed to be from a stinger and is abrasion material loss; however, for the purpose of bottom calculations the material loss will be treated as corrosion.
- 4.) Inspection was limited on the bottom lap welds due to the presence of water and product.

Photograph #15: MFL Indications

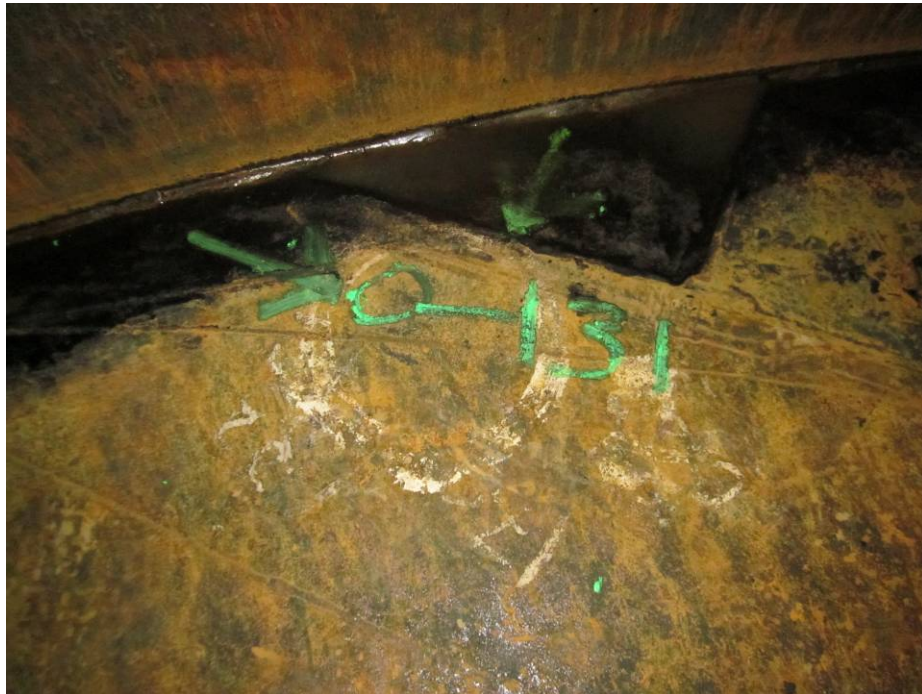
Photograph #16:MFL Indication | Minimum UT 0.131 inch

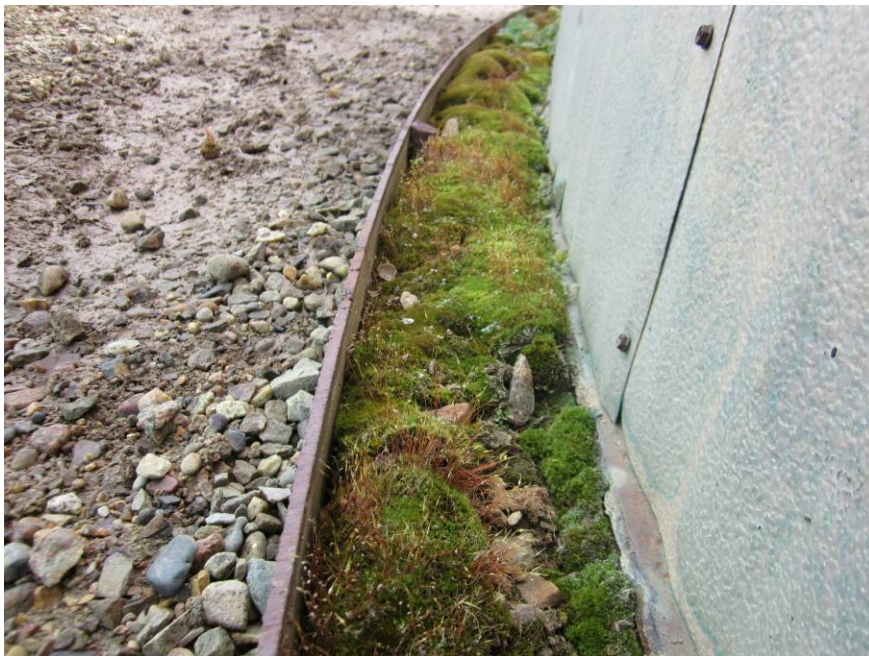
- 1.) The foundation was visually examined from accessible areas. The tank was observed to be resting within a slightly elevated, or even with grade, metal ring on an earth and gravel foundation.
- 2.) Vegetation growth was observed throughout the metal ring adjacent to the bottom plate projection.
- 3.) A void was observed beneath the bottom plate around the manway due to the cleaning process.
- 4.) No berm was observed; however, there is a low point in the battery in the northwest corner that would collect any product if it were to leak.

**Photograph #25: Vegetation Growth around Perimeter**

- 1.) It is recommended to repack the area of the foundation void beneath the manway.
- 2.) Consideration should be given to reworking the foundation so water is directed away from the bottom plate around the entire perimeter of the tank.

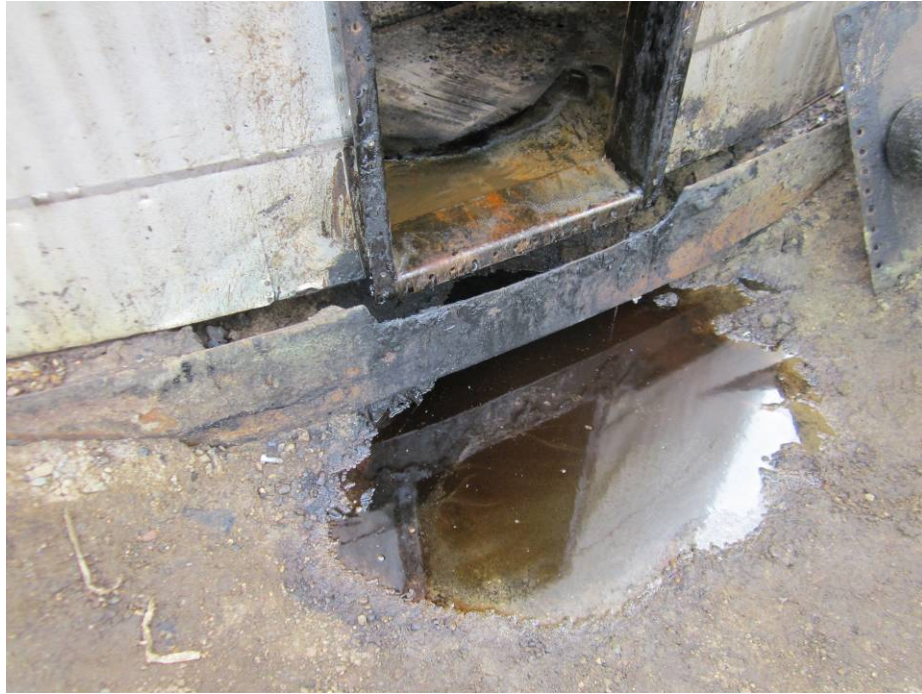
**Photograph #26: Void Beneath Manway from Cleaning**

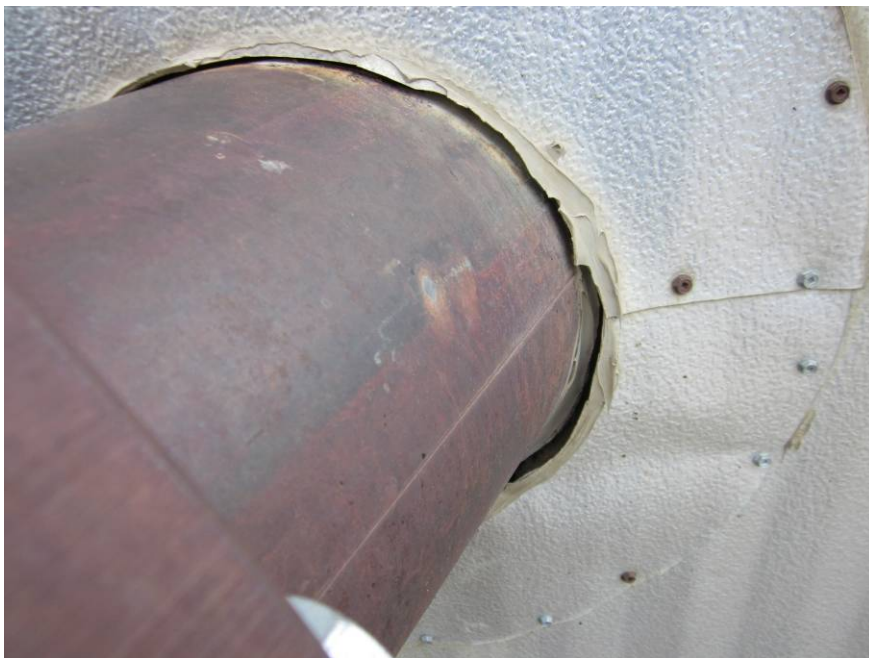
- 1.) The shell plate was visually examined and observed to be insulated. Some areas of sealant failures were present around nozzles.
- 2.) Internally, the visual inspection was limited due to product. Exposed areas were observed to be in acceptable condition at the period of this inspection.
- 3.) Random ultrasonic thickness (UT) readings were taken on the first course shell plate. No significant material loss was observed or recorded. Refer to Table A - Manual UT Shell Plate Readings – Course # 1, for additional data.

**Photograph #28: Sealant Failures**

- 1.) It is recommended to repair the areas of sealant failure around the nozzles.

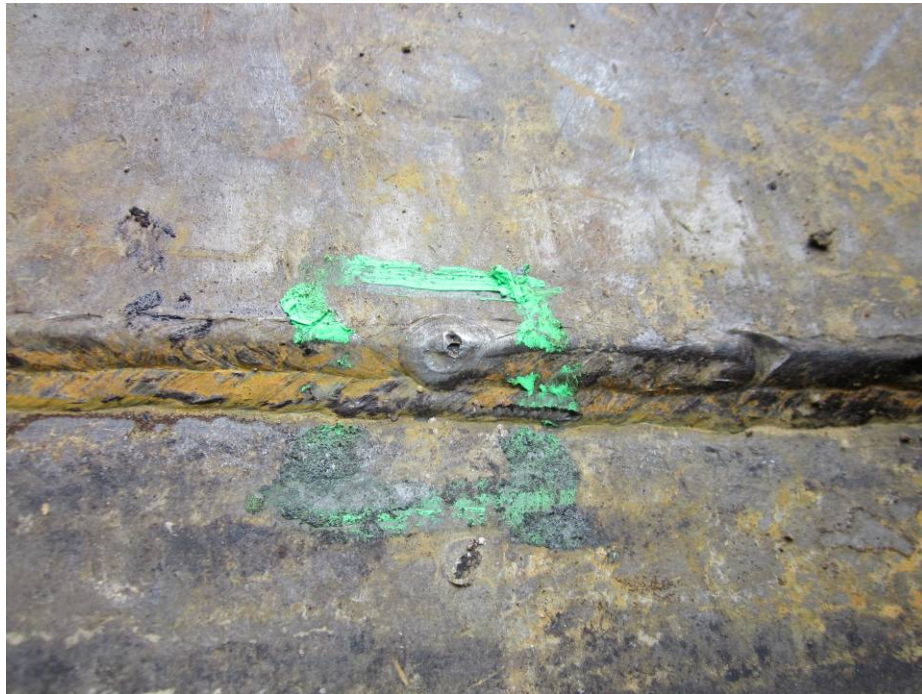
- 1.) The tank nozzles and appurtenances were visually examined. Inspection was limited due to insulation. All exposed nozzles were observed to be in acceptable condition.
- 2.) Internally, inspection was limited due to product. The manway was observed to have one (1) pinhole and one (1) 6 inch length of corrosion on the toe of the manway neck weld. Refer to photographs.

**Photograph #40: Pinhole on Manway Weld**

- 1.) It is recommended to weld repair the pinhole and corrosion located on the manway neck welds.

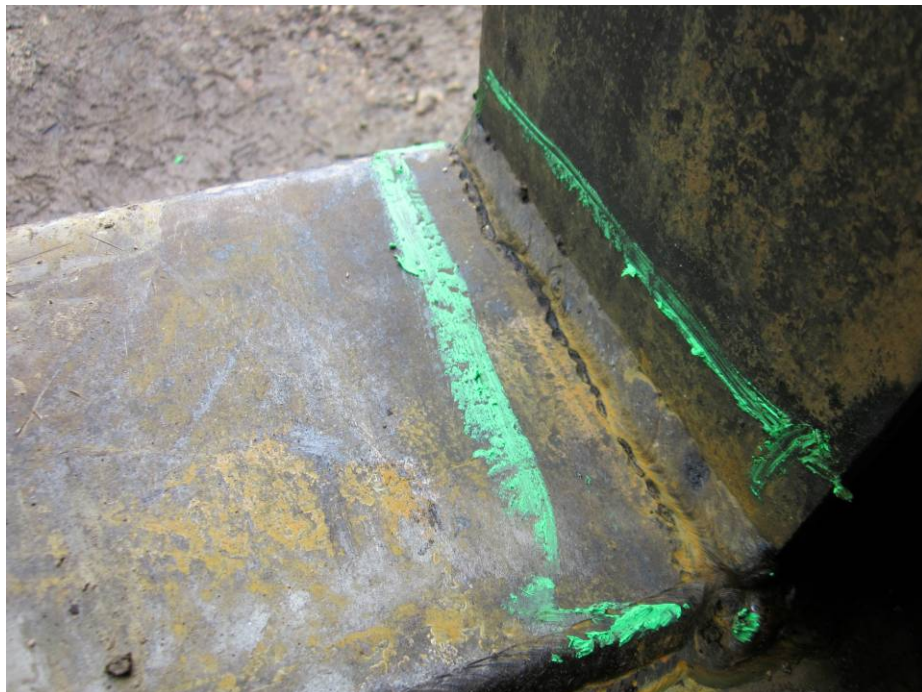
**Photograph #41: Corrosion on Manway Weld**

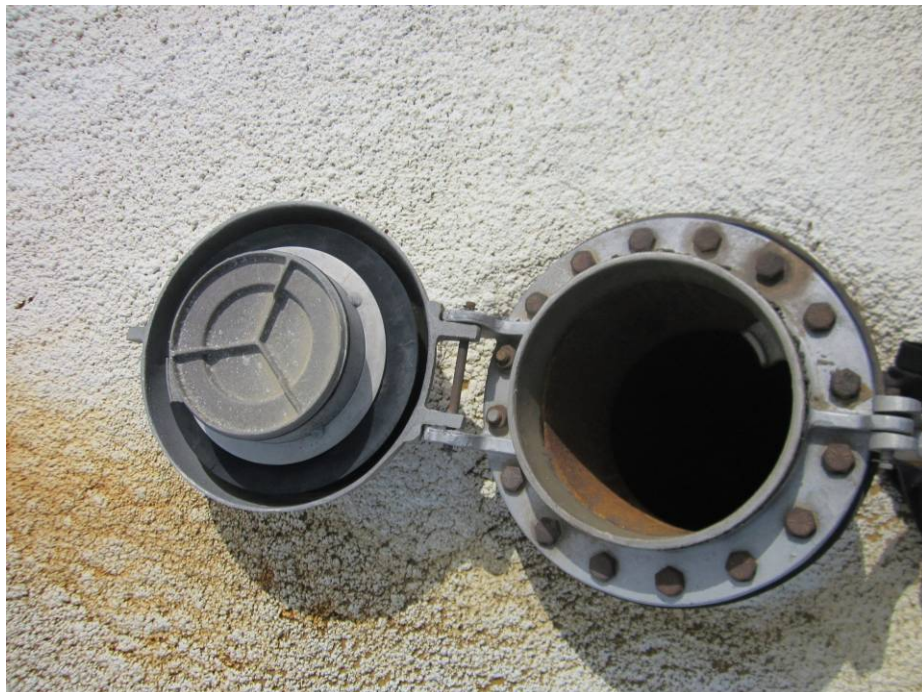
- 1.) A visual inspection was performed on the roof externally. The roof was observed to be foam insulated.
- 2.) The gauge hatch seal was observed to be in deteriorating condition.
- 3.) Internally, the roof plate was visually inspected from the bottom. Areas of oxidation could be seen at the period of this inspection.

**Photograph #52:Gauge Hatch**

- 1.) Consideration should be given to replacing the gauge hatch seal.
