Storage Tank Visual Inspection Report

**ABOVE GROUND STORAGE TANK
API STANDARD 653
OUT-OF-SERVICE
FINAL INSPECTION REPORT
RANGER INSPECTION™
JOB # 22669
(Revision 1)**

**MORGAN BATTERY
LSD: 10-34-051-04 W4M**

TANK # T-106A

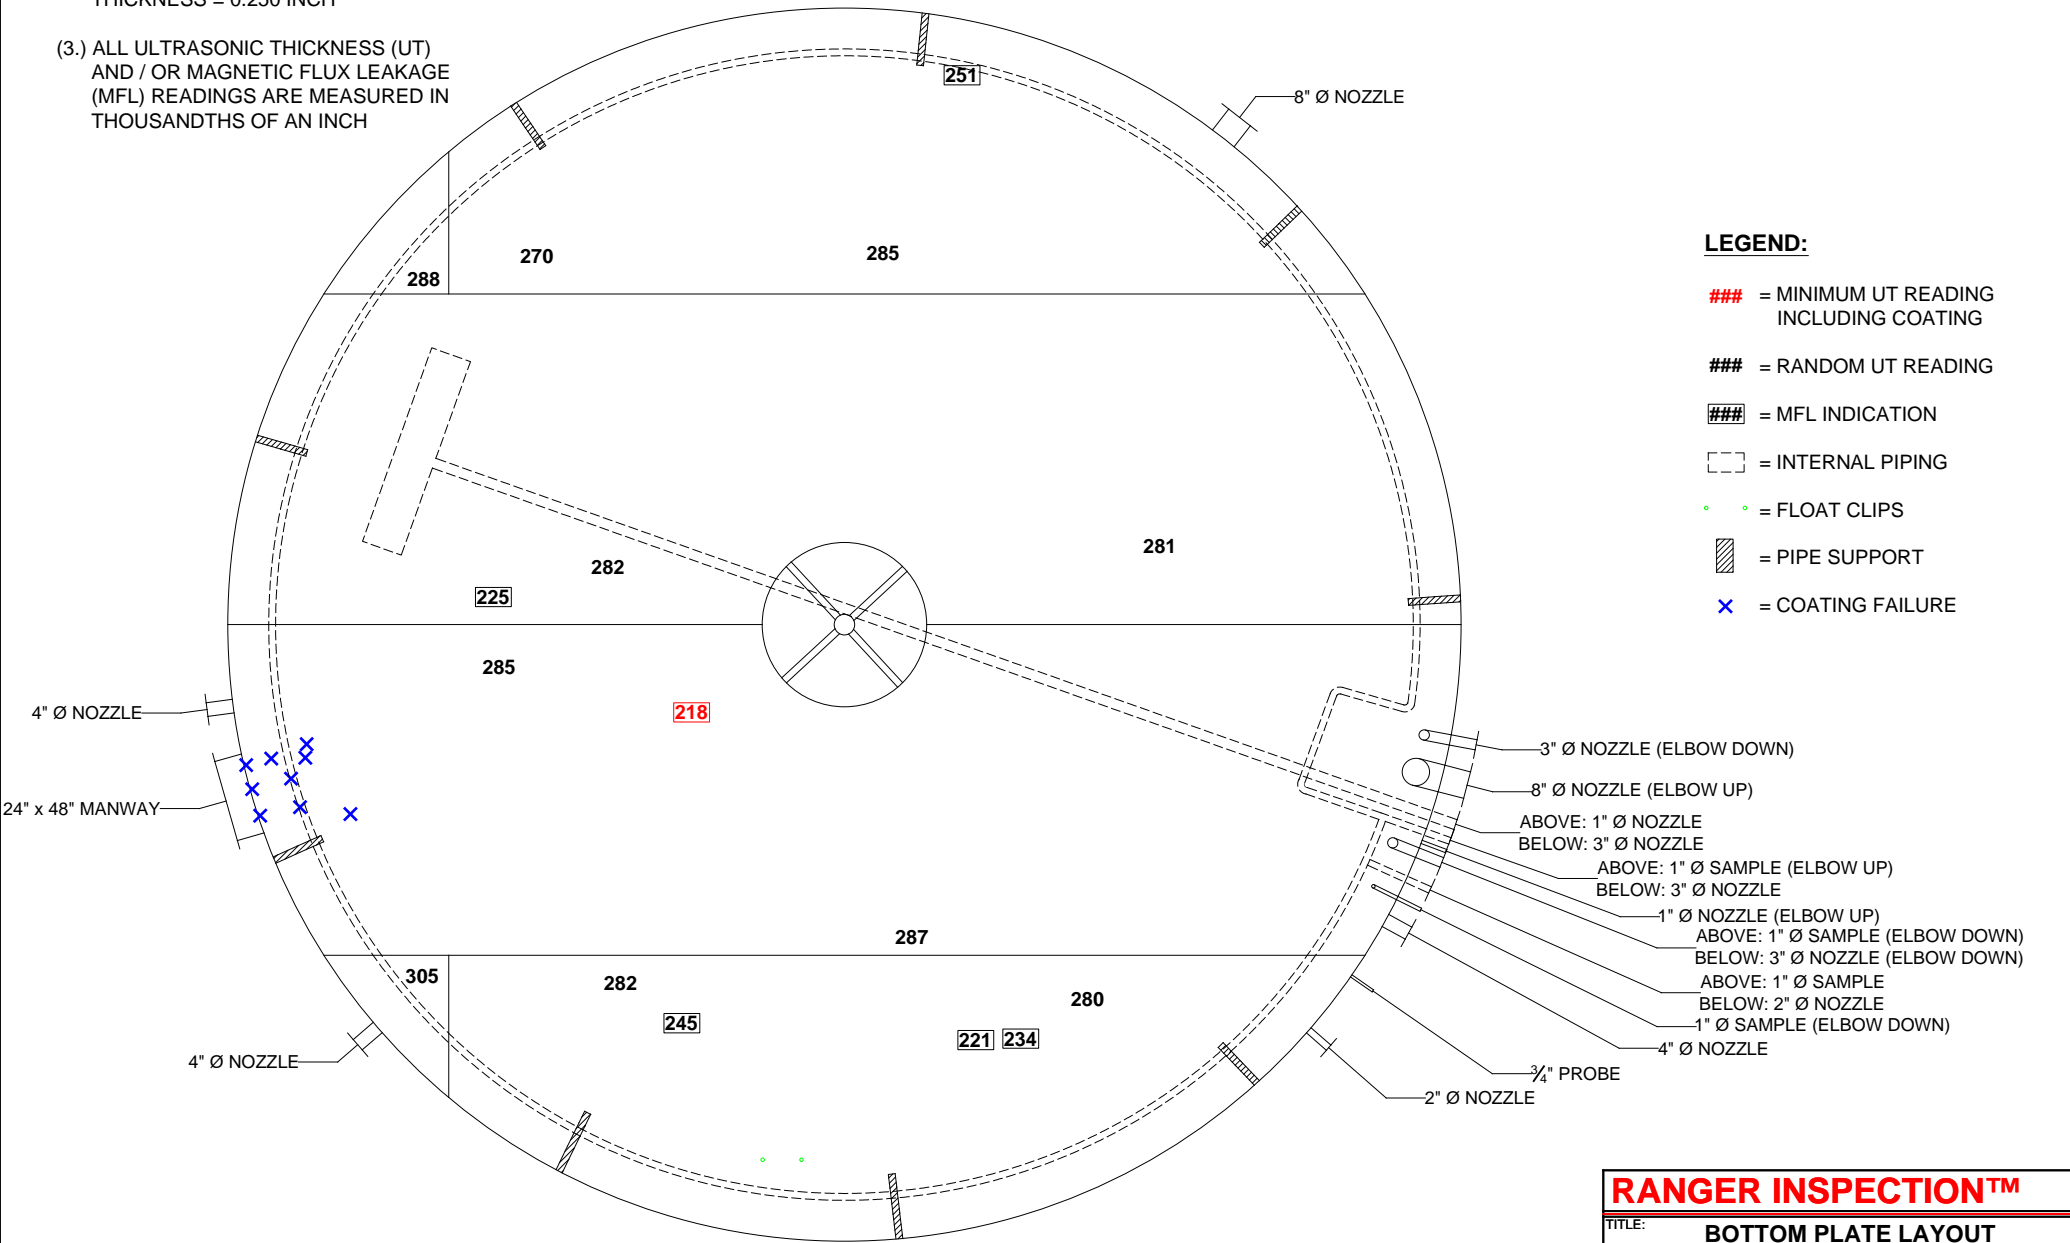
RANGER INSPECTION™			
TITLE:		BOTTOM PLATE LAYOUT	
CUSTOMER:		HUSKY ENERGY	
TANK NO:		T-106A	JOB NO: 22669
LOCATION: MORGAN BATTERY			
SIZE: 30' Ø		DATE: JUN. 14 / 16	
DRAWN BY: KAC/JT		PAGE: 1 OF 1

A Magnetic Flux Leakage (MFL) scan was performed on accessible areas of the tank floor. Six (6) indications of underside material loss were identified. The minimum thickness found was 0.218 inch including coating. The nominal thickness is 0.250 inch. No repairs were required at this time.

- 1.) A Magnetic Flux Leakage (MFL) scan was performed on accessible areas of the tank bottom plate. Six (6) indications of underside material loss were identified.
- 2.) Resulting MFL indications were additionally evaluated with ultrasonics (UT). The minimum thickness found was 0.218 inch including coating. The nominal thickness is 0.250 inch.
- 3.) Nine (9) areas of coating failure were identified and marked on the tank bottom plate (just inside the manway).

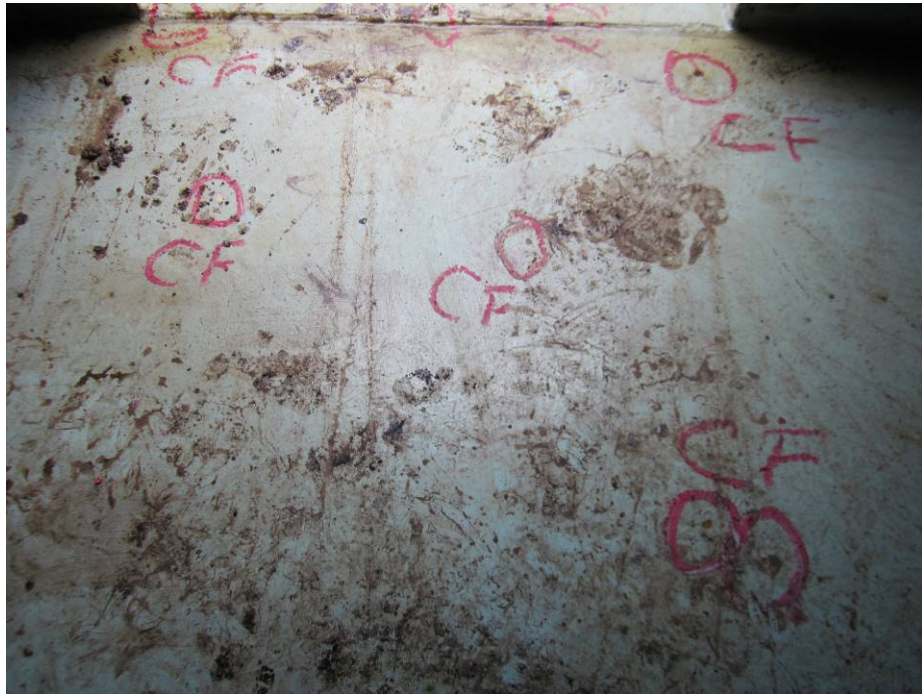
Photograph #12: Coating Failures

- 1.) It is recommended to repair the nine (9) coating failures.

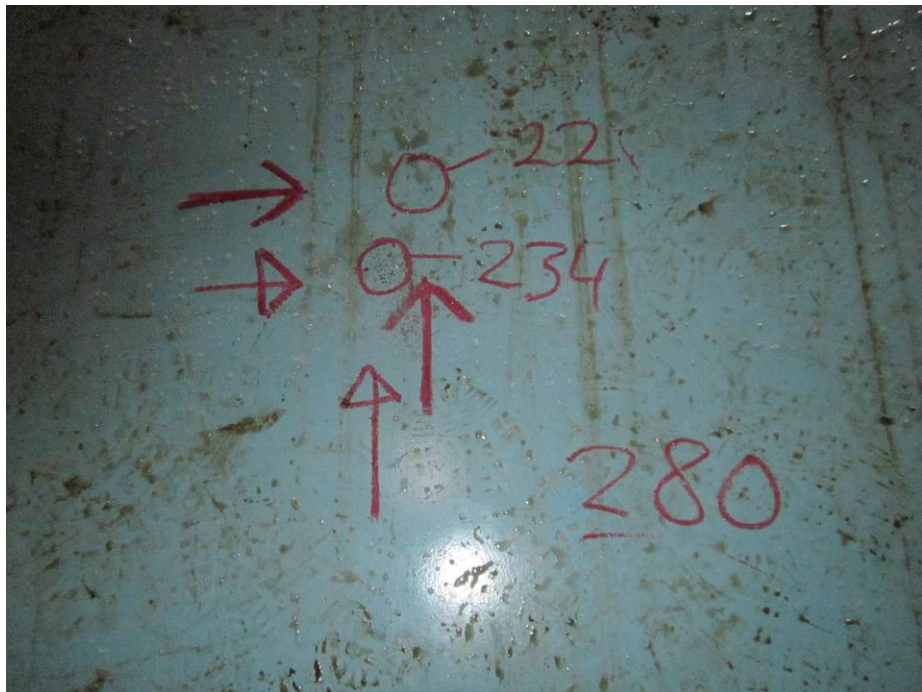
Photograph #13: MFL Indications

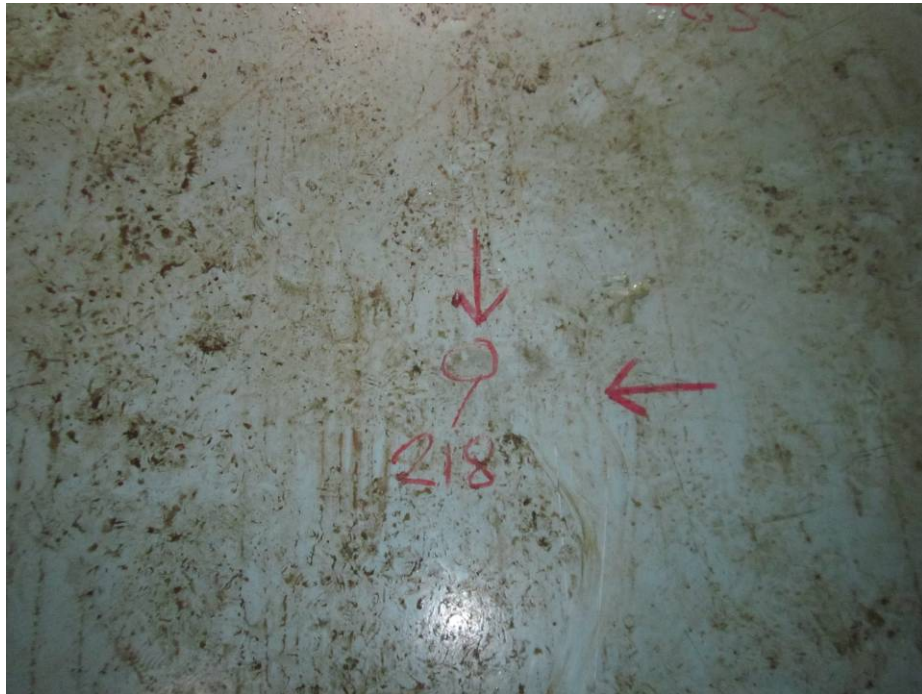
Photograph #14:MFL Indication | Minimum UT = 0.218 inch

Continue the Magnetic Flux Leakage (MFL) scan at the next scheduled inspection.

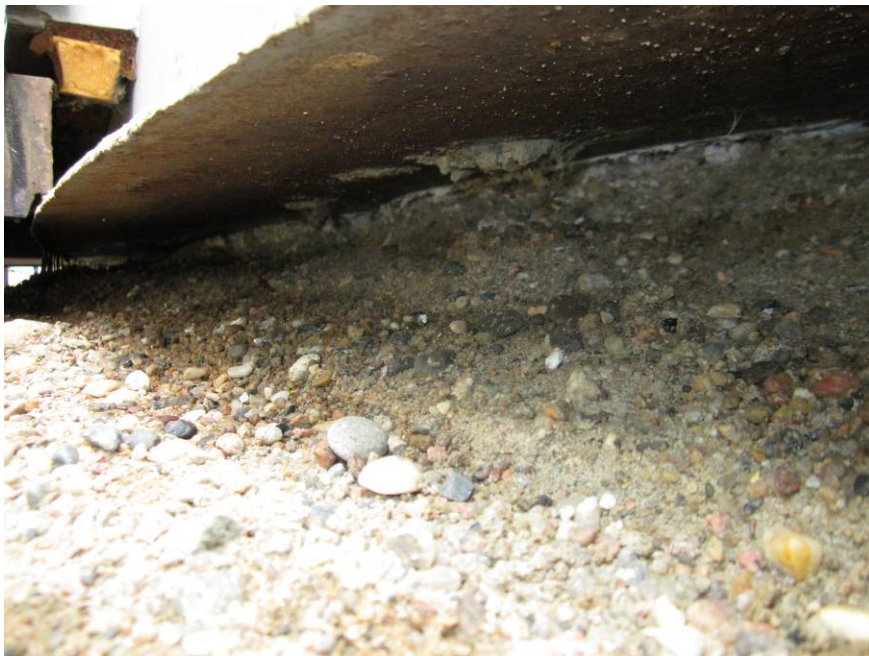
- 1.) The foundation was visually examined from accessible areas. The tank was observed to be resting within an elevated metal ring on an earth and gravel foundation.
- 2.) Erosion was observed beneath the bottom plate projection, extending beneath the shell plate, over approximately 60% of the perimeter of the tank. The worst area of erosion was located beneath the piping on the south side of the tank and extended 18 inches beneath the bottom.
- 3.) No berm was observed; however, there is a low point in the battery in the northwest corner that would collect any product if it were to leak.

Photograph #16:Void Beneath Tank

- 1.) It is recommended to repack the foundation beneath the tank bottom to prevent unnecessary settlement of the tank.

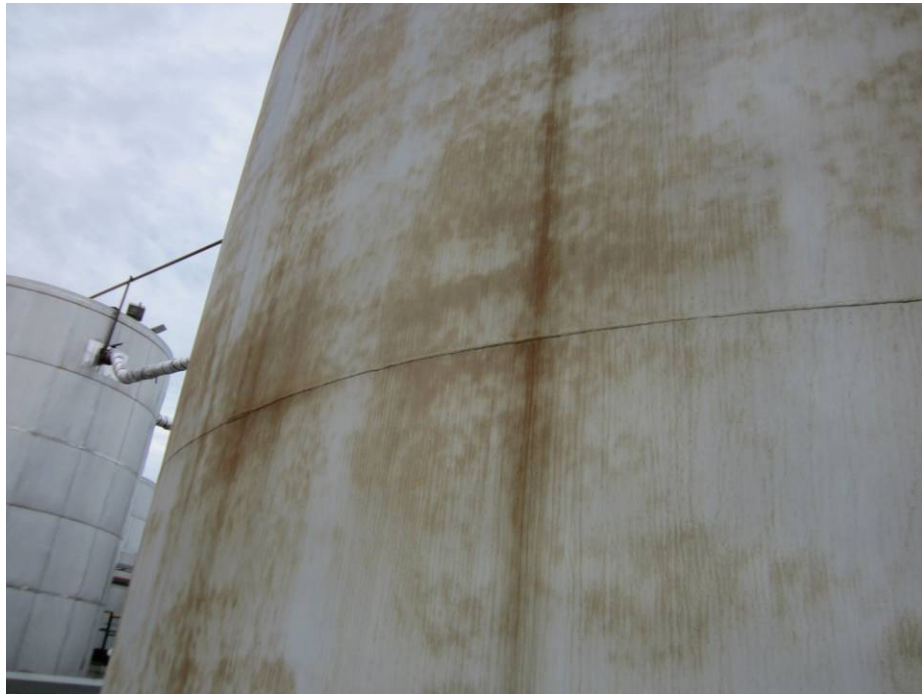
- 1.) The shell plate was visually examined. No significant deformations were observed. Minor areas of coating failures and oxidation were observed throughout.
- 2.) Minor shell plate deflection was observed where the piping is connected to the tank
- 3.) Random ultrasonic thickness (UT) readings were taken on the first course shell plate. No significant material loss was observed or recorded. Refer to Table A - Manual UT Shell Plate Readings – Course # 1, for additional data.
- 4.) Ultrasonic thickness (UT) readings were taken on the accessible shell plate from the vertical ladder. Eight (8) readings were taken per course. No significant material loss was observed or recorded. Refer to Table B - Manual UT Shell Plate Readings – Ladder, for additional data.

Photograph #19:Oxidation on Shell Plate

Consideration should be given to repainting the tanks external surfaces.
Monitor the erosion observed of the tank base.

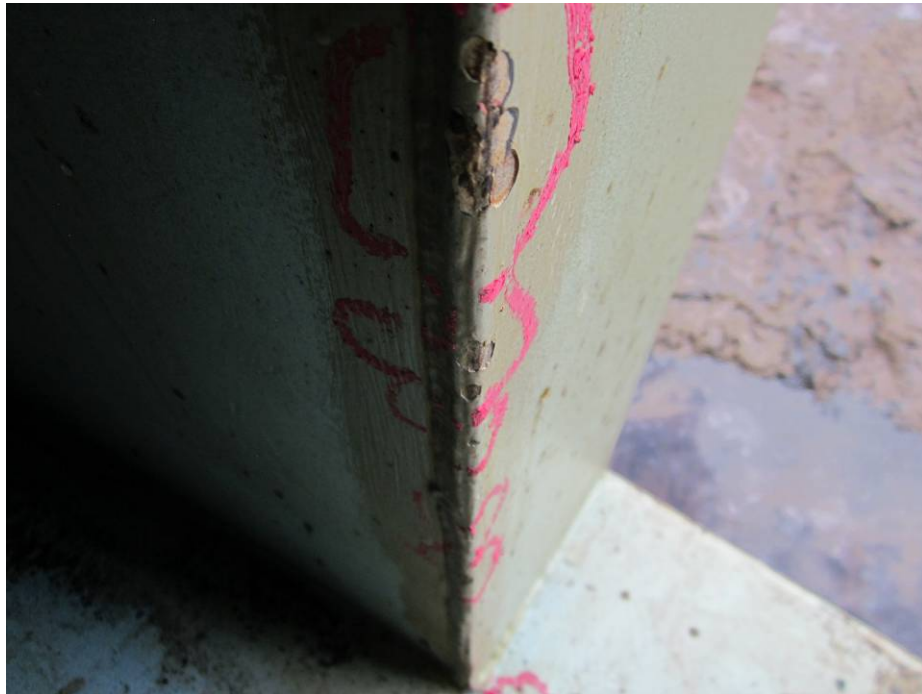
- 1.) The tank nozzles and appurtenances were visually examined. Inspection was limited, in areas, due to insulation.
- 2.) The 4 inch Ø nozzle, located beside the manway, was observed to have improper reinforcing plate weld spacing. No areas of concern could visibly be seen in this area.
- 3.) Internally, ten (10) areas of coating failure were observed on the manway neck to shell welds.

Photograph #31: Coating Failures on Manway

- 1.) It is recommended to periodically inspect the out of compliance reinforcing plate on the 4 inch Ø nozzle for future signs of product staining.
- 2.) It is recommended to repair the ten (10) areas of coating failure on the manway.

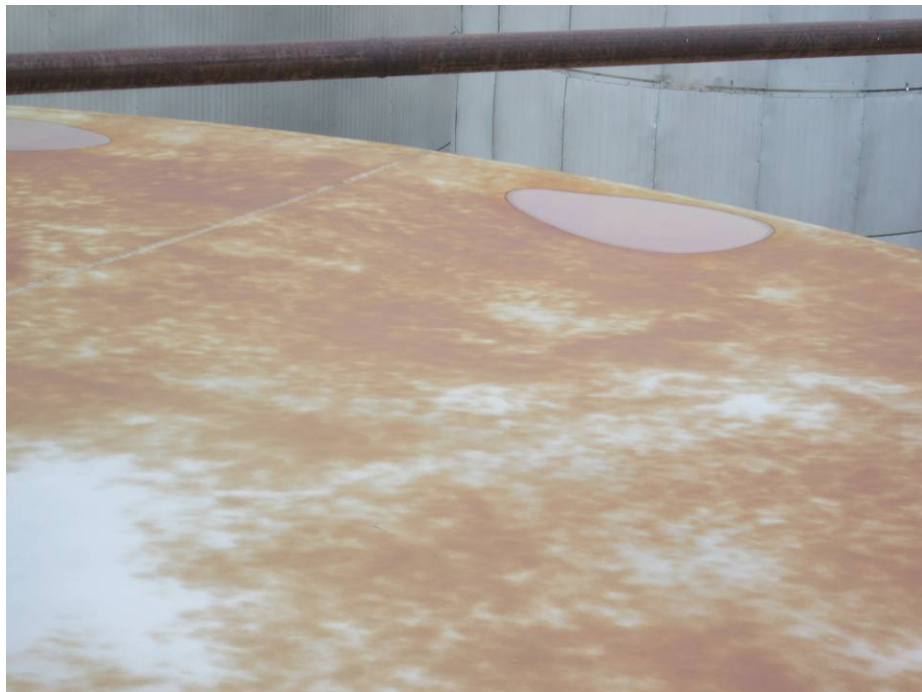
- 1.) The roof plate was observed to have coating failures and oxidation throughout. In addition, areas of pooling water were observed around the perimeter.
- 2.) Ultrasonic thickness (UT) readings were taken on the fixed roof from the vertical ladder. No significant material loss was observed or recorded. Eight (8) readings were taken on the fixed roof. Refer to Table C - Fixed Roof Ultrasonic Thickness Readings, for additional data.
- 3.) The fixed roof support structure was visually evaluated internally from accessible areas. No areas of concern were identified.

C. Roof Deck Drainage					
	✘		8	Look for indication of standing water. (Significant sagging of fixed roof deck indicates potential rafter failure).	<ul style="list-style-type: none"> Pooling water around perimeter

Photograph #41:Pooling Water around Perimeter of Roof
