SEPARATOR INSPECTION REPORT

Notification Number 6075056 Work Order 6078106
 Notification Desc SEPARATOR, 16"OD X 7'6" - 1480 PSI Maintenance Plan QPSEPAR6778
 Tasklist Operation (5Y Inspection Interval) 5Y Code Inspection Separator - Sweet Se

Equipment Number	66117428	Equipment Description	SEPARATOR, 16"OD X 7'6" - 1480 PSI
Class	SEPARATOR	Tag Number	V-100
Serial Number	V-4860-001	Year Built	2006
Manufacturer	IPS MANUFACTURING LIMITED		
Location	FH-BC-007-00008-9000	Location Description	KAKWA GAS PLANT YARD
Provincial Number	0551232	PM Activity	Code
Status Codes	NOPR ORAS	Equipment Status	Idle

Inspected By MATTHEWS P Inspection Date 2008.12.16

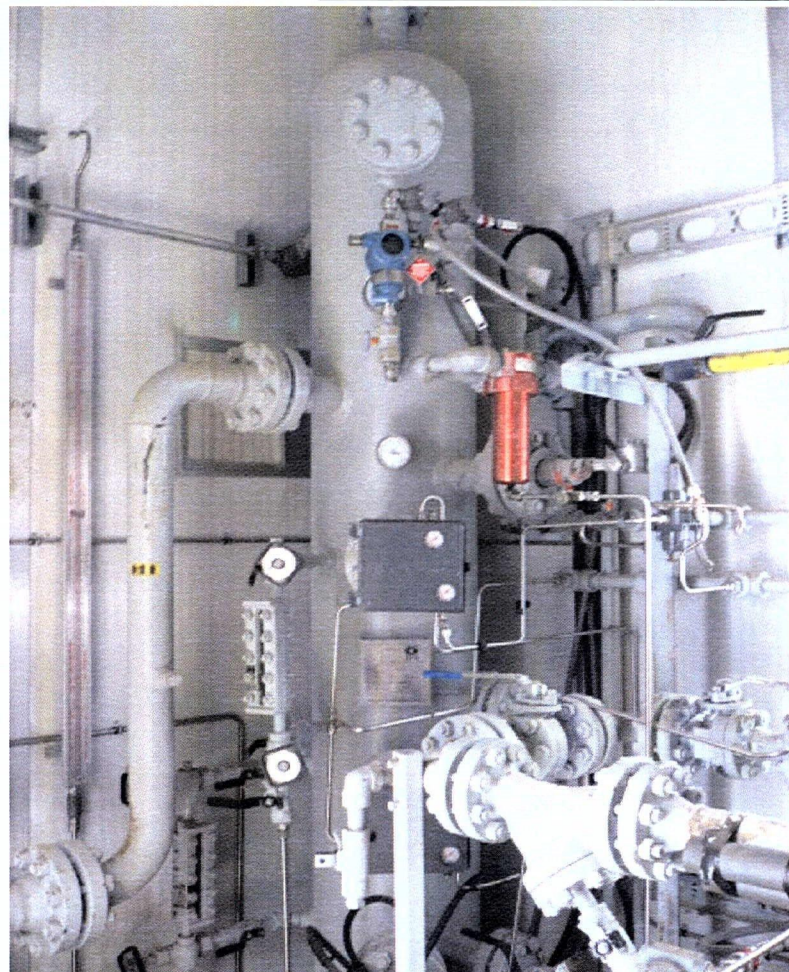
U W RT 1 HT		CERTIFIED BY

MANUFACTURING LIMITED			
YEAR BLT	2008	SERIAL NO.	V-4860-001		
VESSEL TYPE	UG-500X 76 VERT SEPARATOR				
M.A.W.P.	1480	PSI	AT	100	°F
M.D.M.T.	-20	°F	AT	1480	PSI
SHELL TK.	10.31	IN	HEAD TK.	0900	IN
CRN	R-327213		C.A.	0.125	IN
A#	6551232				
JOB 5365-001					
MAILING ADDRESS: BOX 24 HALKIRK ALBERTA CANADA T0C 1M0
