Tank Inspection Report

Location: 6-34-42-1 W4 Tank Type: pop Tank Date: Sept 17, 2019
Mfg: G-LM Year blt: 2008 S/N: 08-053-2 CAP: 210 bbl
Floor Thk: 1/4" Shell Thk: 3/16" Roof Thk: 3/16"
Requisitioned by: Kristy Leeson Approver: Clayton Campbell Approver Code: 22-02013123
WO #: 81425700 PO#: 8401358779 CC: _____ SAP #: 66160853

IRISNDT #: LYN1901541

Item Inspected: 250bbl TANK S/N# 08-053-2

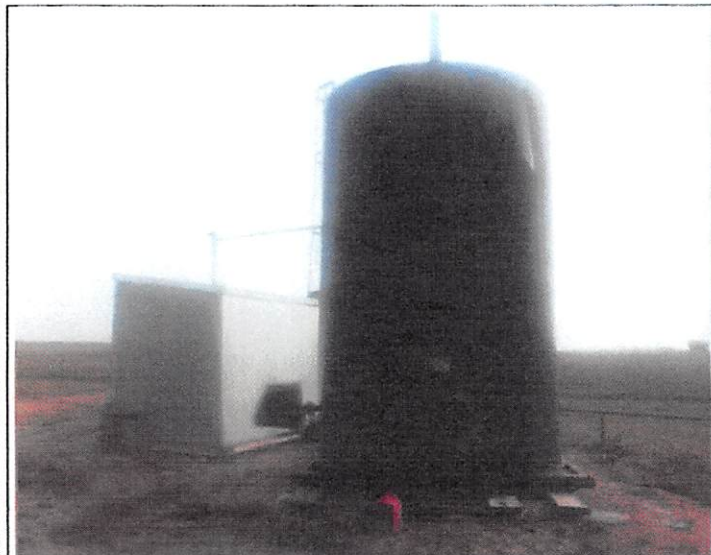
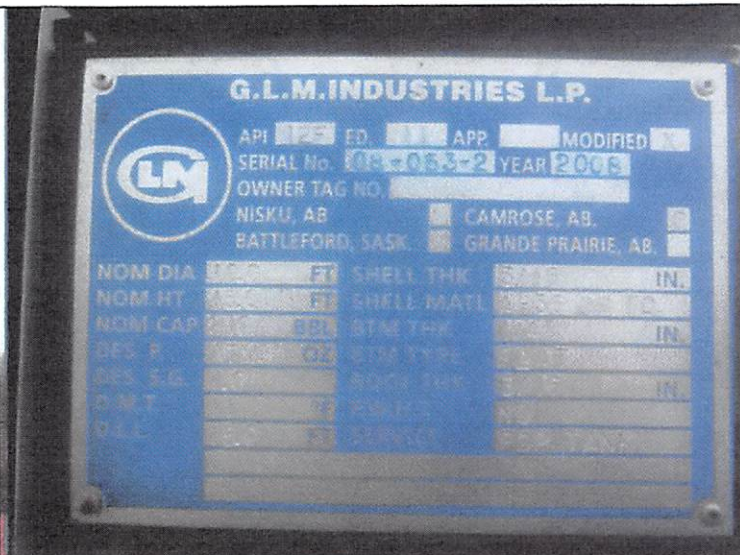
250bbl Tank S/N# 08-053-2: the tank is in good overall condition for a 5yr turnaround, no additional repairs required.

Inspection Limitation(s): Loose rust over the floor surface at the time of the inspection
