**Location:** 100/11-29-46-4W4M
**Tank Type:** Pop tank
**Date:** 25-Oct-2022

**Mfg:** Peaceland Fabricators
**Year blt:** 2010
**S/N:** 020829-01
**CAP:** 100 **bbl**

| | | <b>EXTERNAL TANK<br/>INSPECTION REPORT</b> | | CA1384-TIS1-145<br>Rev 1<br>Date: 2022-Oct-25<br>Page 1 of 5<br>IRISNDT #: LYI2200130 | |
| <b>Tank Name:</b> T-100 | | <b>SAP #:</b> 66202828 | | <b>Serial #:</b> 020829-01 | |

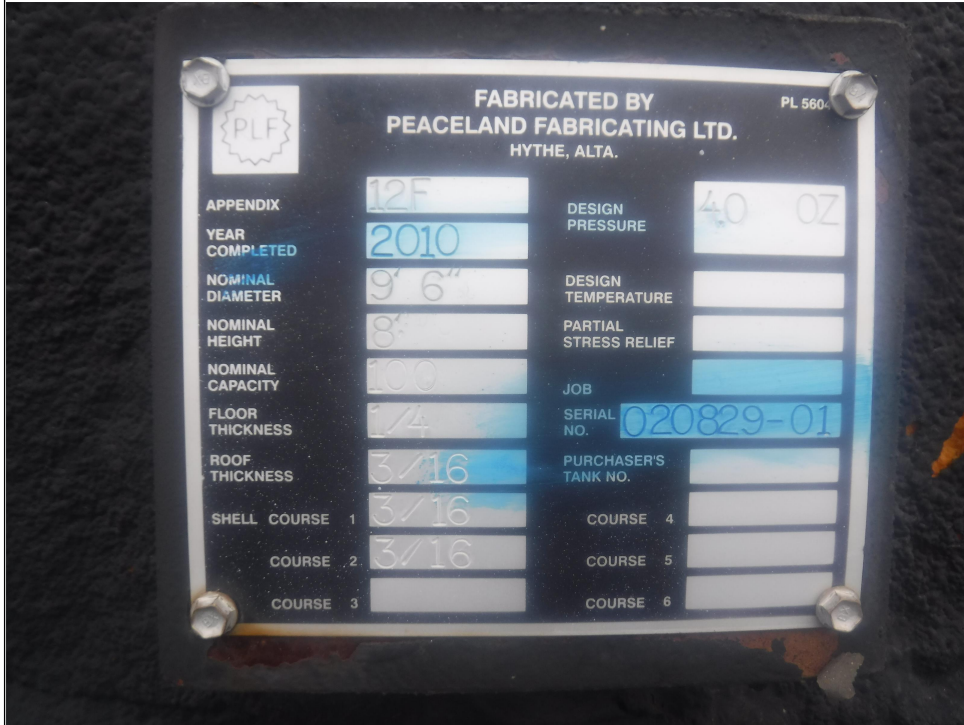
Name Plate

| # | External Inspection Item | Completed | Comments |
|---|---|---|---|
| 16 | Nameplates/Nameplate Brackets | Yes | clear and legible |

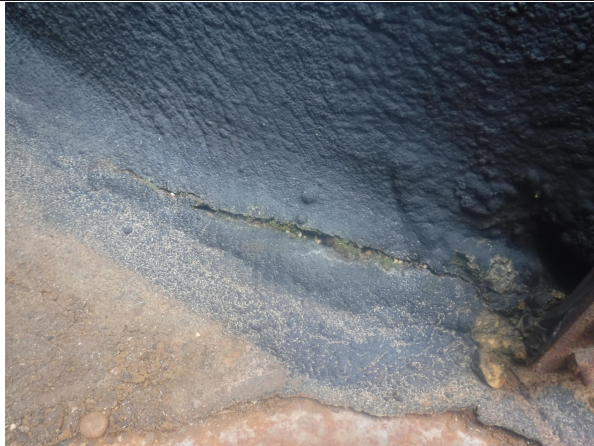
| # | External Inspection Item | Completed | Comments |
|---|---|---|---|
| 23 | Shell-Bottom Junction/Chime | No | Fully Insulated |

CUI suspecte at floor to shell

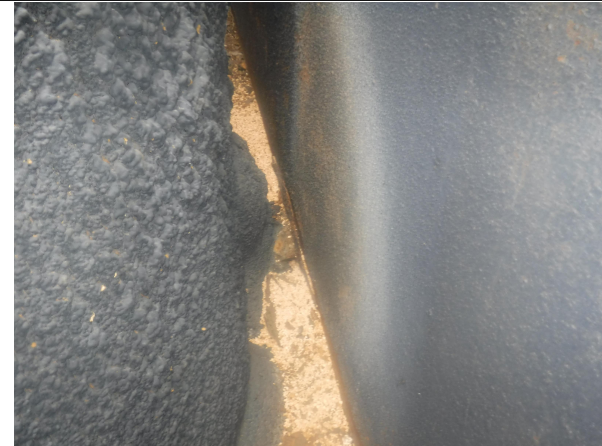
| # | External Inspection Item | Completed | Comments |
|---|---|---|---|
| 29 | Area Housekeeping | Yes | Containment is congested and used for storing temp wrap |

Debris build up between Containment and shell

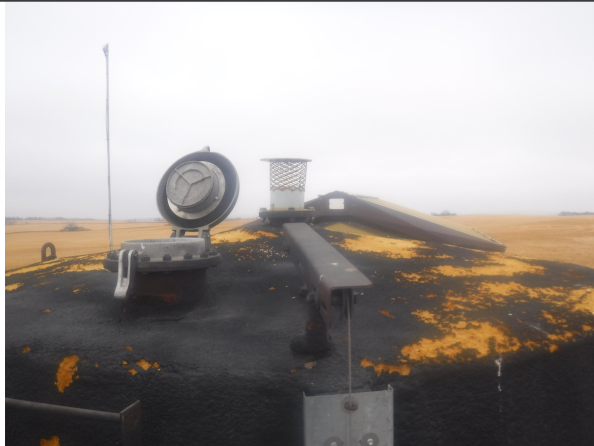
Tank Roof

| # | External Inspection Item | Completed | Comments |
|---|---|---|---|
| 11 | Roofs (fixed) | Yes | Appears properly sloped in good condition |

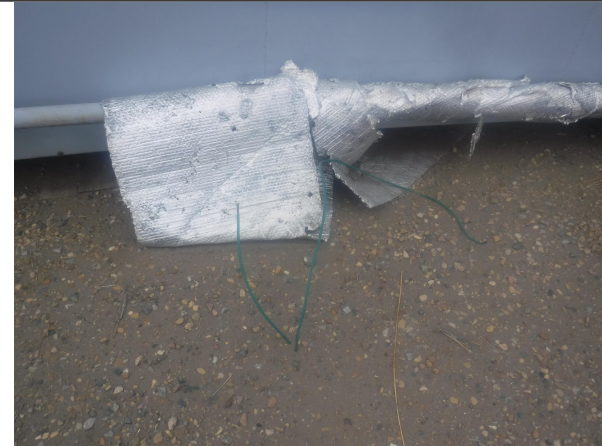
| # | External Inspection Item | Completed | Comments |
|---|---|---|---|
| 15 | Grounding Clips/Grounding Cable Attachment | Yes | Cut from skid |

Cut ground wires

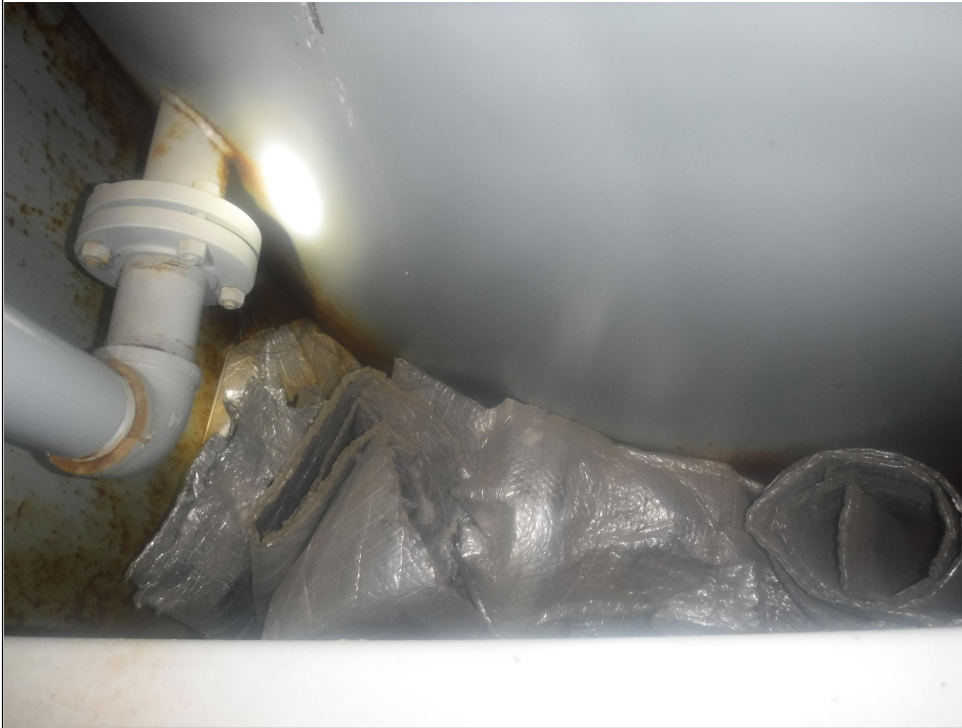
Insulation and rust in containment in the building

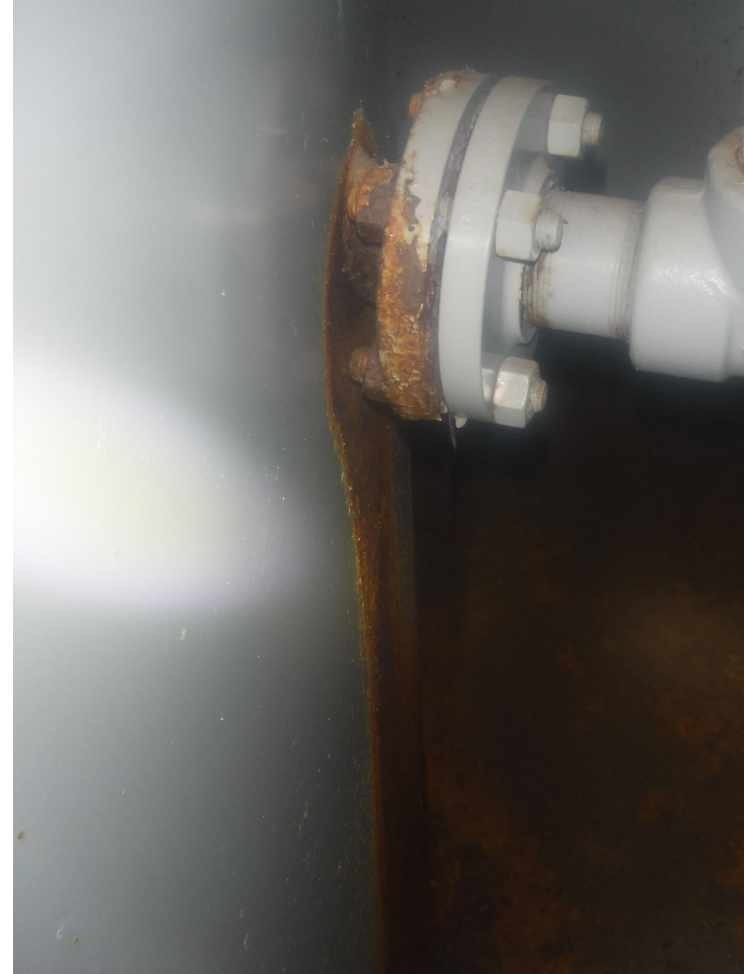
| # | External Inspection Item | Completed | Comments |
|---|---|---|---|
| 1 | Process Leaks (flange, vents, etc.) | Yes | Suspected leaking inlet |
| 6 | Shells | Yes | Leaking shell is suspected - UT indicated severe internal corrosion |

Suspected Leak

| Open tank for Internal Evaluation to determine the scope of repairs required ,due to the size of the tank and severity of internal corrosion detected by sampling a full replacement is recommended | | | | | |
