GENERAL INSPECTION FORM						
Field:			Skid No. : 6126			
Facility: Goodfare Gas Gathering			Location (LSD) Surface: 06-21-72-11-W6M			
Vessel Name & Equipment Number: 3 Phase Separator			PSV Only-Installed on piping: <input type="checkbox"/>			
Orientation: Horizontal <input type="checkbox"/> or Vertical <input checked="" type="checkbox"/>			Location (LSD) Down hole:			
Status: In Service <input checked="" type="checkbox"/> or Out of Service (blinded / fully isolated) <input type="checkbox"/>			Com. Inspection <input type="checkbox"/> Shop Inspection <input type="checkbox"/> Reg. Inspection <input checked="" type="checkbox"/>			
PRESSURE VESSEL NAMEPLATE DATA						
"A" or "G" or "S" (Sask.) or BC Registration Number.			CRN Number: L 7115.2			
A0455071			Size (diameter x length- estimate if necessary): 20 in x 90 in			
Vessel serial number: C9390.VS			Shell material: SA 106 B			
Shell thickness: 26.2 mm			Head material: SA 516 70 N

Photo Table

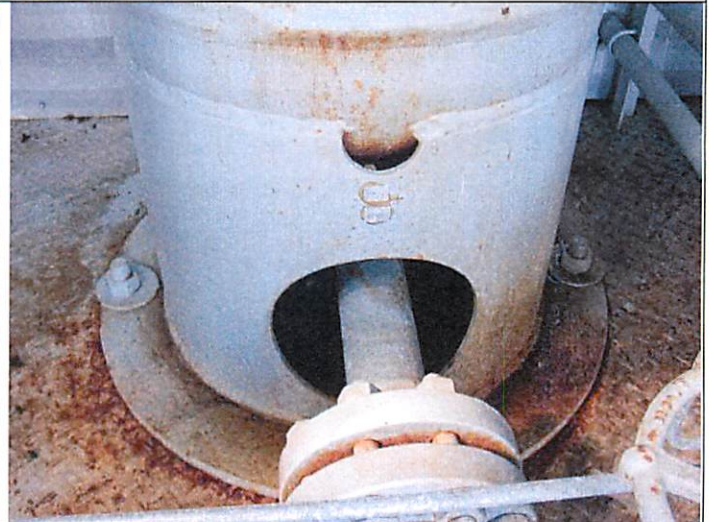
Skirt

External Inspection Items	G	F	P	N/A	Comments
Insulation Verify sealed around man ways, nozzles, valves, etc., no damage present, and there is no ingress/egress of moisture. Are straps secured?				X	No insulation.
External Condition Assess paint condition, areas peeling, record any corrosion, (check roof interface for corrosion), damage, distortion, etc. (record location, size and depth of corrosion or damage)		X			Paint is in fair condition – oxidized with some surface corrosion to 30% of vessel – no pitting.
Leakage Record any leakage at flanges, threaded joints, weep holes on repads, etc.		X			Product is seeping from PSV to vessel connection.
Skirt/ Saddle Assess condition of paint, fire protection, concrete. Look for corrosion, buckling, dents, etc. Look at vessel surface area near supports. Verify no signs of leakage at attachment to vessel and attachment welds are acceptable. Is ground wire attached? Adequate access for UT inspection? Note: For horizontal vessels mounted on saddles ensure anchor bolting loose on one end to allow for expansion/contraction after installation.	X				Skirt: No distortion, no corrosion at skirt to head welds – no leaks. Ground cable attached to skid.

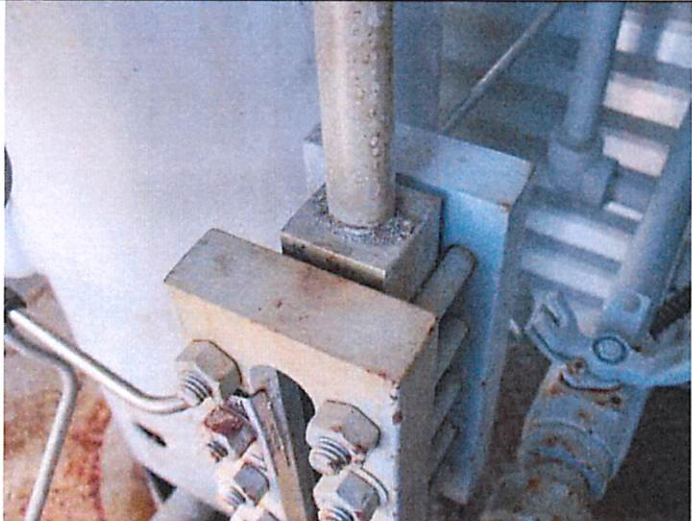
Lower liquid level leaking gas. Audible (loud), Abundant LEL's

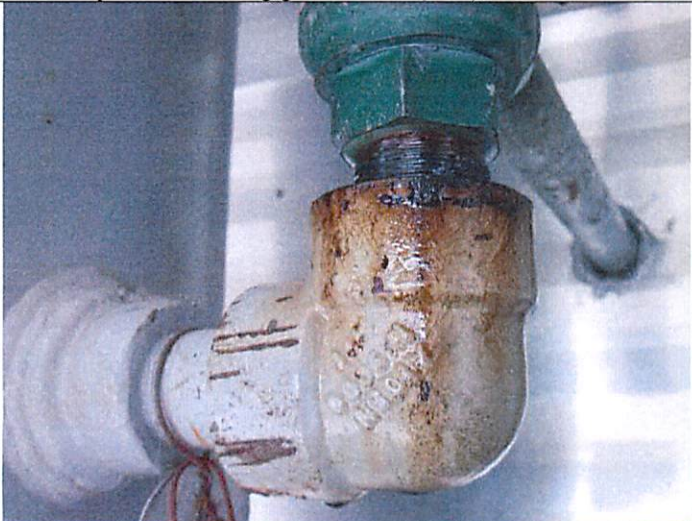
Product seeping from PSV to vessel connection – requires re sealing.

Product weeping from PSV fitting
