Storage Tank Visual Inspection Report

Equip Id 66121625 **SAP ID** 66121625 **Asset Type** Storage Tank
Plant Lloydminster Production **Unit** Gully Lake/Standard Hill **System** N/A
Description TANK, SURGE
FLOC H1-06-003-00001-100001 **LSD** 03-35-049-22W3

Tank Inspection Report

Location: 3-35-49-22w3 Tank Type: Unload Tank. Date: Sept 29-16

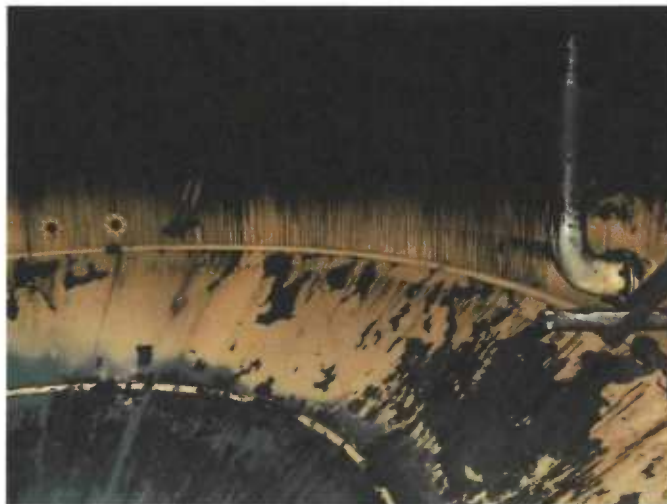
ID	Description	Condition	Location	NCR	Comment
V6	Deposits	Poor			TAK IS VERY DIRTY LIMITED VISUAL ON THE INTERNAL. Lots of scale built up was noted on the floor, shell and internals.
V7	Welds	Good			
V8	Nozzles	Good			
V9	Shell	Good			
V10	Roof	Good			
T11	Floor	Good			
V25	Thermowells	Good			
V27	Nonmetallic Linings	Poor			The coating is in poor condition at the roof to shell interface and on the manway cover. Scaffolding will be require at the next scheduled inspection.
V28	Internal steam coil or other piping	Good			The desand rings appeared to be in good working condition.
V29	Level gauge	Good			
V30	Other Welded Attachments	Good			
V21	Internals Other (Please explain)	Poor			Some of the test tap stainless steel tubing has been under some excessive stress due to the cone flexing. 2 1" collar were in need of replacement.

Dirty internals

The corrosion group should review the scale inhibitor injection program as significant amount of built up was noted inside the tank.

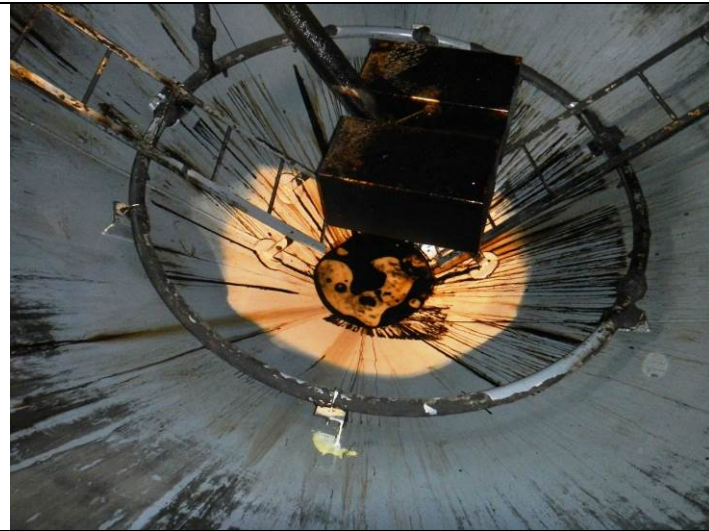
FLOOR AND FLOATING SKIMMER

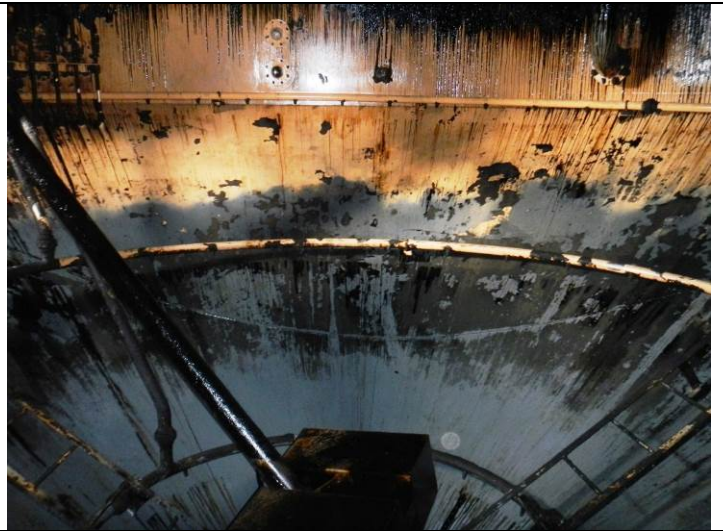
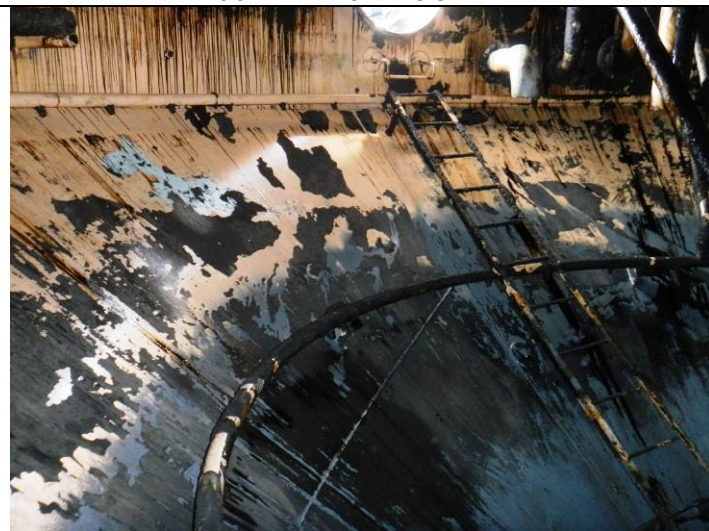
CONE SECTION AND SCALE BUILT UP

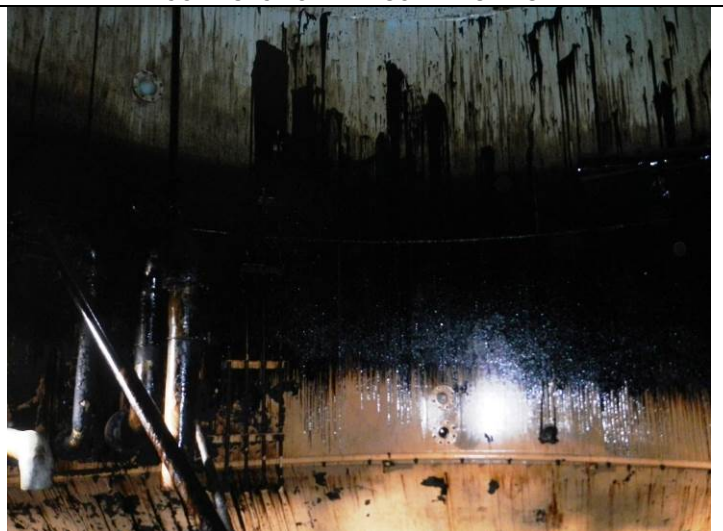
OILY RESIDUES AND SCALE BUILT UP ON SHELL

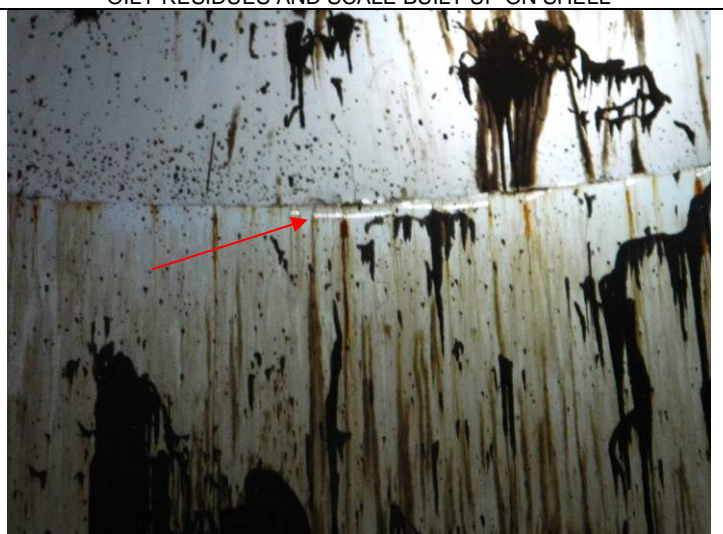
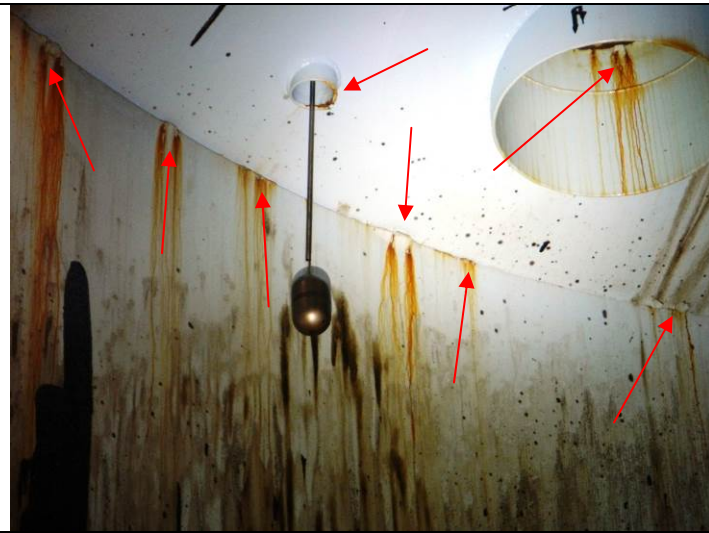
COATING PEELING AT THE ROOF TO SHELL INTERFACE

- COATING FAILURE AT THE ROOF TO SHELL SEAM, RECOMMEND SCAFFOLDING TO THE ROOF FOR A REPAIR.

Scaffolding should be erected at the next scheduled inspection to repair the failed coating at the roof to shell interface.

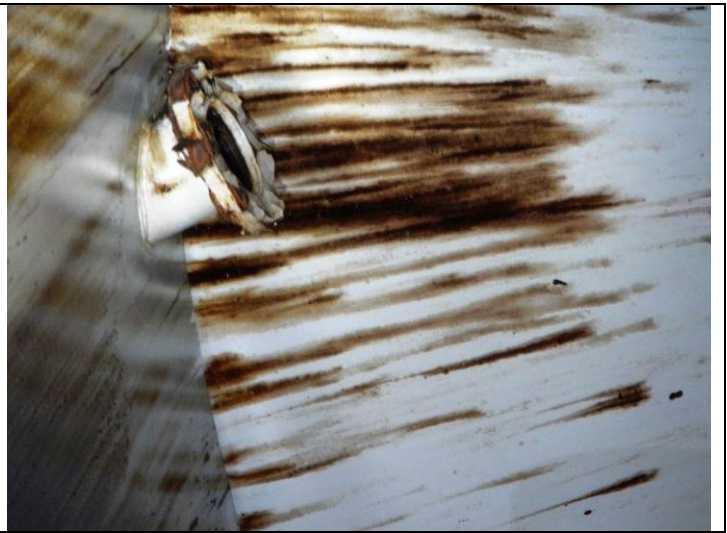
COATING PEELING ON UPPER SHELL NOZZLE

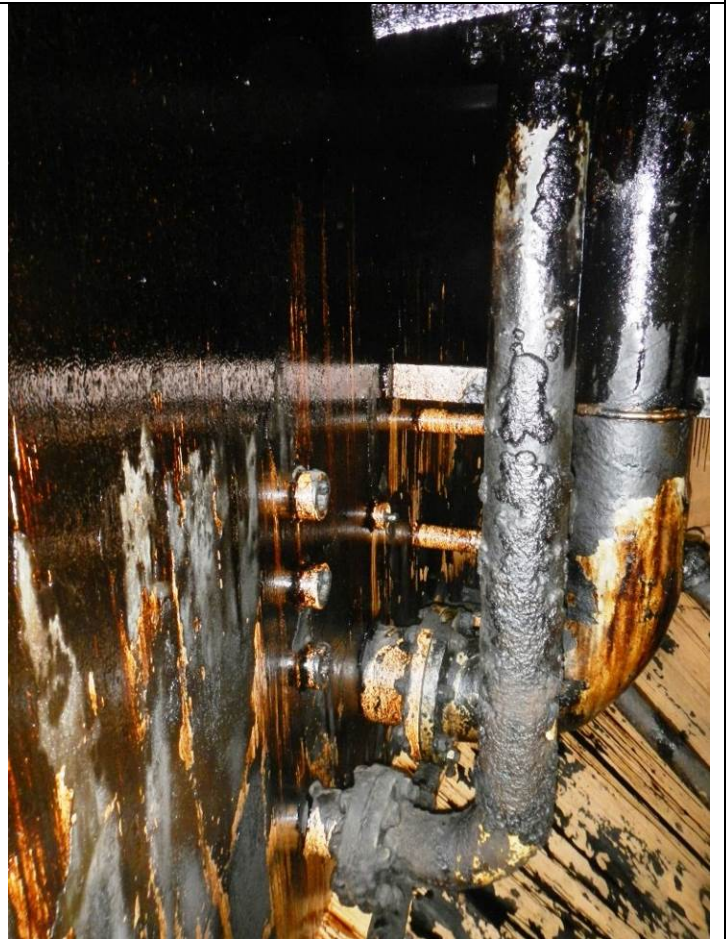
SCALE BUILT UP ON RISERS

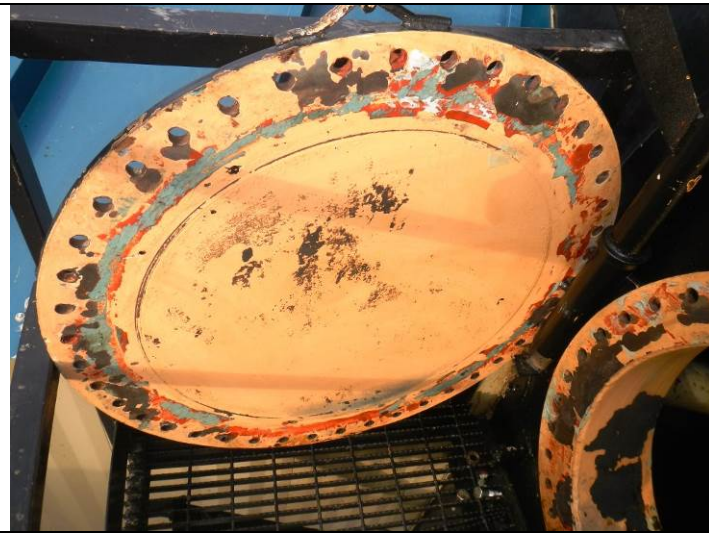
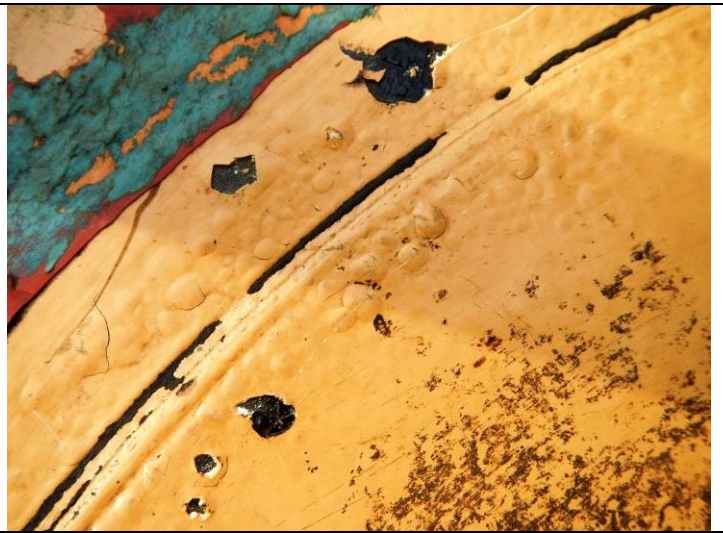
COATING IN POOR CONDITION ON MANWAY COVER

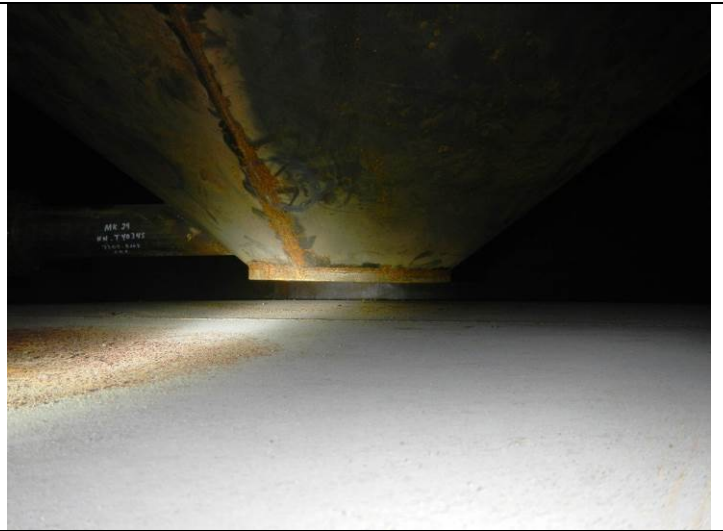
UNSUPPORTED CONE FLOOR

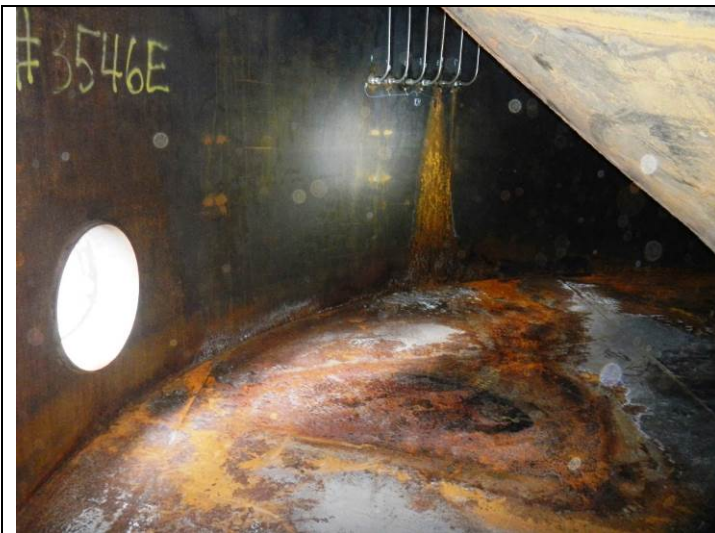
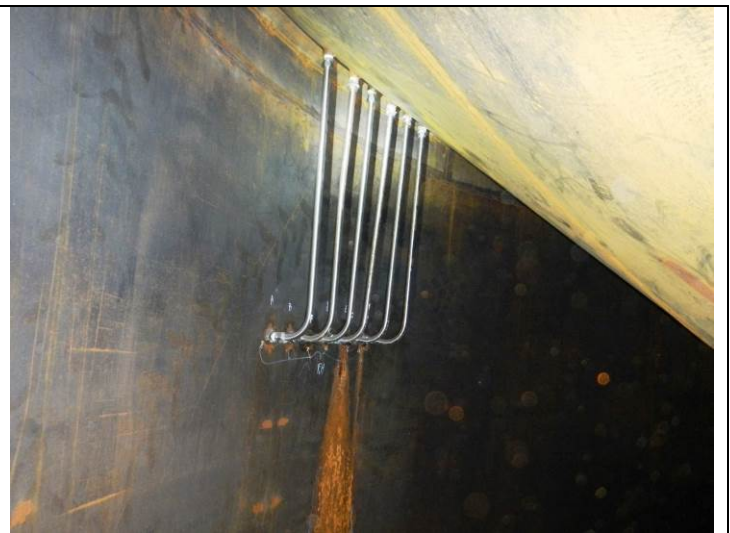
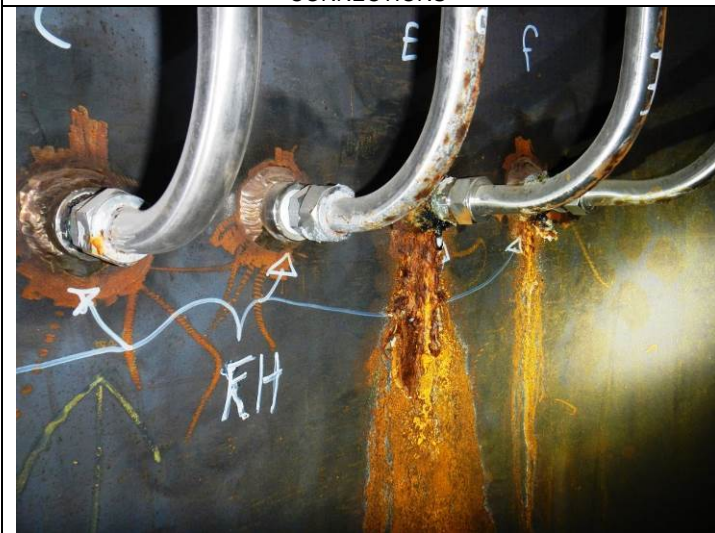
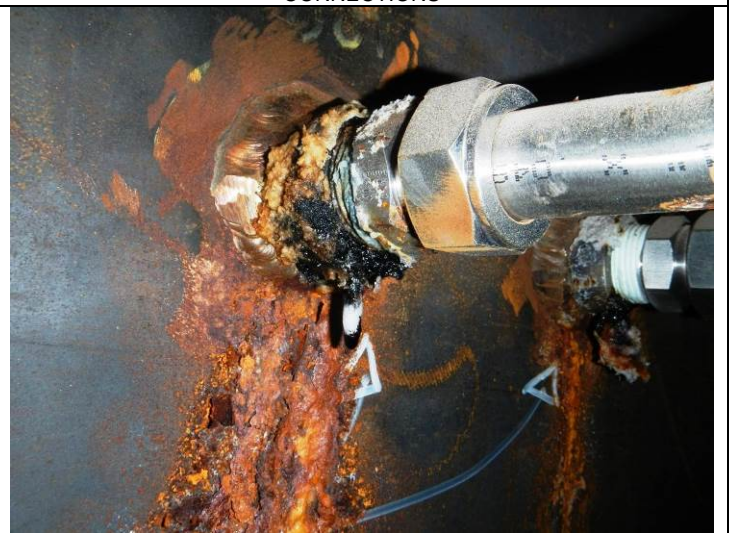
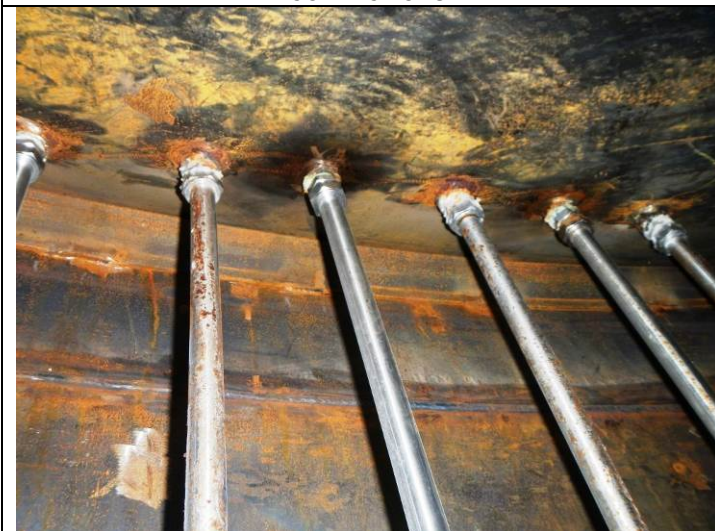
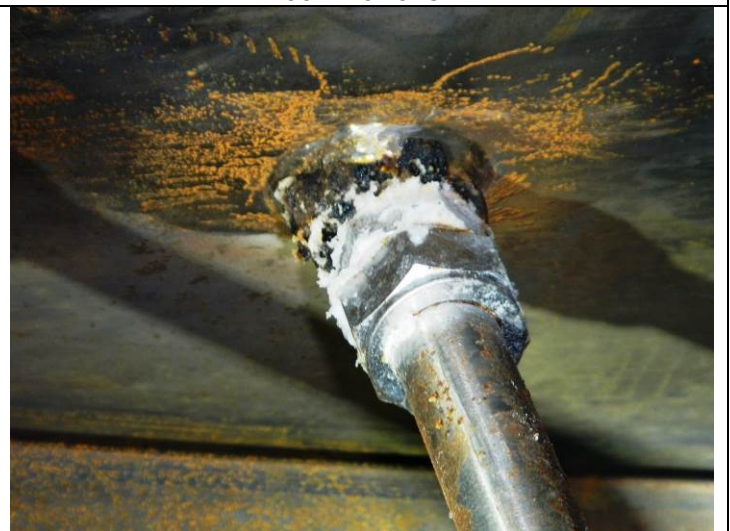
SIGNS OF LEAKAGE FROM THE TEST TAPS THREADED CONNECTIONS

Some 1" stainless steel flex hose should be installed on the test tap to avoid future leak / failure. See the attached NDE report for the repairs performed during the 2016 inspection.

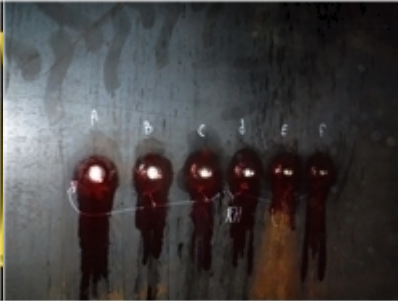
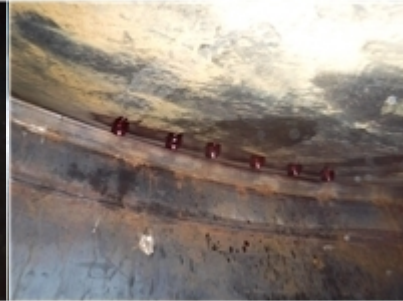
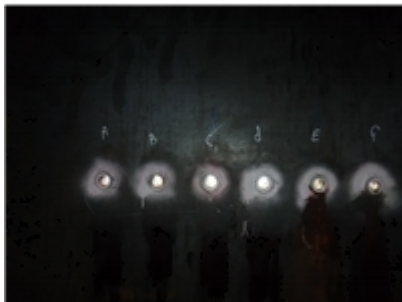
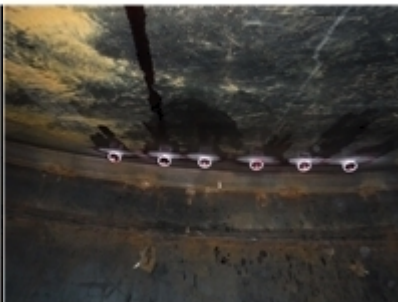
Weld #	Size	SCH	Material	Welder ID	Accept	Reject	Remarks
PT-1	1"	XS	ST	N/A	✓		LOWER "A" COLLAR
PT-2	1"	XS	ST	N/A	✓		UPPER "A" COLLAR
PT-3	1"	XS	ST	N/A	✓		LOWER "B" COLLAR
PT-4	1"	XS	ST	N/A	✓		UPPER "B" COLLAR
PT-5	1"	XS	ST	N/A		✓	LOWER "C" COLLAR / REPLACE DUE TO DAMAGED THREADS
PT-6	1"	XS	ST	N/A	✓		UPPER "C" COLLAR
PT-7	1"	XS	ST	N/A	✓		LOWER "D" COLLAR
PT-8	1"	XS	ST	N/A	✓		UPPER "D" COLLAR
PT-9	1"	XS	ST	N/A		✓	LOWER "E" COLLAR / REPLACE DUE TO DAMAGED THREADS
PT-10	1"	XS	ST	N/A	✓		UPPER "E" COLLAR
PT-11	1"	XS	ST	N/A	✓		LOWER "F" COLLAR
PT-12	1"	XS	ST	N/A	✓		UPPER "F" COLLAR
							-NO CRACKS FOUND AT TIME OF INSPECTION

LOWER COLLARS DURING PROCESSING

UPPER COLLARS DURING PROCESSING

LOWER COLLARS AFTER PROCESSING

UPPER COLLARS AFTER PROCESSING
