# Storage Tank External Visual Inspection Report

Organization: Husky	Inspection Date: 25/05/2015 12:00:00AM
Plant: Lloydminster Production	Equipment ID: 62022723
	Asset No: 62022723
	System: 00002 PARADISE VALLEY 6-5 COMPRES
	Operating Unit: H1-02-006 RIVERCOURSE

Description:	TANK, GLM 64M3
--------------	----------------

# Storage Tank Internal Visual Inspection Report

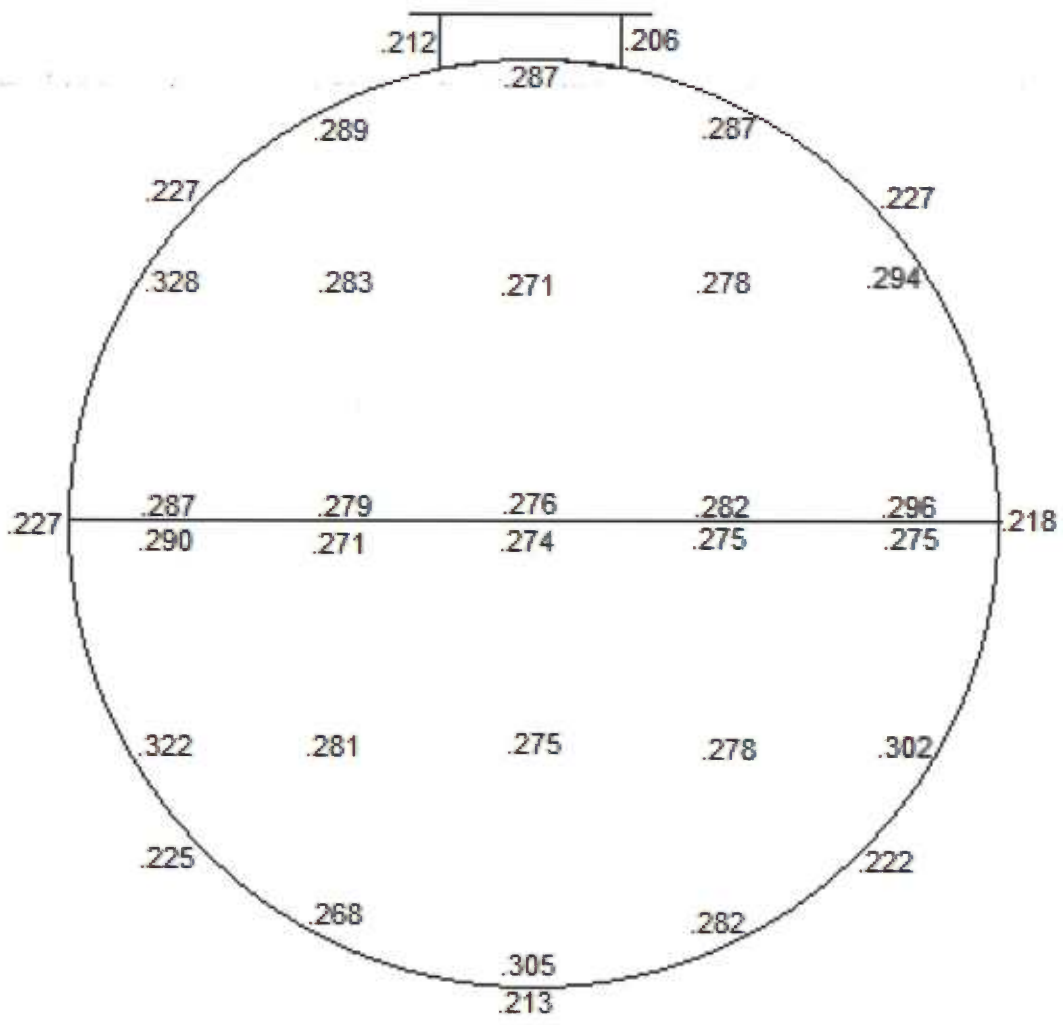
LOCATION 6-5-47-4W4 Comp DATE 2015-05-25 MFG \_\_\_\_\_ GLM \_\_\_\_\_  
 YEAR 1994 S/N B-94-445-5 CAP 150 BBL AFE/CC 80070488  
 FLOOR THK 1/4" SHELL THK. 3/16" ROOF THK. 3/16"  
 SAP # 62022723

Random locations of the tank's floor and lower shell were UT thickness tested with some minor metal loss identified.

The lowest thickness identified was found to be 0.206". See attached sketch for thicknesses found and approximate locations of tests. NOTE: The UT readings shown include the thickness of the coating and may not accurately identify the true condition of the tank floor.

Continue the UT thickness survey on the tank floor and lower shell at next scheduled inspection.
