RE: OBSERVATION REPORT ON 160 M3 (1000 BBL) STORAGE TANKS

TANK 1 S/N 4-10-18-13534 BUILT 2004

TANK 6 S/N 03-06-05-12208 (ZERO IN 12208 MIGHT BE A 9)
YEAR BUILT 2003.

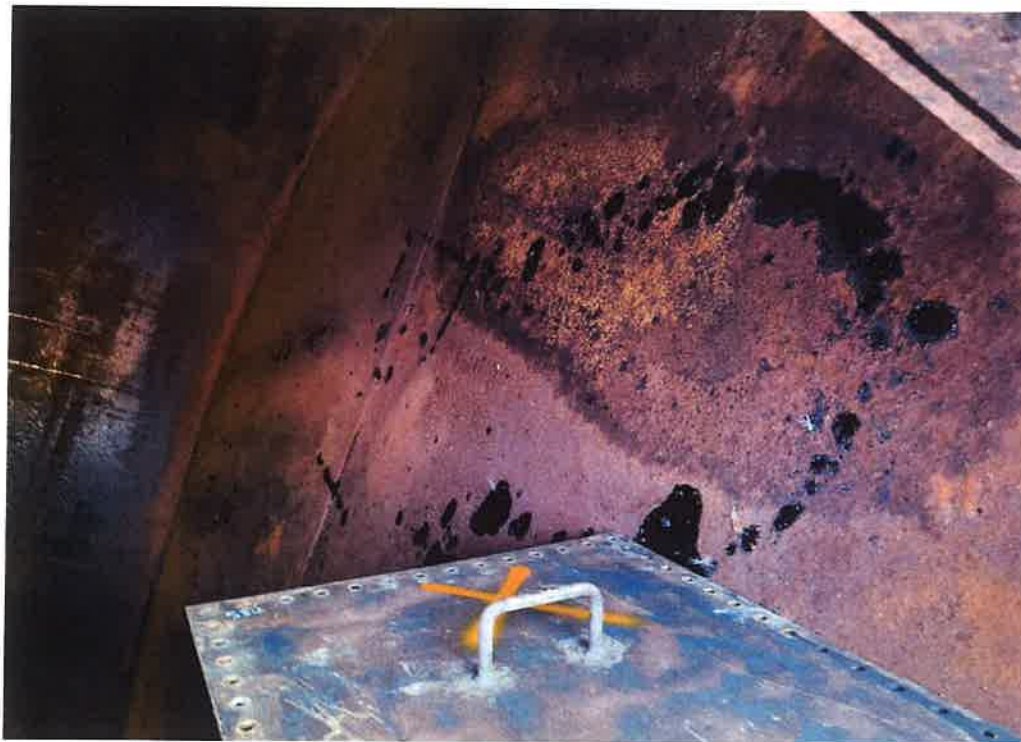
CORROSION AREA NEAR TO MANWAY

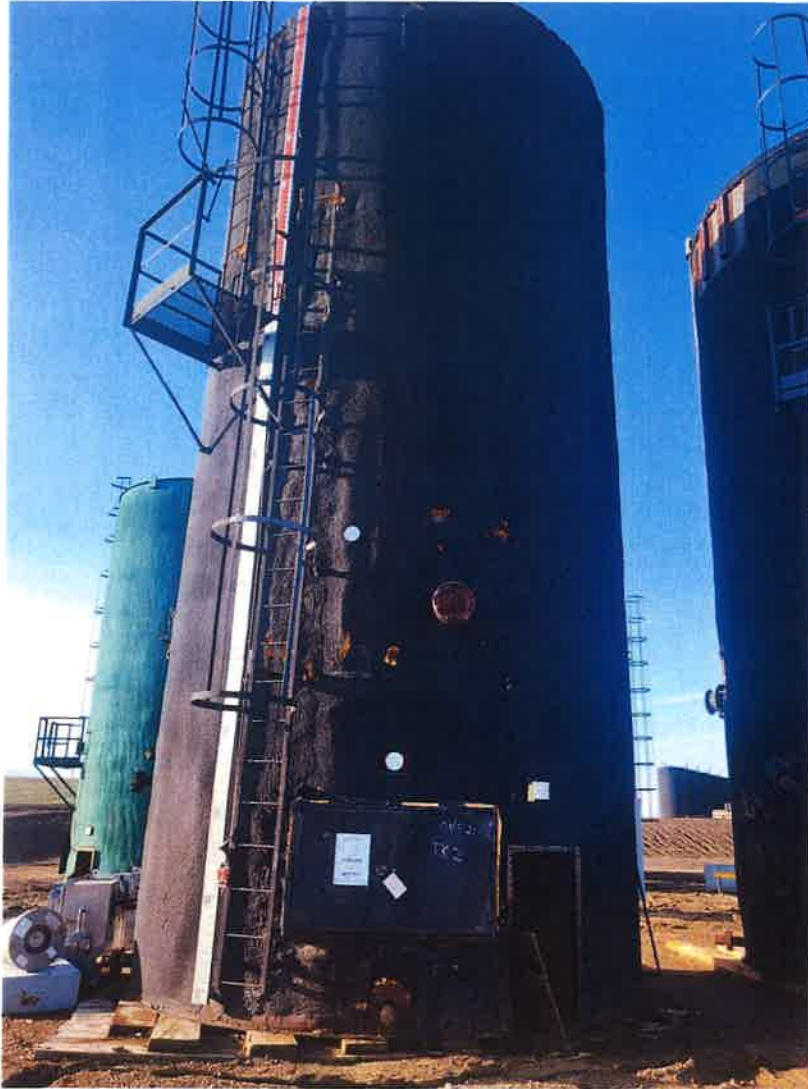
TANK IS SITTING ON PLANKS WITH NO GROUND CONTACT
ALL LADDERS AND PLATFORMS ARE INCLUDED ON ALL
TANKS, NO BURNER OR BMS, LAST INSPECTION 2017,
ENVIRO BOX FOR VALVES
TANK MAY REQUIRE FLOOR REPAIRS.

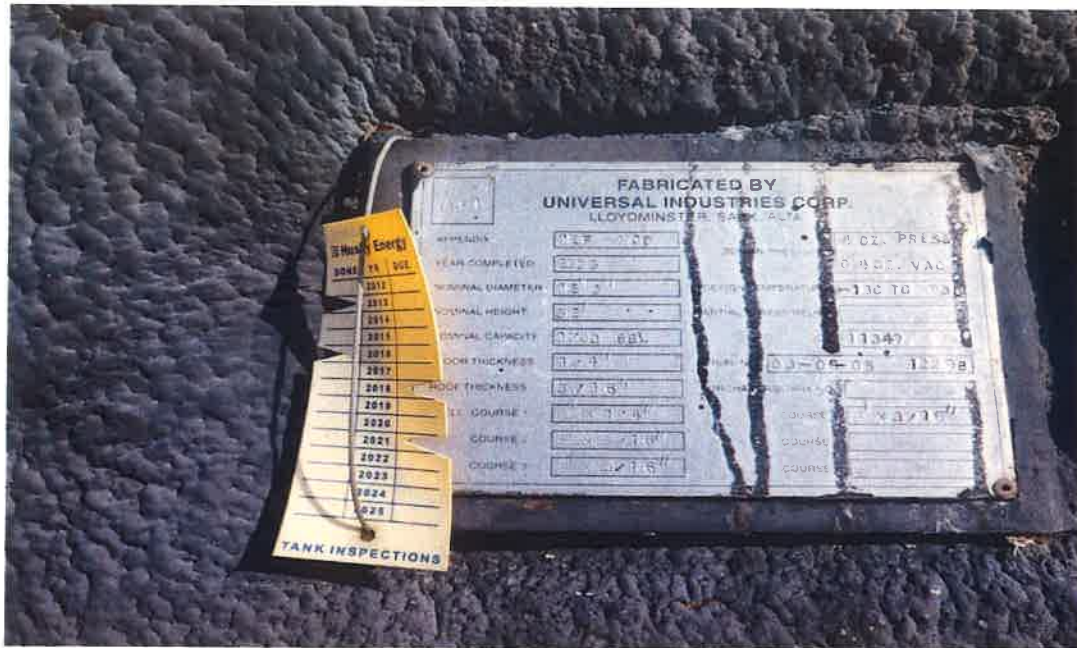
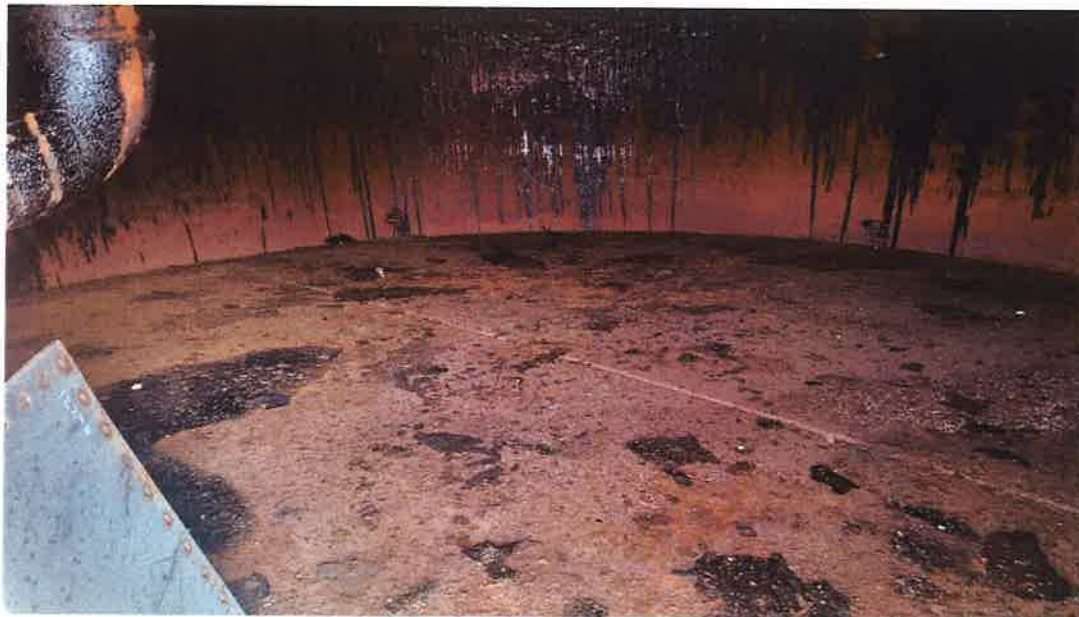
TANK BOTTOM IS ROUGH, UNKNOWN LEVEL OF
CORROSION.

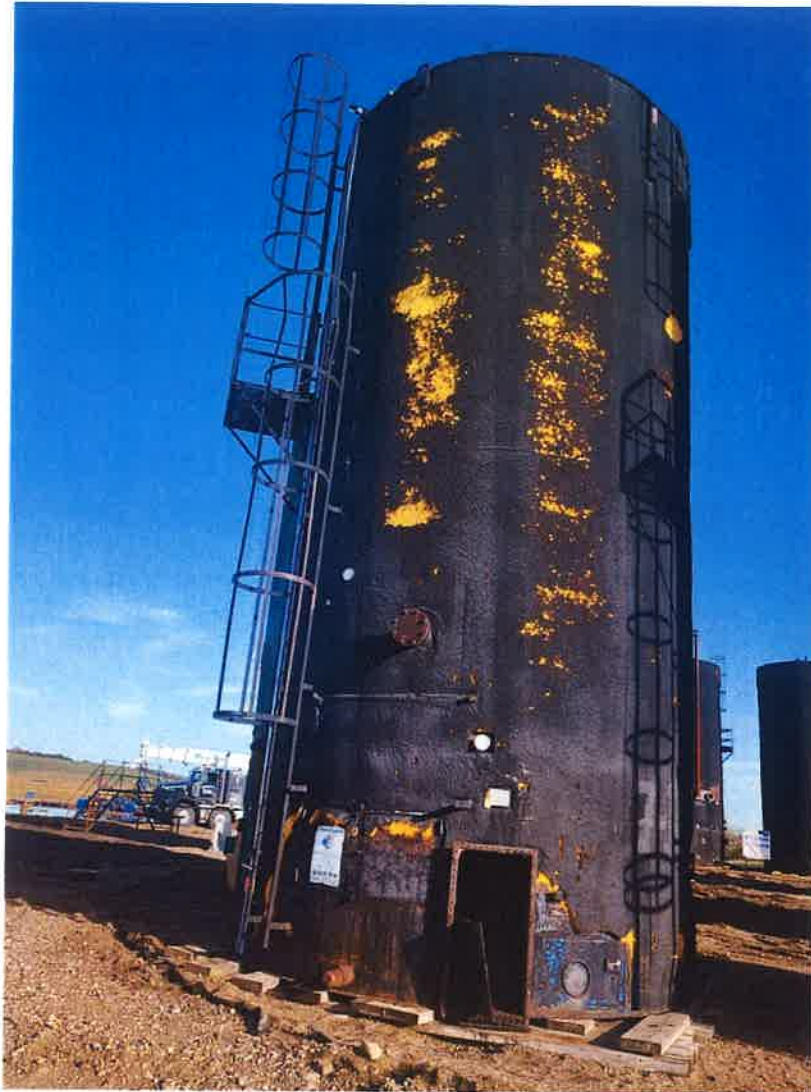
TANK IS SITTING ON PLANKS, INSULATION HAS SOME DETERIOATION, MAY REQUIRE A NEW FLOOR.
