STORAGE TANK INSPECTION REPORT

IR 191125RJWa

LSD: 2-29-79-23 W4

Equipment ID: 66083224

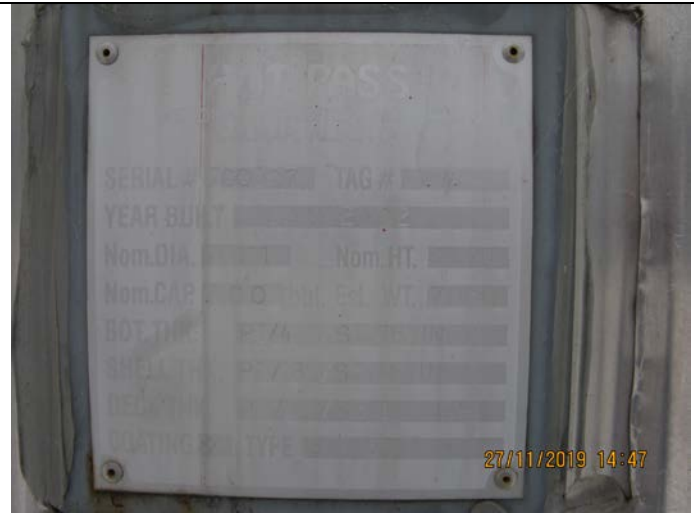
| ID | Description | Condition | Location | NCR | Comments |
|---|---|---|---|---|---|
| T1 | General Other (Please Explain) | FAIR | | | Nameplate is legible. |

TANK NAME PLATE

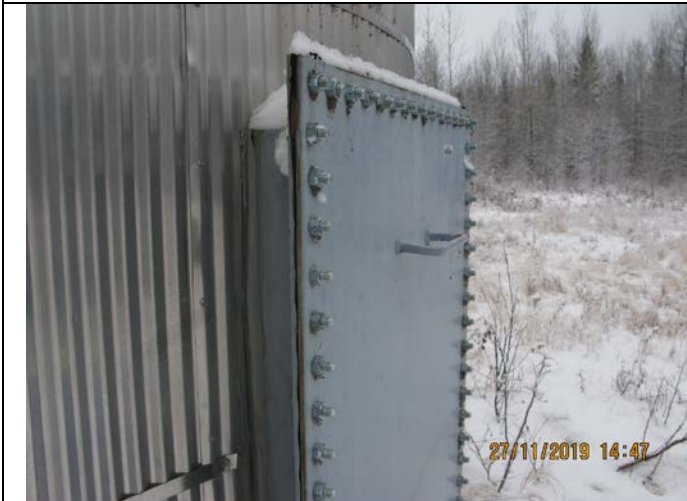
| ID | Description | Condition | Location | NCR | Comments |
|---|---|---|---|---|---|
| T45 | Manways/Hatches | GOOD | | | SECURE AND ATTACHED |

TANK MANWAY, WITH NO LEAKS VISIBLE

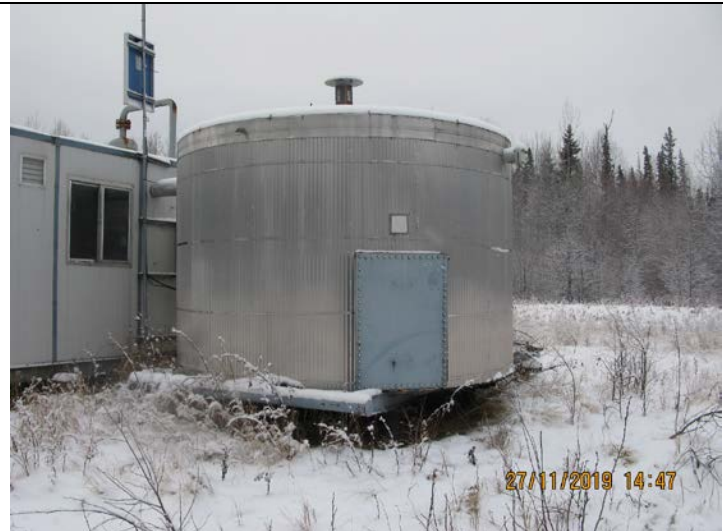
OVERALL VIEW OF TANK SET ON PILES

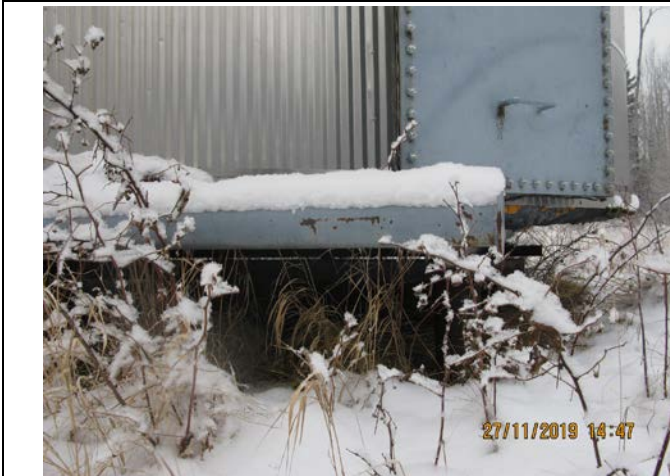
| ID | Description | Condition | Location | NCR | Comments |
|---|---|---|---|---|---|
| T31 | Support Other (Please explain) | FAIR | | | SKID IS SECURE WITH NO DAMAGE |
| T32 | Foundation | FAIR | | | PILES AND SKIDS. |

TANK SKID SET ON PILES ABOVE GROUND

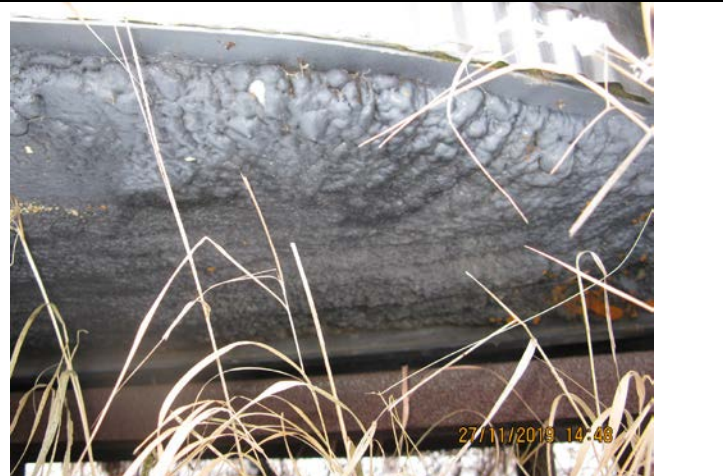
| ID | Description | Condition | Location | NCR | Comments |
|---|---|---|---|---|---|
| T13 | Bottom | FAIR | | | Tank underside is insulated. |

UNDERSIDE OF TANK WITH SPRAY FOAM INSULATION LIQUID.

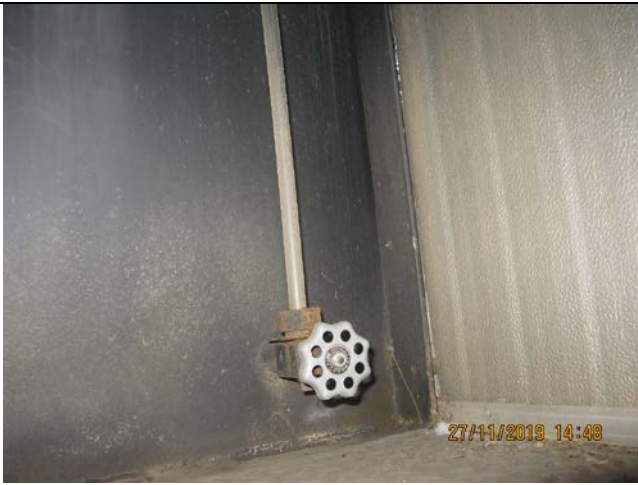
| ID | Description | Condition | Location | NCR | Comments |
|---|---|---|---|---|---|
| T14 | Secondary Containment | FAIR | | | Double walled interstitial space. |

INTERSTITIAL SPACE SITE GLASS

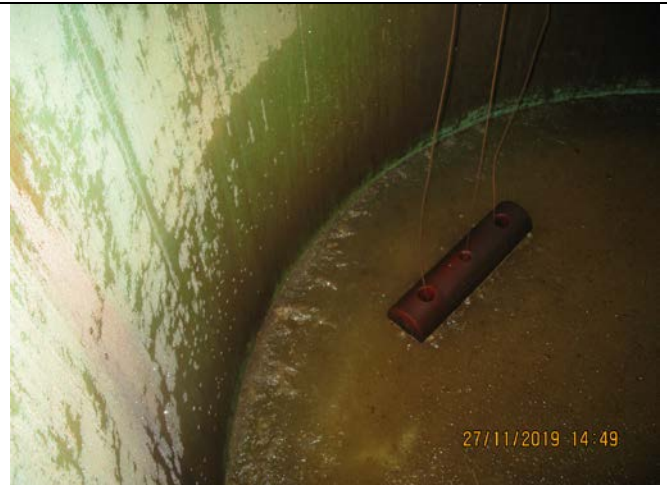
VISUAL INTERNAL: No full visual Internal inspection was performed on the tank. Only a top view from the thief hatch was performed to assess the level in the tank and part of the shell coating.

VIEW OF INSIDE OF TANK THROUGH THIEF HATCH

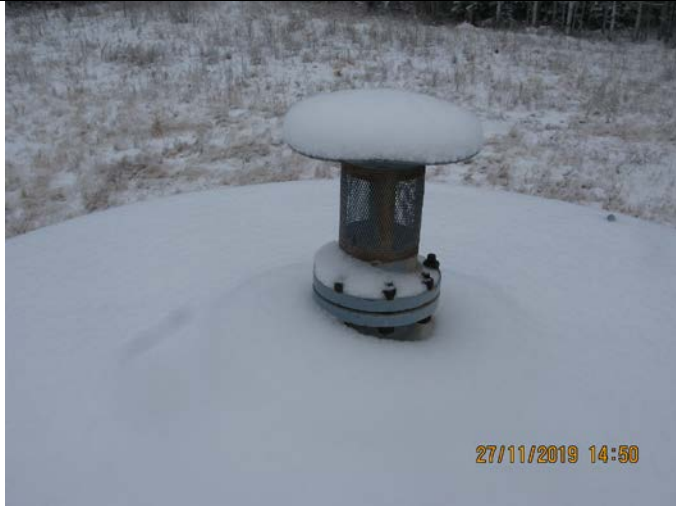
TANK VENT ON TOP OF TANK WITH BIRD CAGE
