# Tank Inspection Report

Location: 111/12-31-50-22W3 Tank Type: Water tank Date: July 24, 2018  
Mfg: GLM Year blt: 2002 S/N: DO2-244-S1 CAP: 400 bbl  
Floor Thk: 1/4" Shell Thk: 3/16" Roof Thk: 3/16"  
Requisitioned by: ROGER SKARROOD Approver: Dean Domes Approver Code: 27-0200966  
WO #: 81316283 PO#: 8401273069 CC: \_\_\_\_\_ SAP #: 62045257

Item Inspected: 400bbl tank s/n# D02-244-S1

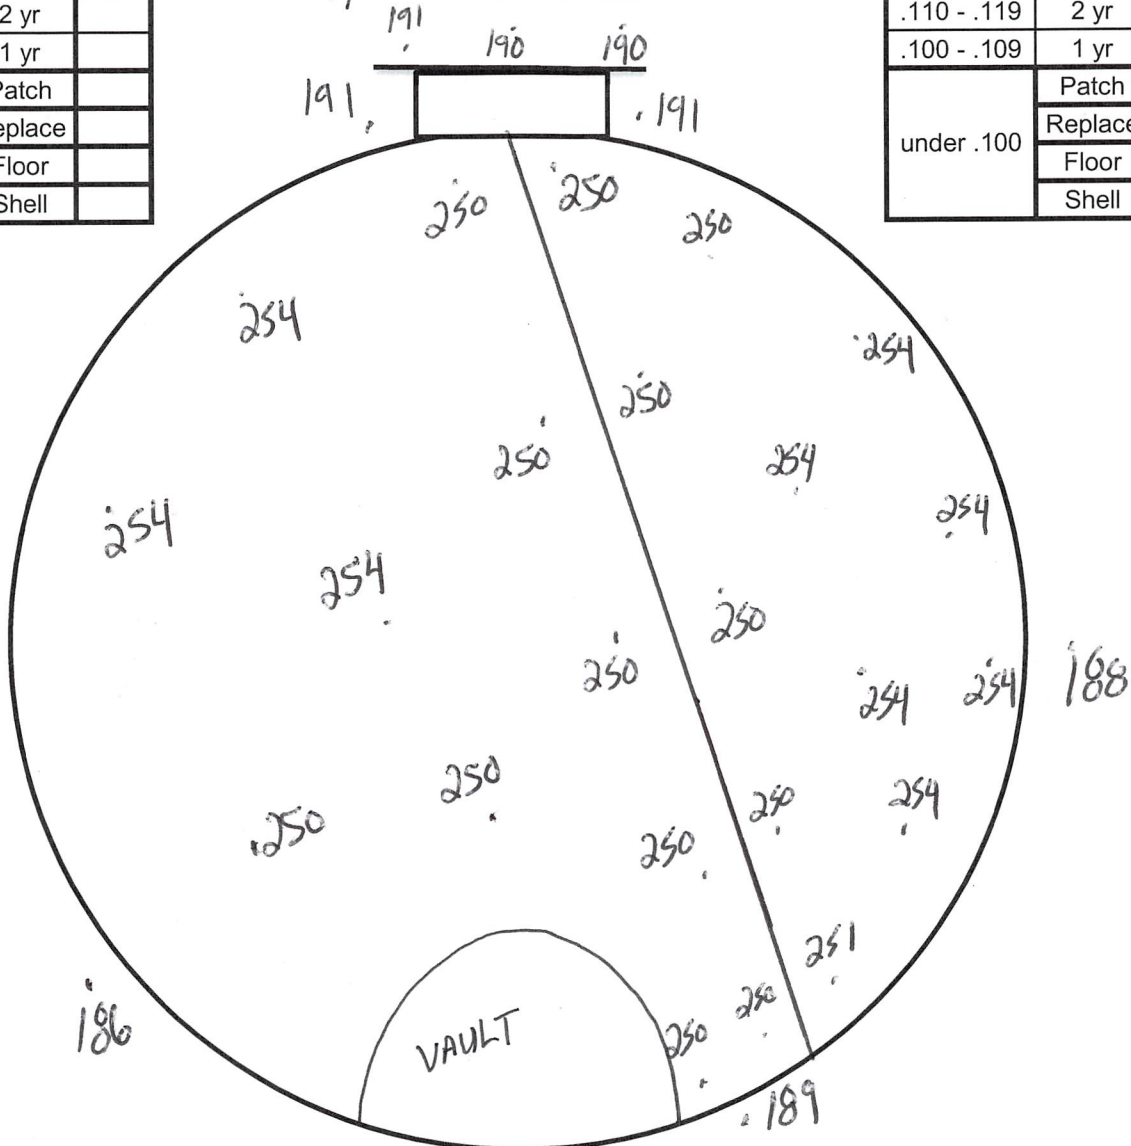
Tank In Good Overall Condition For A 5YR Turnaround. NO  
Repairs Required.

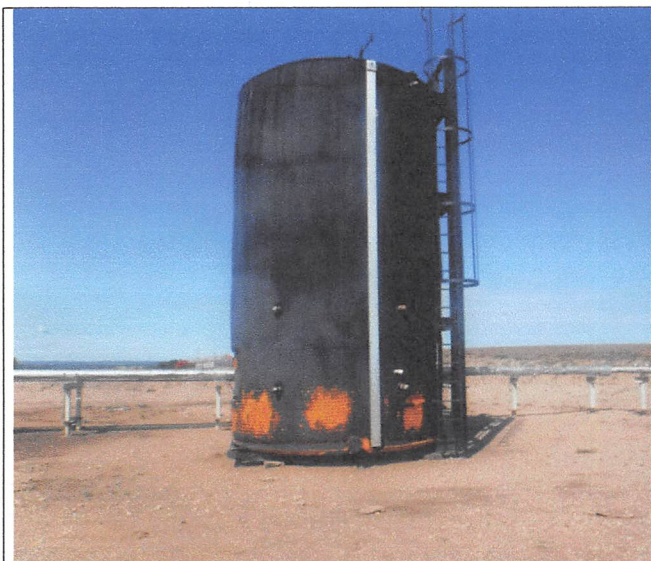
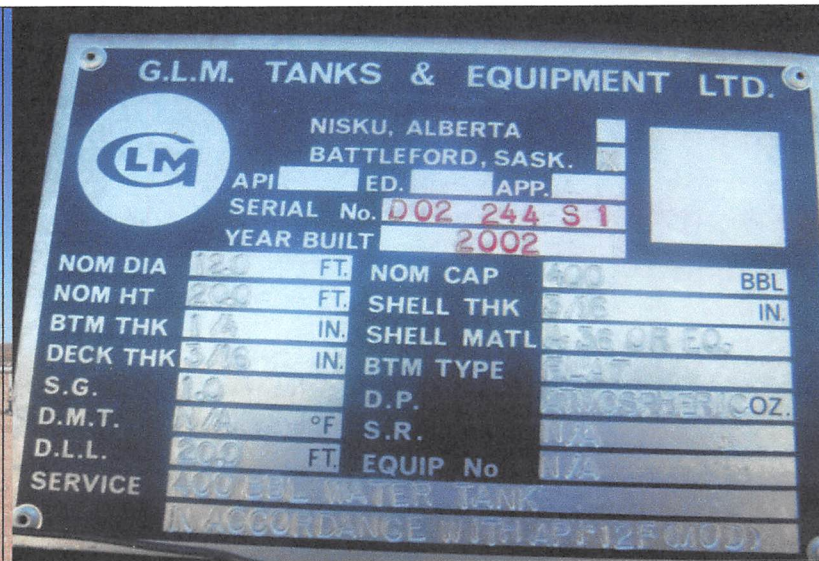
400bbl tank S/n # D02-244-S1 : tank in good condition overall, no repairs required.

Inspection Limitation(s): oil / shale on the shell and piping. rusty floor surface
