Pressure Vessel Visual Inspection Report

Equip Id	62065240	SAP ID	62065240	Asset Type	Treater
Plant	Lloydminster Production	Unit	Marsden NB	System	N/A
Description	TREATER, FIREVESS-VESSEL				
FLOC	H1-04-004-00001	LSD	01-30-044-26W3		
Insp Date	Sep 18, 2018	Inspector	Luke Newport	Insp Type	VIExt
Company	Inspector	Confidence	Medium

Marsden Unit 1 Battery - 01-30-044-26W3
Eq# 62065240, Treater, Uni-Melt serial # 88-J-57, A#154920, CRN A-0777.3
MAWP 75psi @ 300F

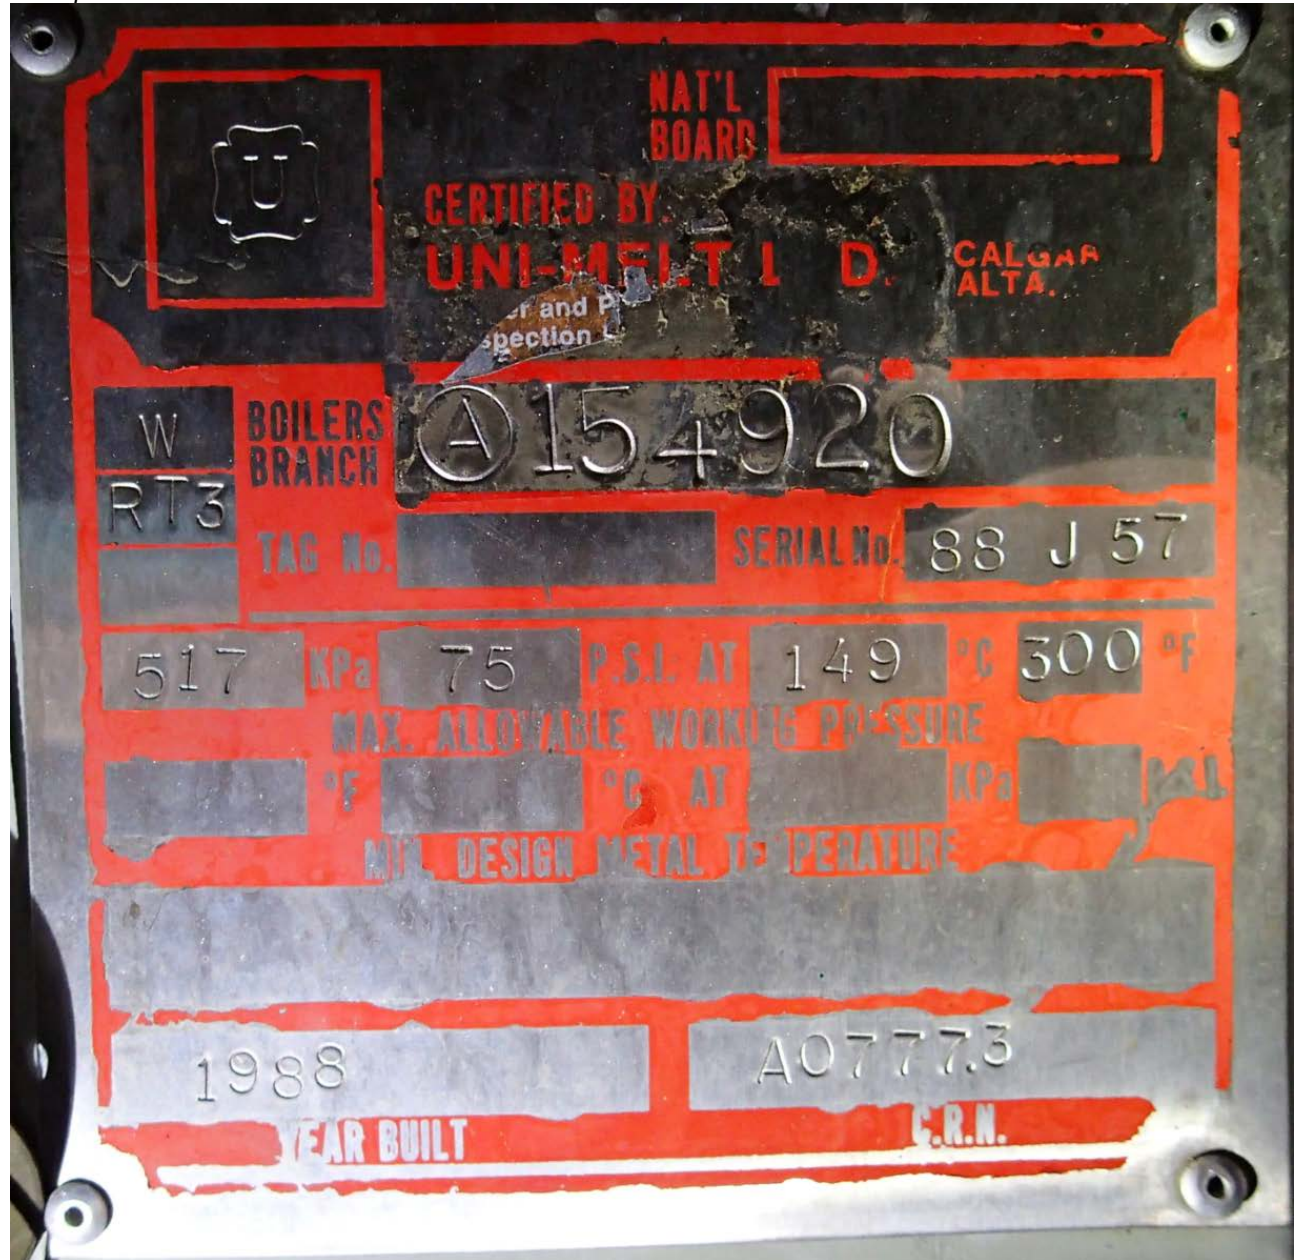
ID	Description	Condition	Location	NCR	Comment
V1	General Other (Please Explain)	Fair			Nameplate was in-place and clearly legible. Saskatchewan CRN A0777.3 in-place. TSASK license 1011527 current.
V6	Ladder/Stairway/Platform	Poor			Ladder and PSV access platform supported on one vertical I-beam. Access platform moves when you climb it.
V7	Heads	Fair			Head visible inside attached building no concerns.
V9	Electrical Ground	Fair			The vessel was ground through the skid. Ground wires are secure.
V11	Coating/Painting	Fair			The east head and north side of shell inside the building were fully painted. Paint in fair condition with a few area's missing with only minor surface corrosion.
V13	Gauge/Site Glass	Fair			Associated temperature and pressure gauges were clear and appeared in fair condition.
V14	Shell	Fair			Shell visible inside attached building no concerns.
V24	Saddle/Skirt	Fair			Supported by two saddles on steel skid, anchor bolts secure

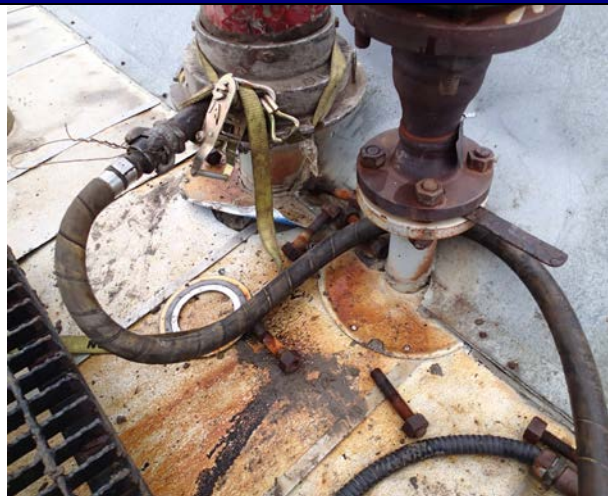
Cladding that requires repair on the top of the vessel.

- repair cladding around nozzles on the top of the vessel
- clean tubing for bottom two sample points
- internally inspect treater in 3 years; at that time:
 - sandblast and MT firetube
 - repeat UT survey of desand nozzles and piping
 - remove internal sand pans and external desand valves for flange evaluation
 - monitor areas where coating has failed for corrosion occurring to the shell

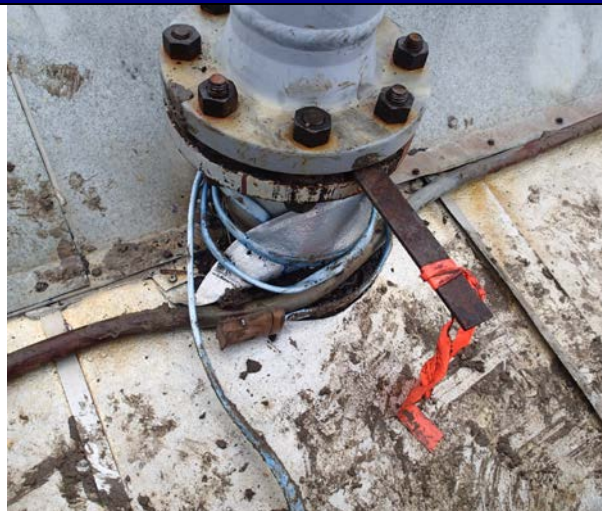
Cladding that requires repair on the top of the vessel.

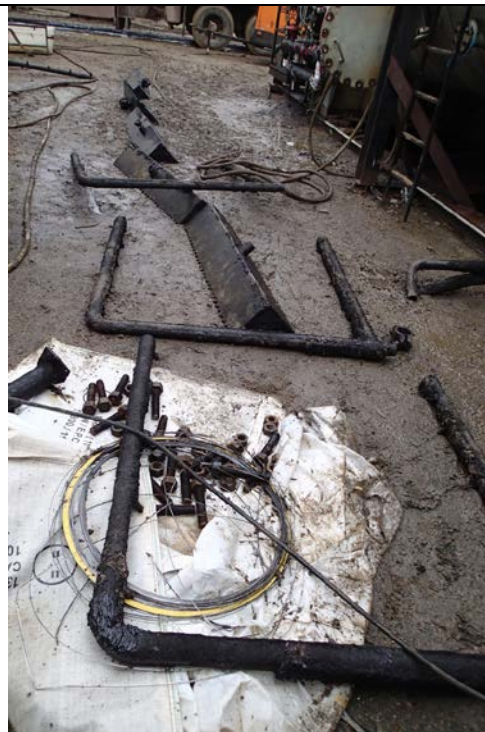
The sand pans and desand piping removed from the vessel.

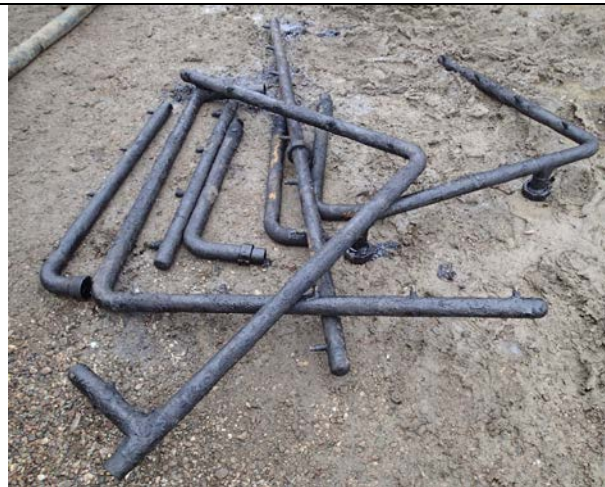
ID	Description	Condition	Location	NCR	Comment
V7	Heads	Fair			Acceptable
V8	Welds	Fair			Acceptable
V9	Nozzles	Fair			PSV nozzle clear
V10	Shell	Fair			Acceptable
V21	Internals Other (Please explain)	Fair			Desand piping - Desand piping had major scale build-up, sand pans are coated with minimal scale.
V21	Internals Other (Please explain)	Fair			Anodes - The vessel was equipped with four anode connections. The anodes were 50% consumed. External shunt wires were secure and in place.
V21	Internals Other (Please explain)	Poor			Bottom two sample lines in water level were scaled over
V21	Internals Other (Please explain)	Fair			Firetubes (2) -were sandblasted. MT performed with no cracking identified. Visual inspection revealed no concerns with the south tube, north tube on top of the burner side on tube to tube sheet fillet weld under deposit corrosion has occurred and requires repair. See DM for repair and MT completed.

Desand internal piping.

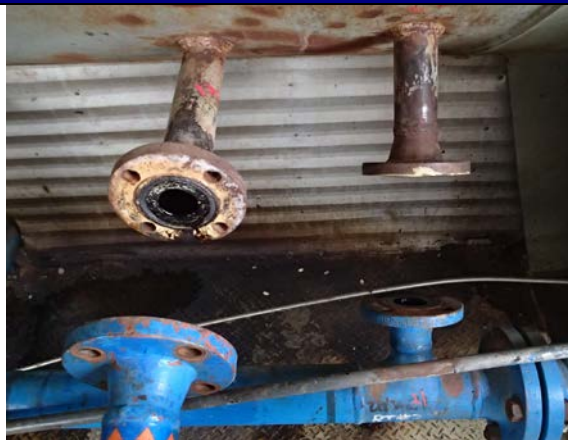
The desand inlet and outlet valves removed for flange face evaluation.

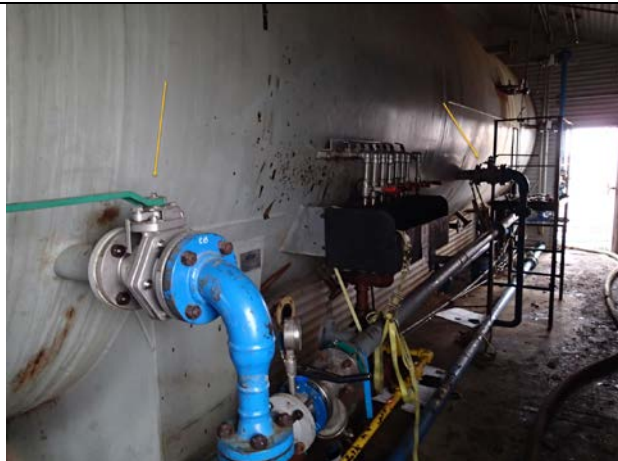
Desand outlet piping all the valves were removed except for the two 3" valves with arrows pointing at them.

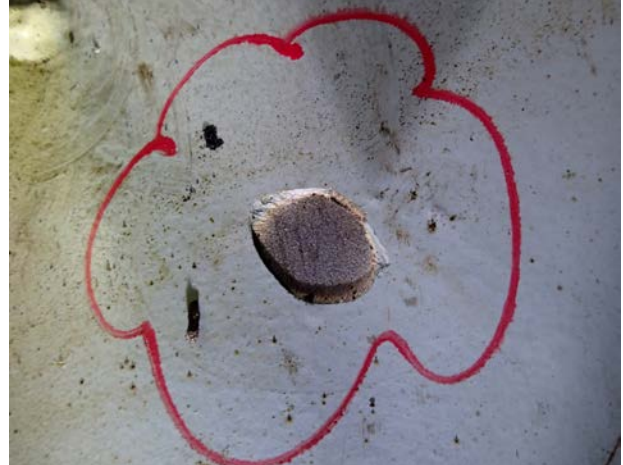
V23	Baffle/Wier	Fair			Treater baffles and weirs were secure. Screens in place and secure.
V25	Thermowells	Fair			Acceptable
V27	Nonmetallic Linings	Poor			2018: Coating looks to have been applied to heavily and is starting to crack out and fail, worst area is in the firetube end. Some internal damage to the coating at the 5-7 o'clock position from removing internals. Also the coating has failed from the sand pans rubbing through in the mid-section. Test strip in the firetube section had been coated over and has failed. Any locations that had previously failed had scale build over with no corrosion occurring in areas that were removed. Due to the amount of coating repairs required they will be left as is and monitored at next inspection.

One of the coating failures.

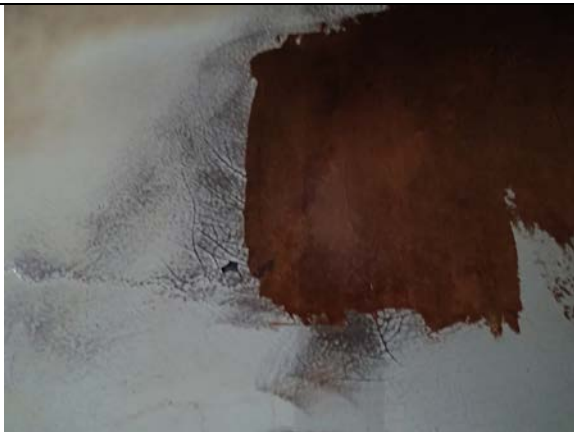
The patch that was applied to the north side of the vessel, cracking to the coating can be seen beside the patch.

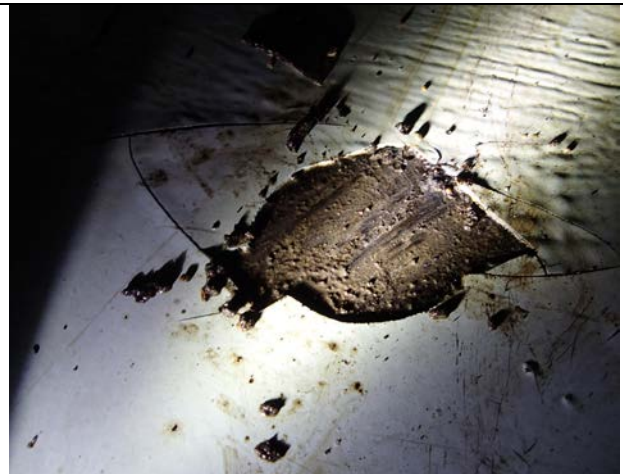
Area of coating failure in the bottom of the vessel from the firetube end to the sales end of the vessel. Coating was applied too heavily.

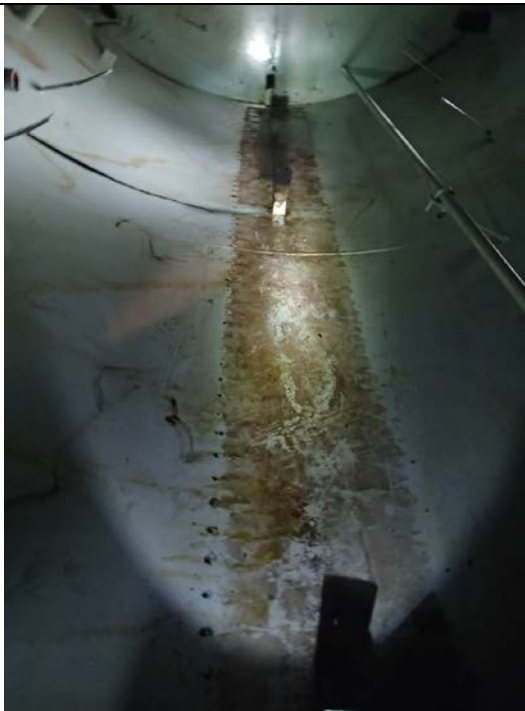
<p><i>The back end of the vessel, black dots are spots of coating failure where sand pans were rubbing.</i></p>

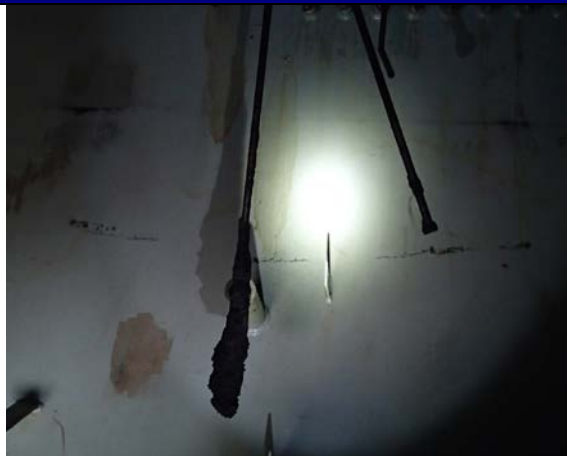
The bottom two sample lines that are plugged off.

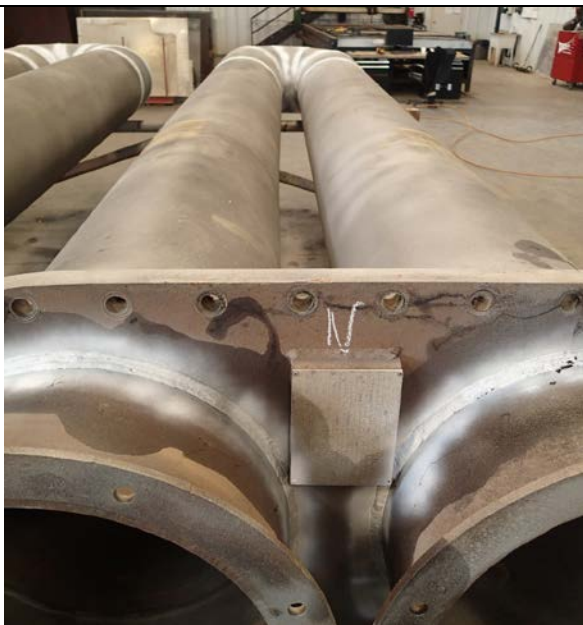
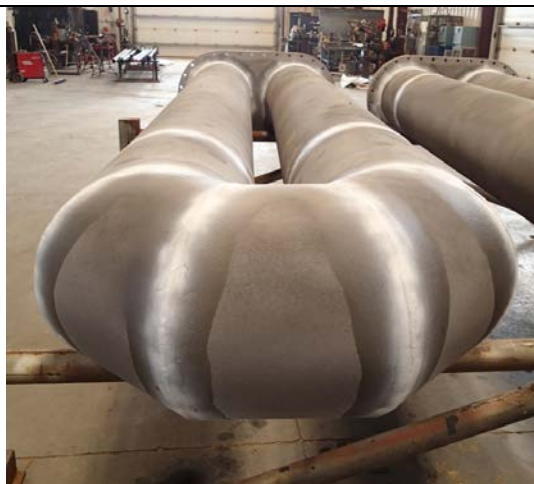
<p><i>North fire tube top of burner side with under deposit corrosion occurring to the fillet weld.</i></p>
