PRESSURE VESSEL & COLUMN INSPECTION REPORT

SAP#	62065570	Date:	April 26, 2022	LSD	01-30-044-26 w 3	Report #	IR220426GENa
------	----------	-------	----------------	-----	------------------	----------	--------------

Plant:	MANITOU	Op Unit:	SWS	Work Order:	60894919
Prov. Insp.#	SK 19702 NB -	CRN	A1952.3	Equip. Tag#	V-101
Description:	FREE WATER KNOCKOUT	Serial #:	91-1275	Year Built:	1991
Manufacturer:	IP CONSTRUCTORS LTD	Vessel Class:	TREATERS		
MAWP:	517 Kpa @ 50 °C	MDMT:	-29 °C		
Shell Material:	SA-516-70	Thickness:	9.5 mm	Corr. Allowance:	1.6 mm
Head Material:	SA-516-70	Thickness:	10.6 / 16.0 mm	Corr. Allowance:	1.6 mm
Nozzle Material:	SA-106B	Thickness:	12.7 / 7.6 mm	Corr. Allowance:	mm
Code:	ASME VIII (U)	RT	2	PWHT:	No
Internal Access:	Yes	Type:	Manway	Internal Coating:	Yes
Painted:	Yes	Insulated:	Yes	Location:	Outside Portion
Product Description:	Crude Oil / Water / Gas	Sweet	Operating Pressure:	- Kpa @ - °C

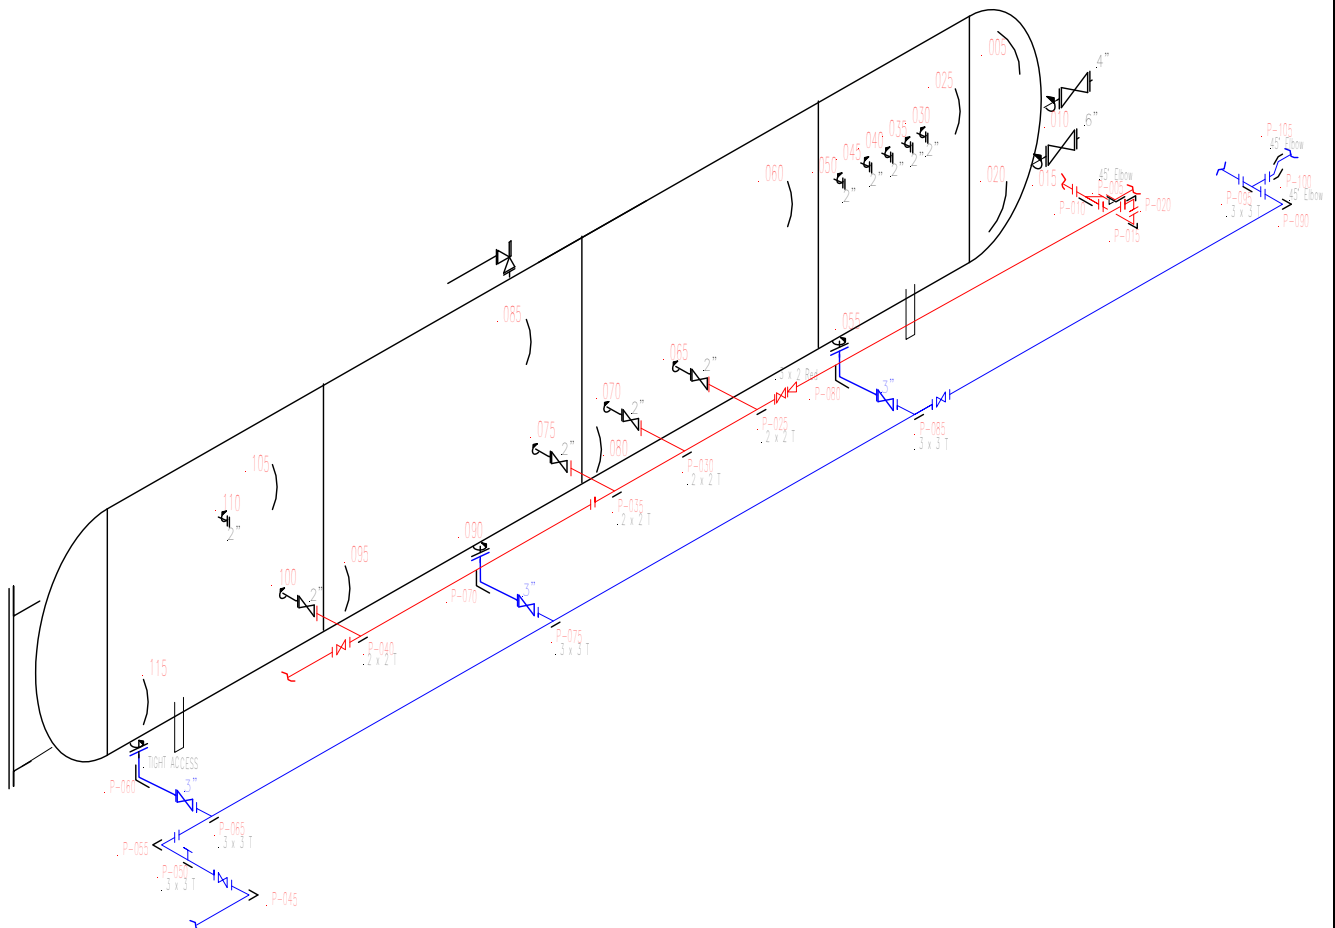
UT DRAWING

UT was performed to confirm remaining thicknesses.

The readings are within acceptable limits.

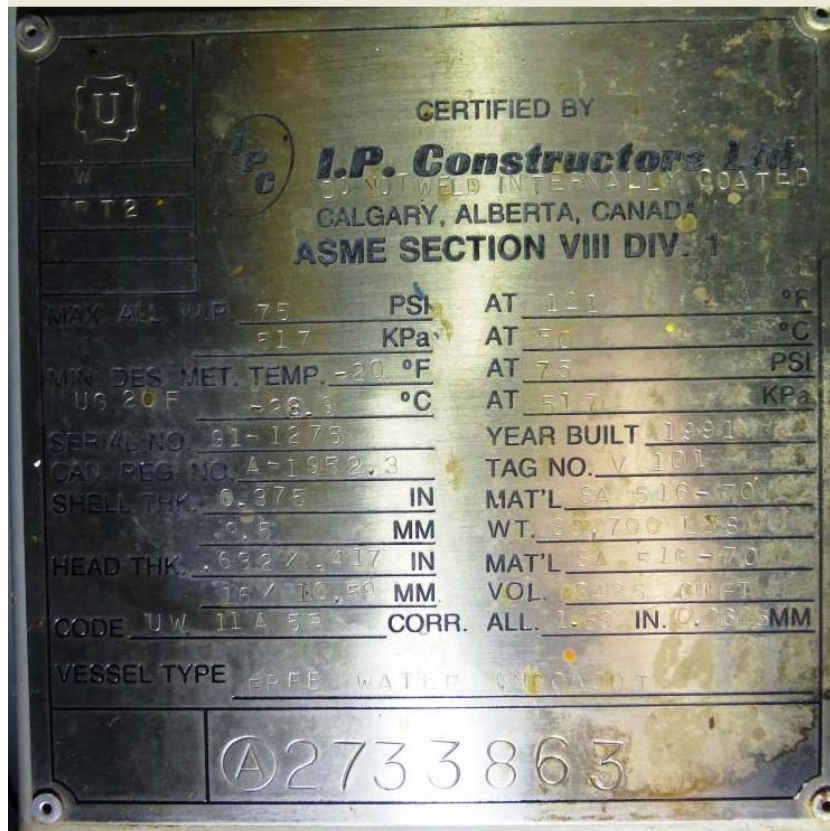
Nameplate

The nameplate is intact and legible.

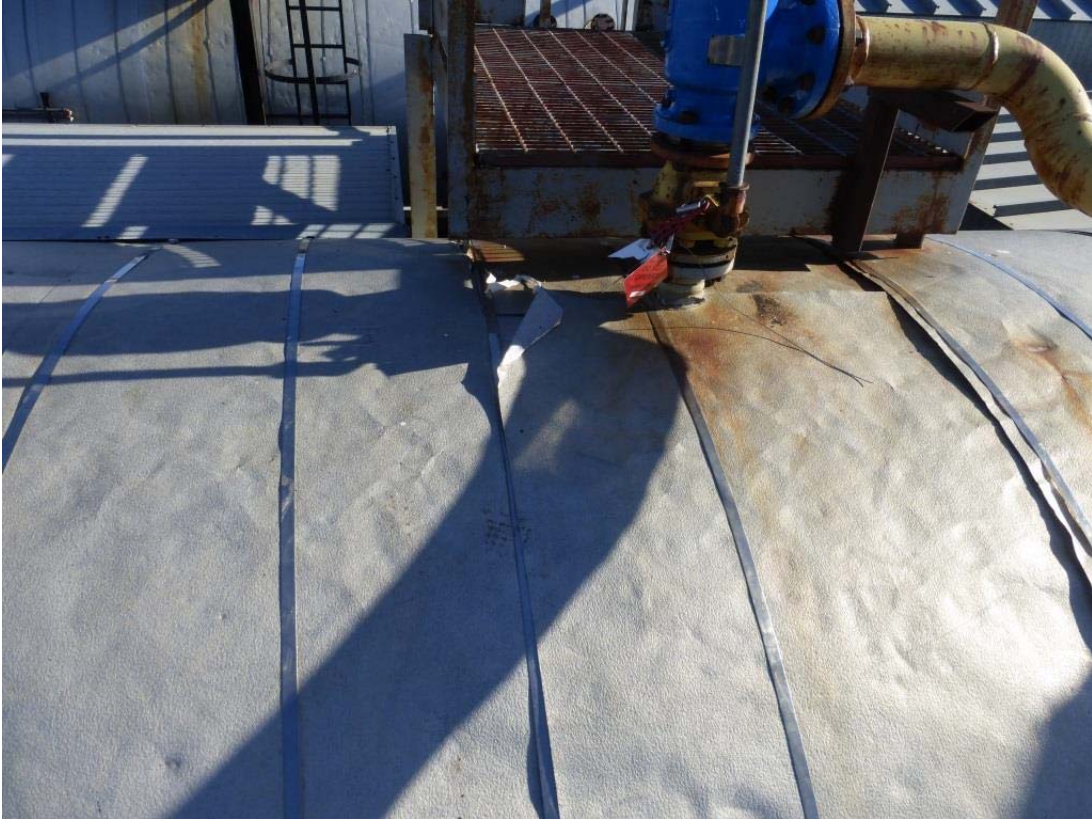
V37	Bolting	Good			The studs / nuts are secure and of adequate thread engagement.
V38	Flanges	Good			The flanges are intact with no defects noted.
V39	Leak Clamps	N/A			
V41	Insulation Other (Explain)	Fair			The insulation and cladding are in fair condition.
V42	Damage	Fair			The cladding has some minor damage around the PSV.
V43	Penetrations	Fair			The penetrations are not sealed allowing water to penetrate the insulation.
V44	Insulation Jacket	Fair			The insulation cladding has some minor damage noted.
V45	Banding	Fair			The insulation banding is in good condition.
V46	Seals/Joints	Fair			The seals / joints are missing sealant.
V51	Relief Devices Other (Explain)	Fair			The PSV is missing the service tag.
V52	Relief Devices Corrosion	Good			No corrosion noted.
V53	Relief Devices Leaks	Good			No leaks were present.
V54	Restricted Inlet/Outlet	Good			The inlet and outlet are satisfactory to code requirements.

Cladding Damage

The damaged insulation cladding should be repaired.

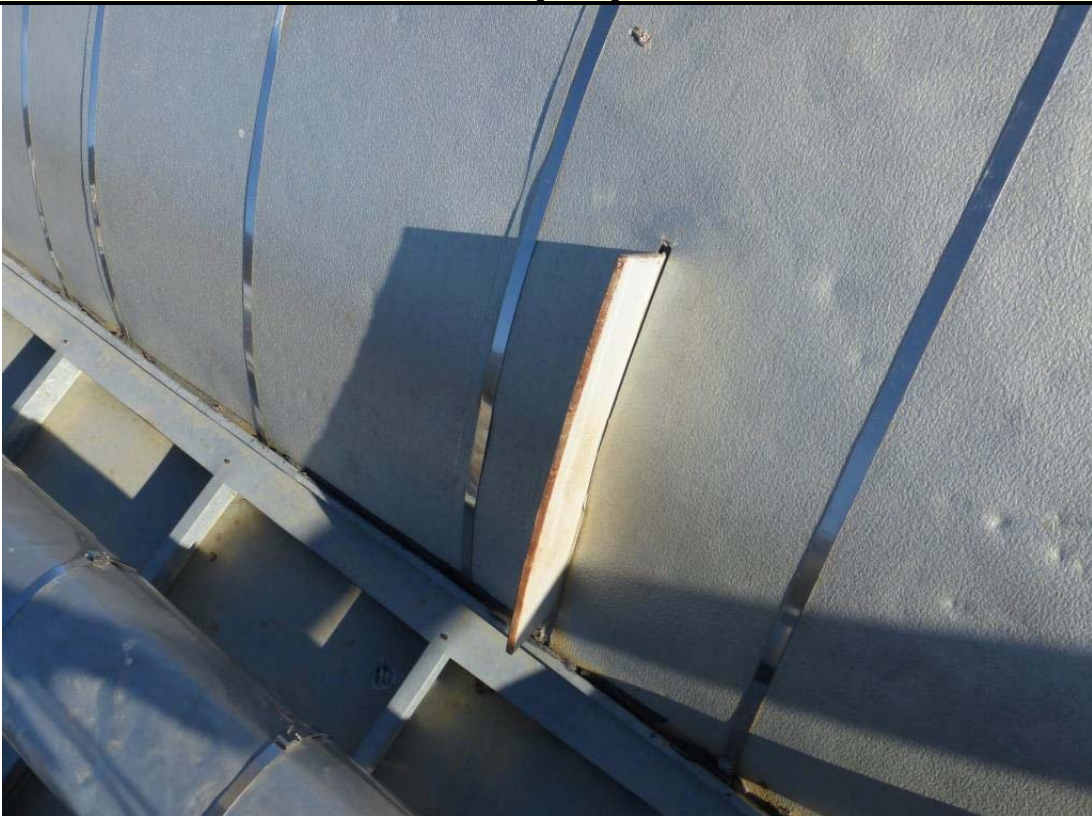
Insulation Penetration with no sealant

The cladding penetrations require some sealant.
