**ABOVE GROUND STORAGE TANK
API STANDARD 653
OUT-OF-SERVICE
FINAL INSPECTION REPORT
RANGER INSPECTION™
JOB # 22996
(Revision 1)**

HUSKY ENERGY

**MARSDEN BATTERY
LSD: 01-30-044-26 W4M**

TANK # T-107

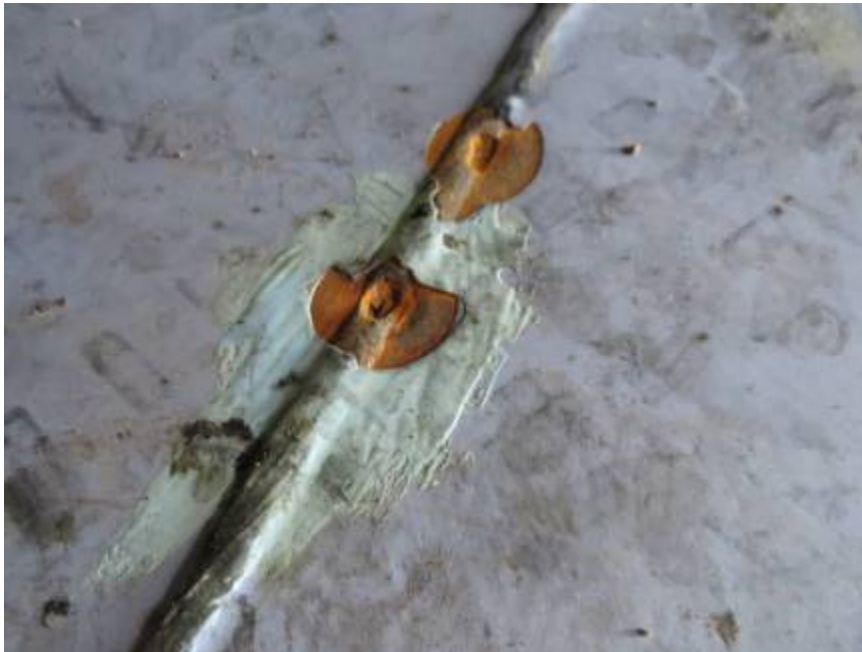
Photograph #11: Bottom Plate Weld Corrosion

- 1.) Four (4) patch plates are recommended on the bottom plate to cover topside pits.
- 2.) Three (3) areas of the bottom plate butt welds are recommended to be ground out and re-welded.
- 3.) The old center column reinforcing pad is recommended to be gouged out and the bottom plate underneath be evaluated for corrosion.
- 4.) It is recommended that all coating failures on the bottom plate be repaired.
