2023 INSPECTION & TEST PLAN

STATIC DATA					
Plant	Manitou	Eq#	62066330	Manufacturer	Universal Industries
LSD	01-30-044-26W3	Tag #	T-107	Serial #	95 01 17 8944

**QNATANK-7 10Y Code Inspection Tank 2000 to 10,000 bbl,
Fully Coated**

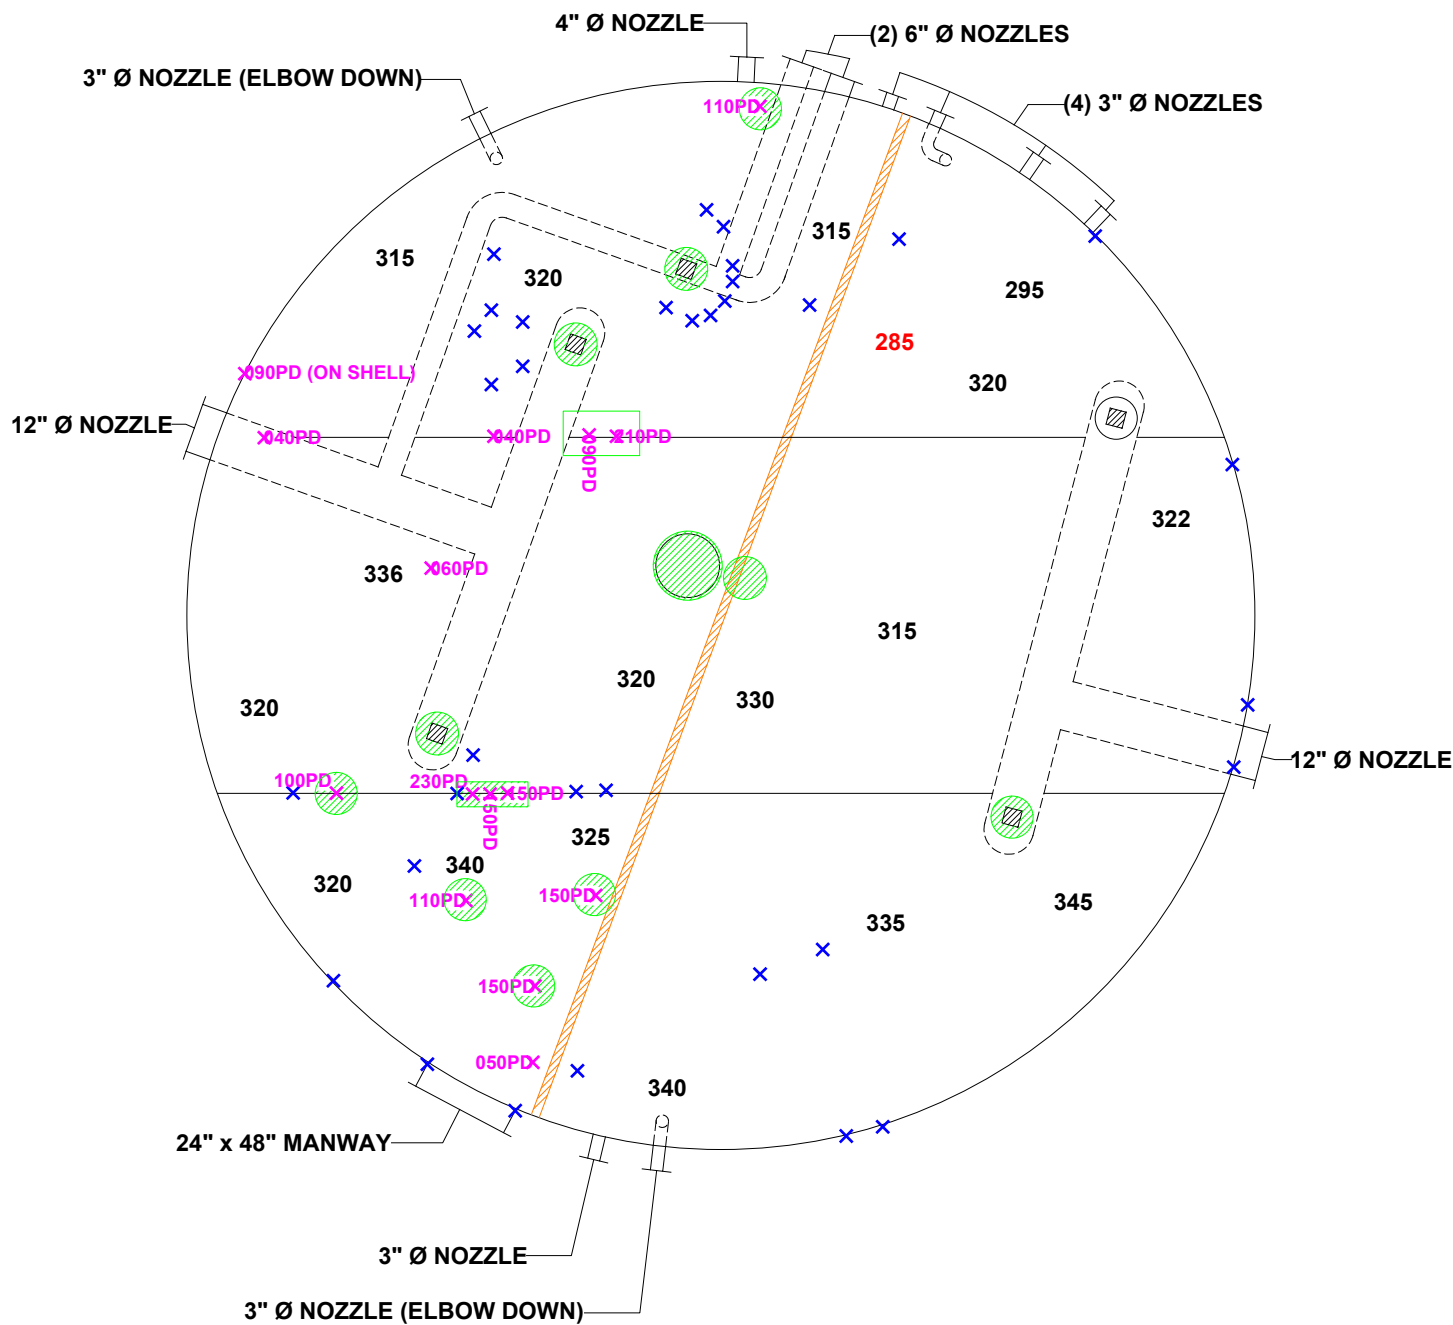
Drawing # 1 of 1 – Bottom Plate Layout

- 1.) A Magnetic Flux Leakage (MFL) scan was performed on accessible areas of the tank bottom plate. No indications of underside material loss were identified. The MFL threshold for the scan was approximately 0.030 inch.
- 2.) Forty-six (46) areas of coating failure were identified and marked on the tank bottom plate.
- 3.) The bottom plate was visually examined for topside pitting. Fourteen (14) areas of isolated pitting up to 0.150 inch deep were identified.

- 1.) Four (4) patch plates are recommended on the bottom plate to cover topside pits.
- 2.) Three (3) areas of the bottom plate butt welds are recommended to be ground out and re-welded.
- 3.) The old center column reinforcing pad is recommended to be gouged out and the bottom plate underneath be evaluated for corrosion.
- 4.) It is recommended that all coating failures on the bottom plate be repaired.

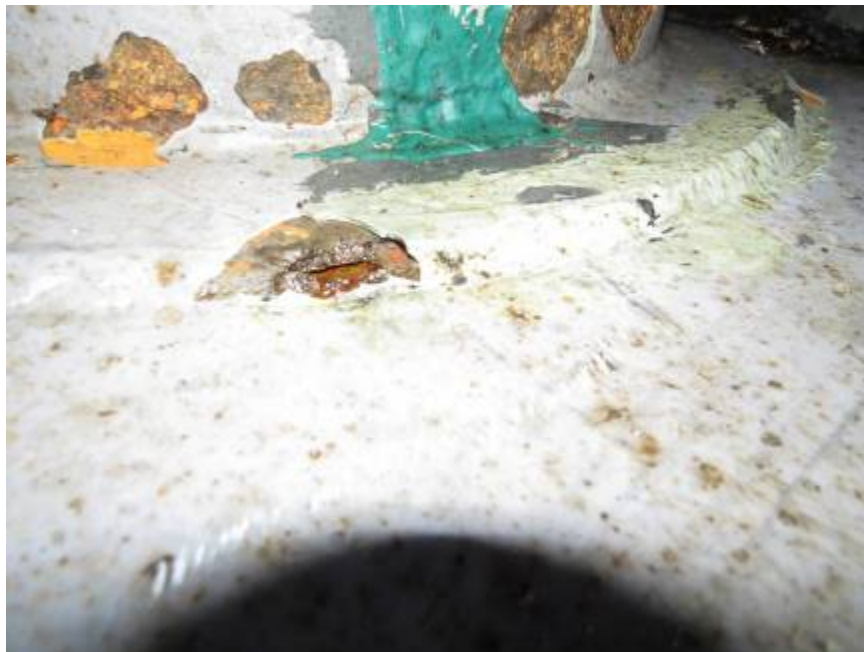
Photograph #9: Center Column Reinforcing Pad Corrosion

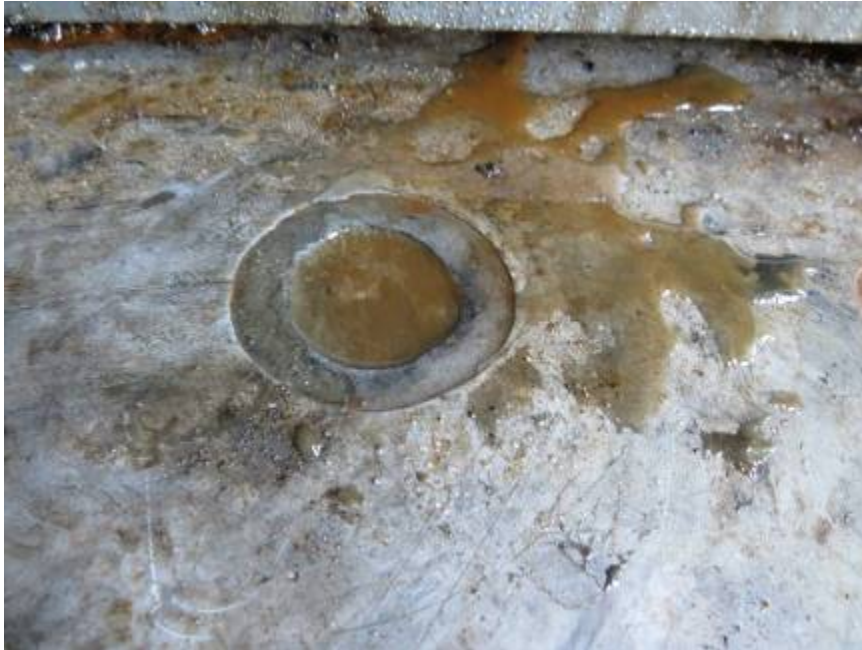
Photograph #10: Bottom Plate Pit

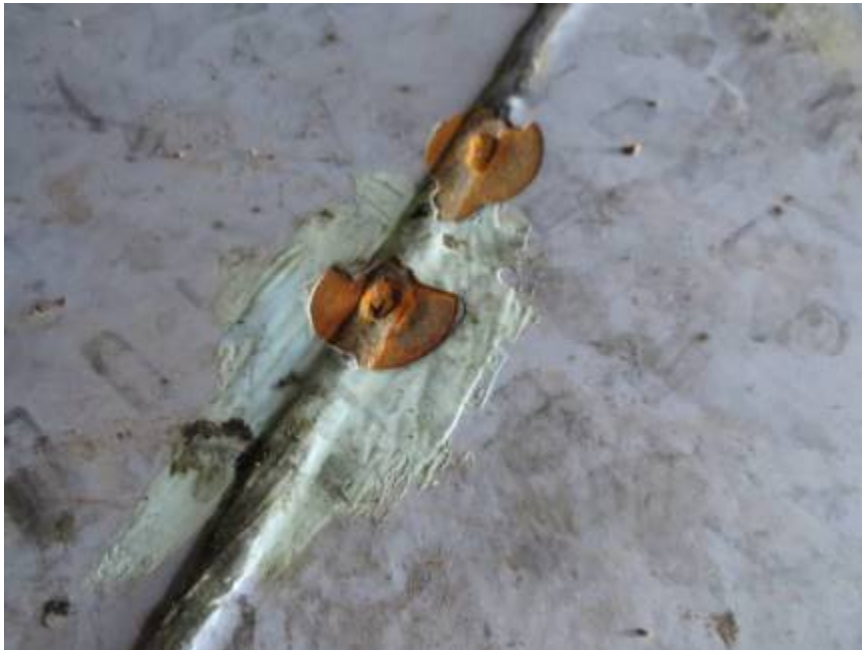
Photograph #11: Bottom Plate Weld Corrosion

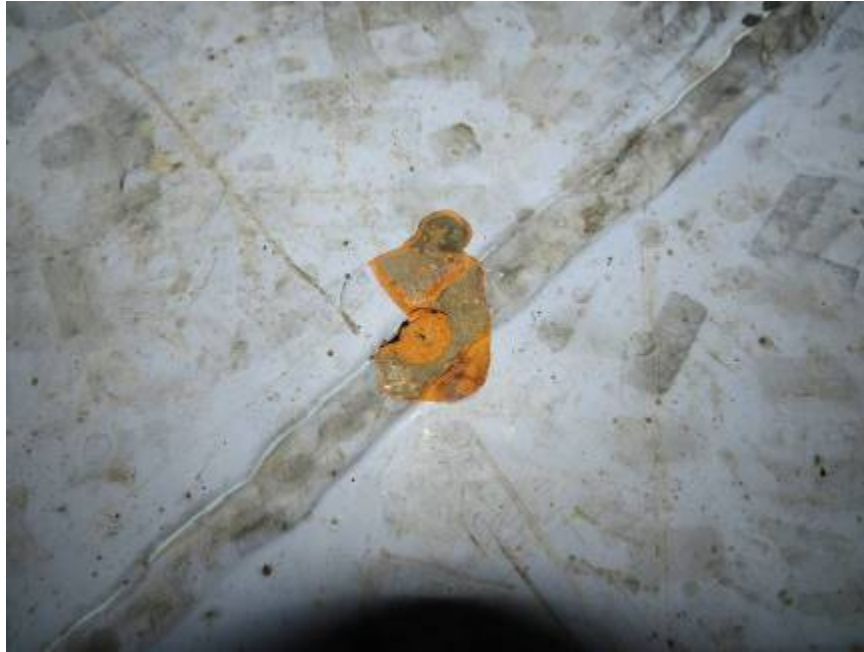
Photograph #12: Bottom Plate Weld Corrosion

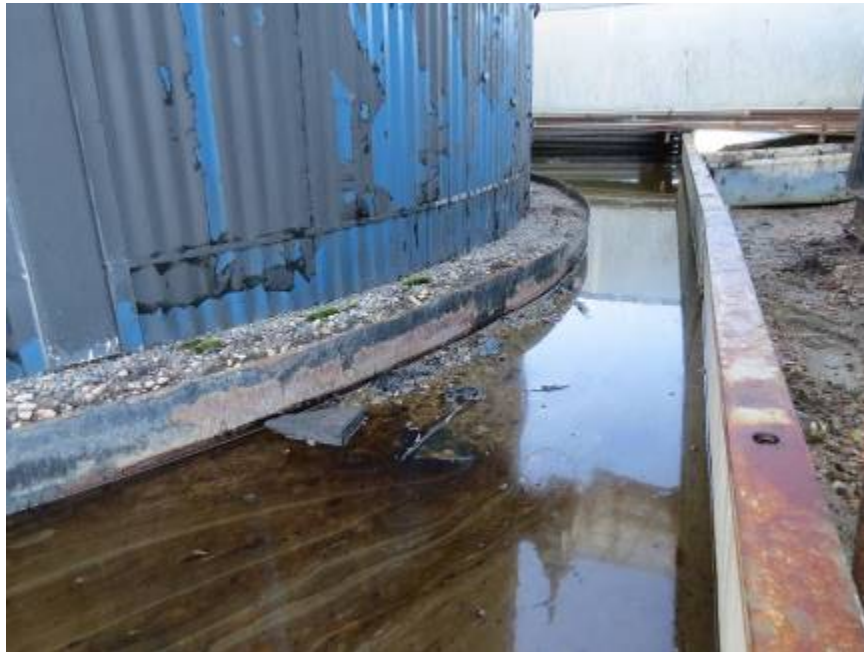
- 1.) The foundation was visually examined from accessible areas. The tank is sitting on an elevated earth and gravel pad, contained within a steel ring. It was found that the tank is sitting below grade; therefore rain water is not directed away from the bottom plate.
- 2.) The shared tank berm was full of water at the time of inspection.

Photograph #15: Foundation and Berm Overview – Full of Water

- 1.) It is recommended that the foundation be reworked to allow for water to be directed away from the bottom of the tank.
- 2.) It is recommended that the water be drained from the berm.

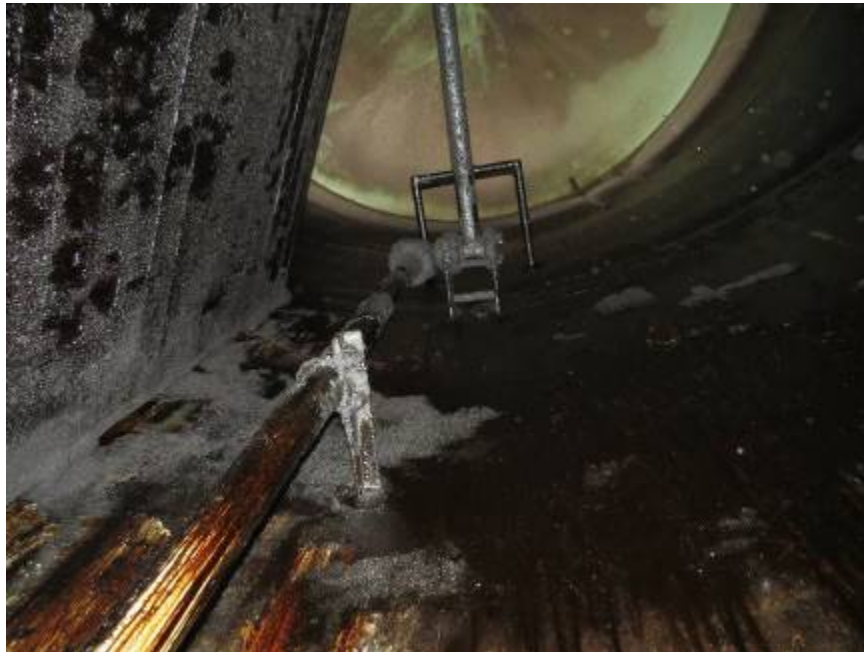
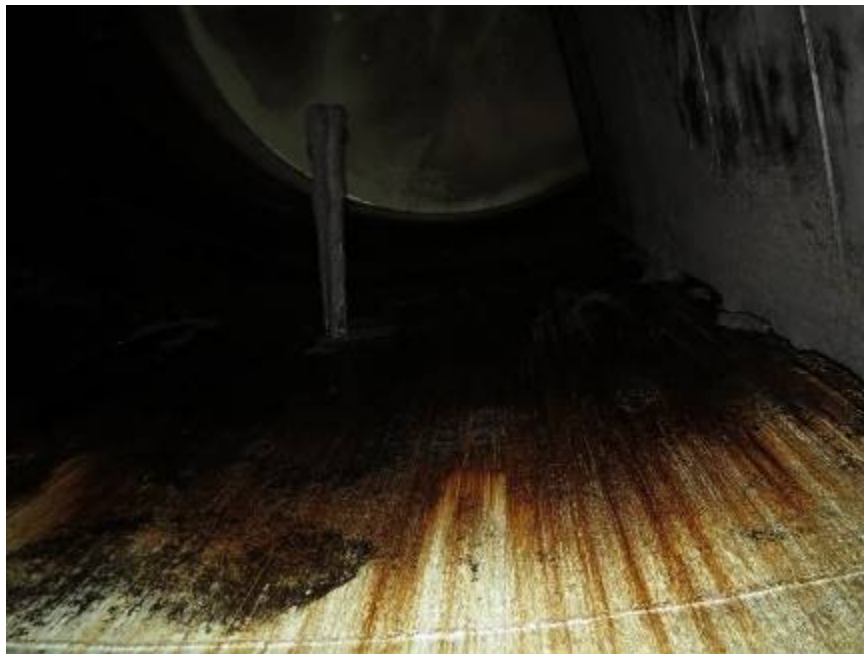
- 1.) A limited visual inspection was performed on the external shell plate due to the shell being covered by insulation and flashing.
- 2.) The internal shell plate was visually examined. No significant deformation was observed. Seven (7) coating failures were identified and marked on the shell plate.
- 3.) Random ultrasonic (UT) thickness readings were taken on the first course shell plate. No material loss was observed or recorded. Refer to Table A - Manual UT Shell Plate Readings – Course # 1, for additional data.
- 4.) One (1) area of shell pitting was observed, the pit was recorded at 0.090 inch deep.

Photograph #18: Internal Shell Overview

- 1.) It is recommended that all coating failures on the internal shell plate be repaired.

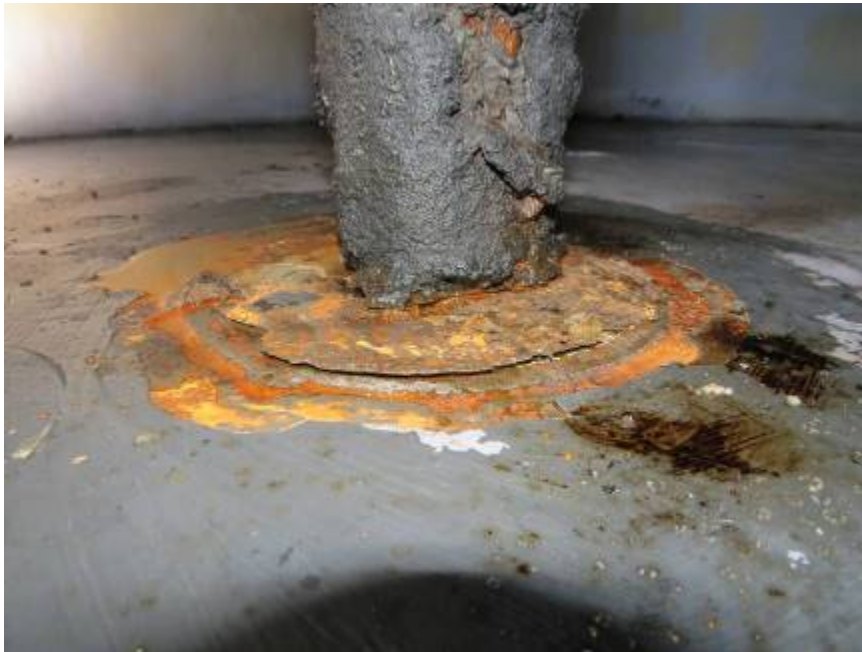
- 1.) The tank nozzles and appurtenances were visually examined.
- 2.) The internal pipe support reinforcing pads and welds were observed to be severely corroded.

Photograph #35: Pipe Support Reinforcing Pad Corrosion

- 1.) It is recommended that four (4) of the pipe support reinforcing pads be removed and evaluated for further corrosion of the bottom plate. New pipe supports and reinforcing pads should then be welded to the bottom of the tank.

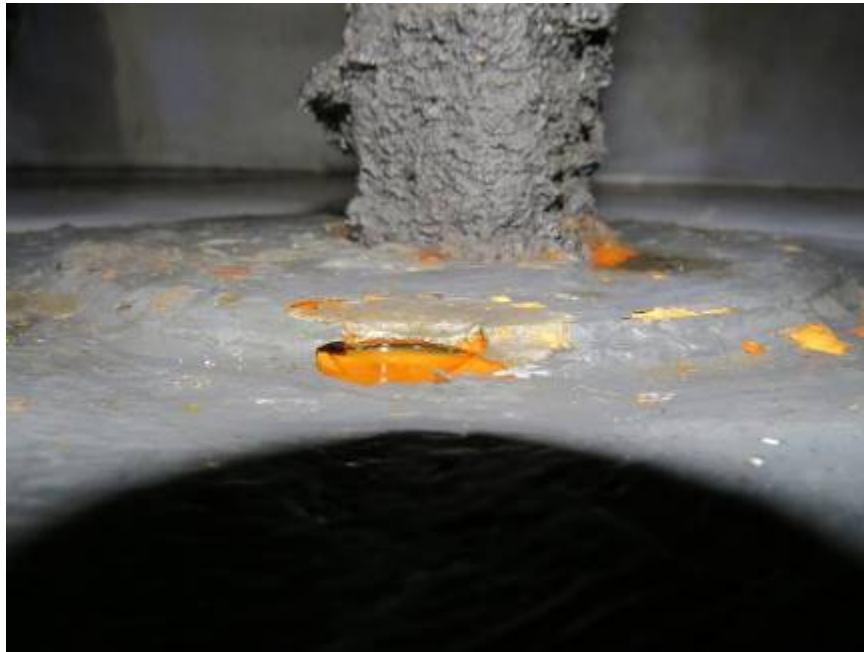
Photograph #36: Pipe Support Reinforcing Pad Corrosion

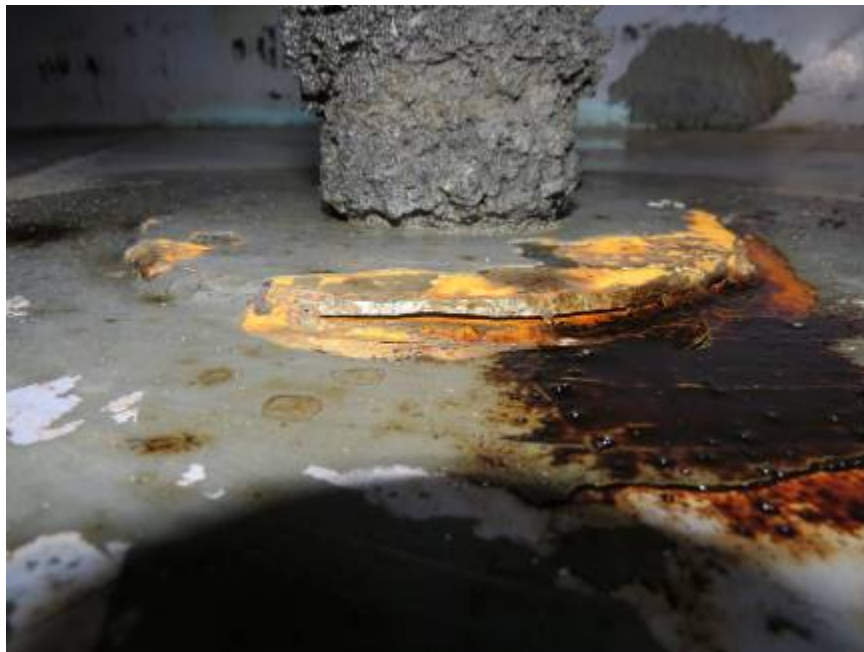
Photograph #37: Pipe Support Reinforcing Pad Corrosion

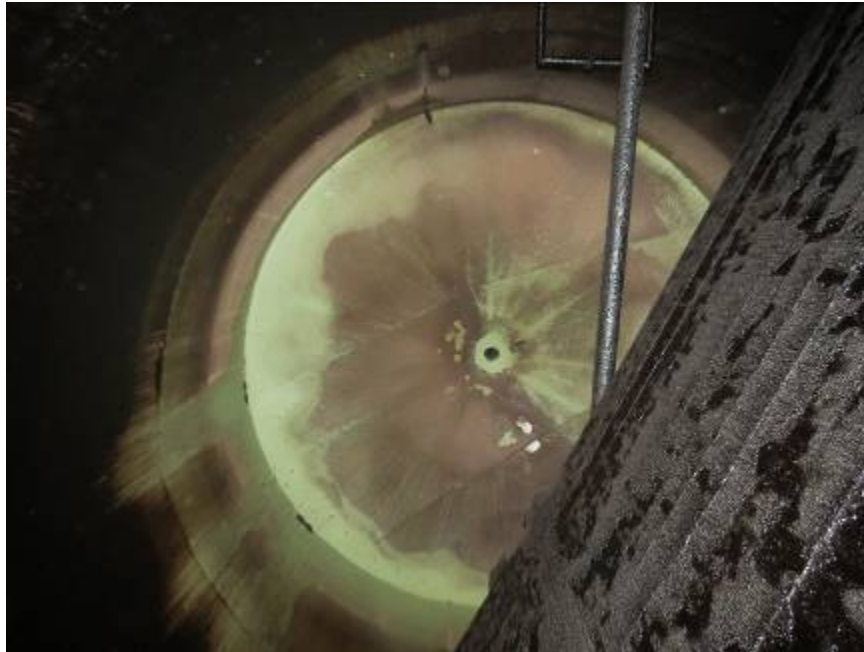
✓	✕	N/A	#	Description	Comments
A. General					
✓			1	Visually inspect the underside surface of the roof plates for holes, scale buildup, and pitting.	<ul style="list-style-type: none"> Visually acceptable Old coating hanging off of interior
		N/A	2	Hammer test or ultrasonically examine to check for thin areas, particularly in the vapor space of floating roofs and at edge of roof on cone roof tank.	<ul style="list-style-type: none"> N/A
		N/A	3	Check all clips, brackets, braces, etc. welded to the roof deck plate for welded reinforcing pads and see that they have not broken free.	<ul style="list-style-type: none"> Under insulation
		N/A	4	Inspect protective coating for breaks, disbondment, and deterioration.	<ul style="list-style-type: none"> Under insulation
		N/A	5	Spark test the interior surface coating if recoating is not planned.	<ul style="list-style-type: none"> N/A
✓			6	Photograph the roof structure if no rafter layout drawing exists.	<ul style="list-style-type: none"> Refer to photographs

Photograph #38: Fixed Roof Overview

- 1.) No fixed roof repairs are recommended at the period of this inspection.
