2023 INSPECTION & TEST PLAN

STATIC DATA					
Plant	Manitou	Eq#	66155552	Manufacturer	Wilco Industries
LSD	01-30-044-26W3	Tag #	T-103	Serial #	016349-04

Tank Inspection Report

Tank Type: T-103 Slip tank

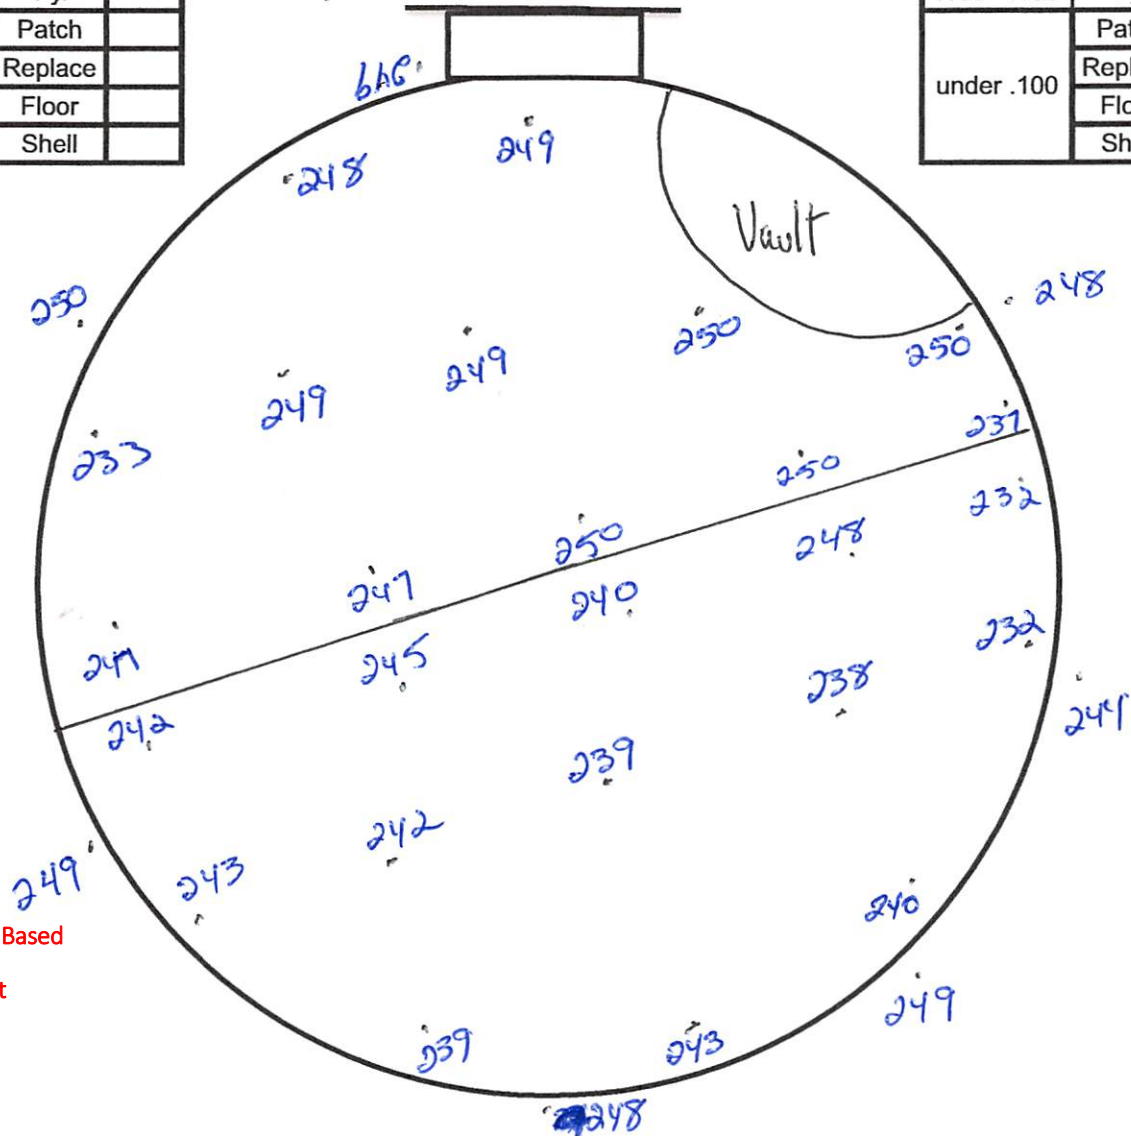
With MFE		
.140 - .150	5 yr	
.130 - .139	4 yr	
.120 - .129	3 yr	
.110 - .119	2 yr	
.100 - .109	1 yr	
under .100	Patch	
	Replace	
	Floor	
	Shell

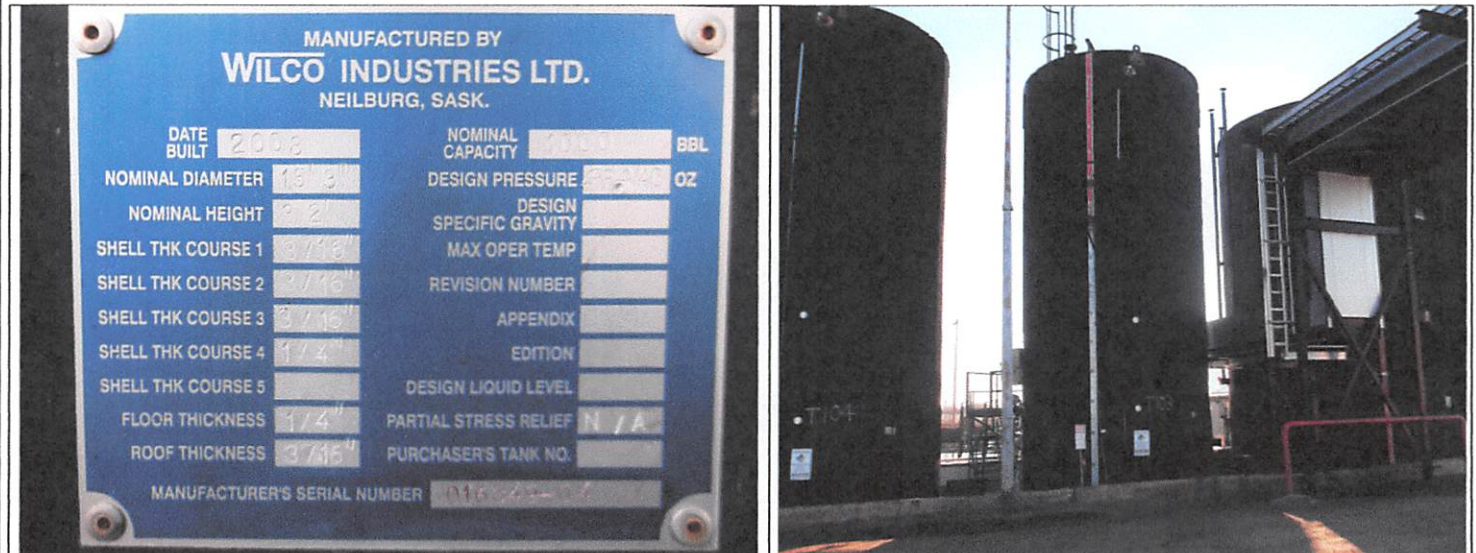
A UT and Visual inspection was carried out on the following 10000BBL oil tank for the purpose of continued fitness for service and determination of inspection interval. See the field report for results of inspection, UT recorded values and inspection interval.

Inspection Limitation(s): Only 1st course cleaned for inspection

-Recommend removing the float guide wires
Tank suitable for service
