2023 INSPECTION & TEST PLAN

STATIC DATA					
Plant	Manitou	Eq#	66155548	Manufacturer	Wilco Industries
LSD	01-30-044-26W3	Tag #	T-104	Serial #	016040-10

Tank Inspection Report

Location: 01-30-044-26W3

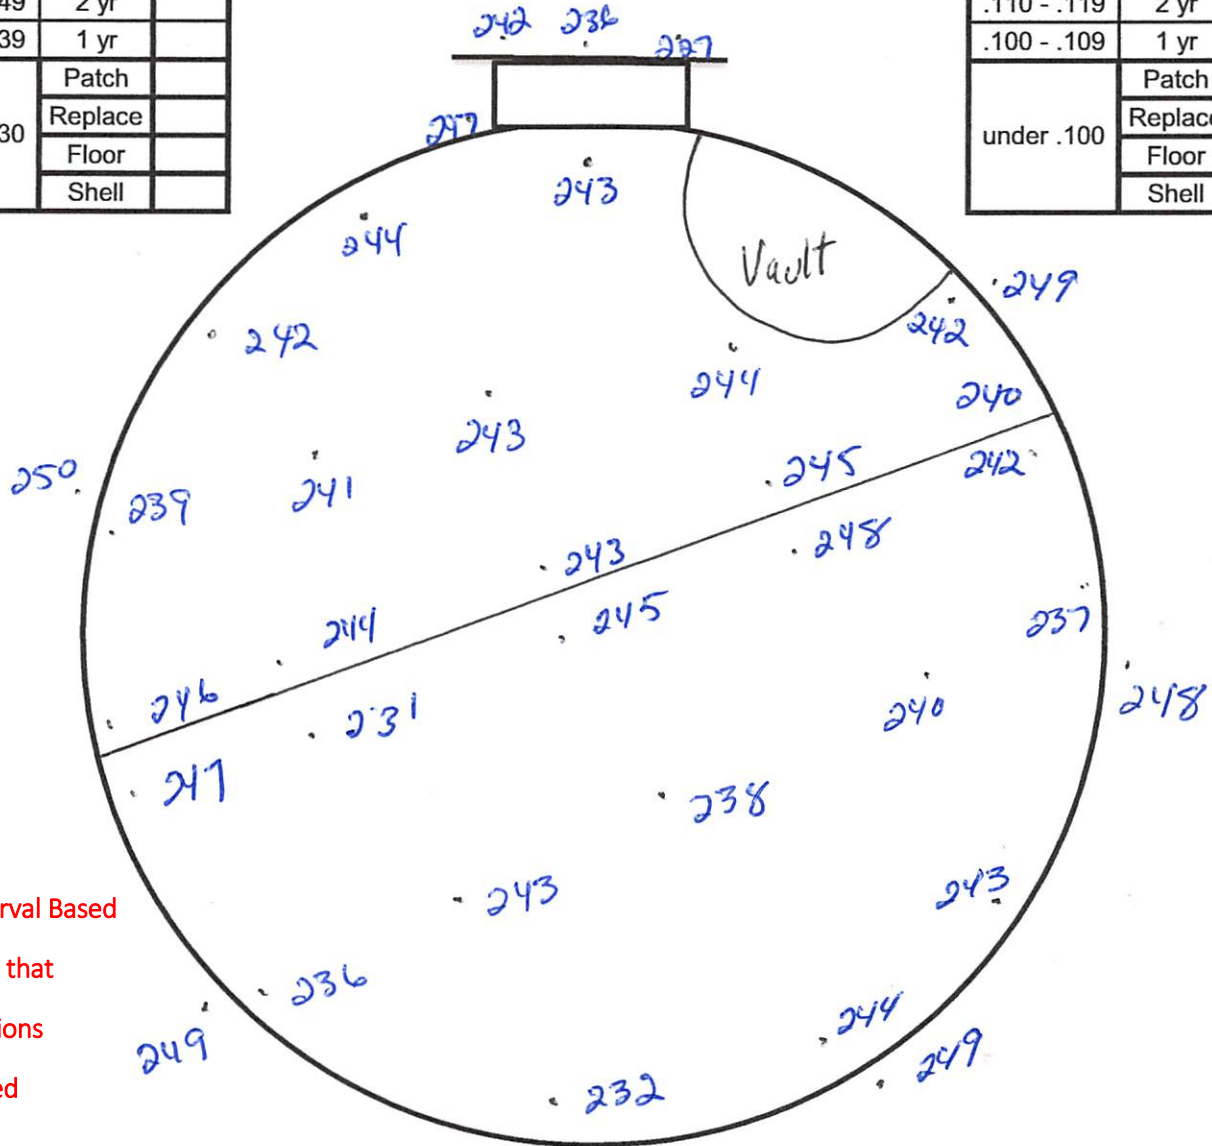
With MFE		
.140 - .150	5 yr	
.130 - .139	4 yr	
.120 - .129	3 yr	
.110 - .119	2 yr	
.100 - .109	1 yr	
under .100	Patch	
	Replace	
	Floor	
	Shell

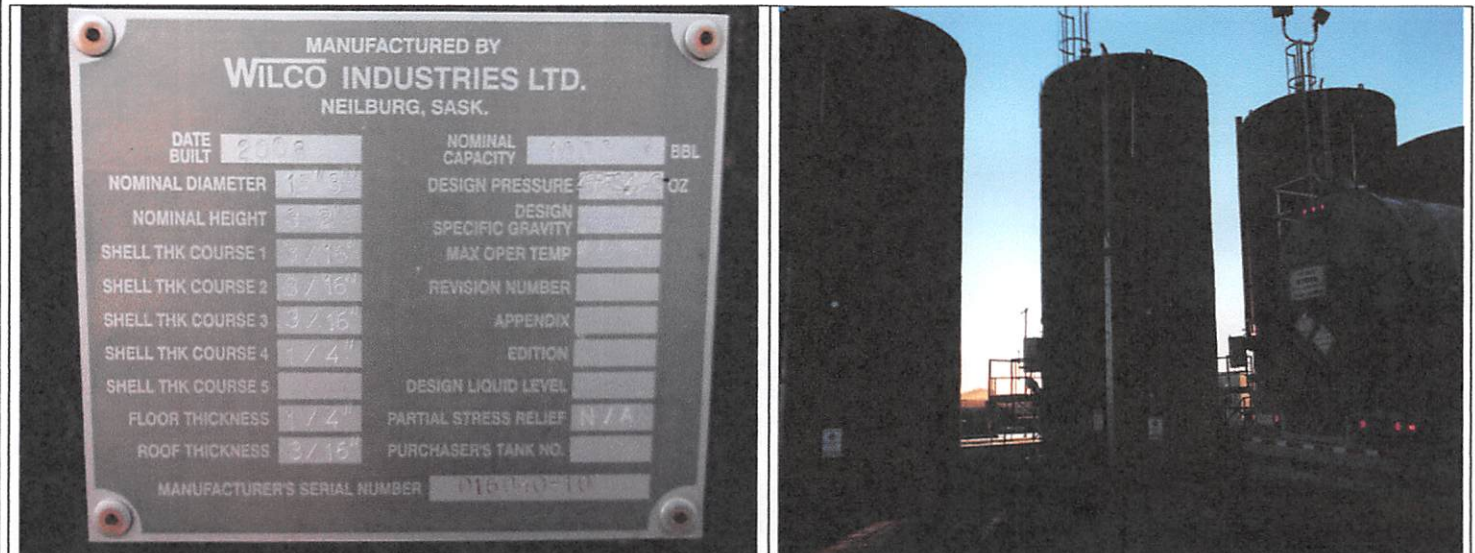
A UT and Visual inspection was carried out on the following 10000BBL oil tank for the purpose of continued fitness for service and determination of inspection interval. See the field report for results of inspection, UT recorded values and inspection interval.

Inspection Limitation(s): Only 1st course cleaned for inspection

-Recommend removing the float guide wires
Tank suitable for service
