Bootis Hill Integrity Management Inc	Installation Inspection	Form No. 001
Revision # 1	Form (Electronic)	Effective Date: 2013-02-18

Owner	Yoho Resources	Location	13-23-083-11W6
		Field	Balsam
	Vesse	l Data	· ·
Vessel Description	Sweeten Skid Fuel Gas Scrubber	PWHT	NO
Manufacturer	Lo Tech Mfg. Inc.	Diameter	6"
A# / NB#		Length	36"
Serial #	1006-3384	Radiography (RT)	
CRN #	0H7154.21354	Corrosion Allowance	
Date Built	2006	Shell Thickness	
MAWP	150 PSI	Shell Material	
MAWT	650 ° F	Head Thickness	
MDMT (-29C)	-20 ° F	Head Material	
	PSV	Data	
	PSV #1		PSV #2
PSV Location	Vessel Piping	PSV Location	
Manufacturer(s)	Wellmark	Manufacturer(s)	
Serial #	S09627-33	Serial #	
CRN #	0G7969.52/56	CRN #	
Model #	W9501-RSA200	Model #	
Set Pressure	150 PSI	Set Pressure	
Capacity	433 scfm	Capacity	
Service or Built Date	Service Company 09/10	Service or Built Date	
Service Company	Unified Valve	Service Company	
Inlet Size	1"	Inlet Size	
Outlet Size	1"	Outlet Size	
Inlet Type	Threaded	Inlet Type	
Outlet Type	Threaded	Outlet Type	
PSV Outlet Trapped	NO	PSV Outlet Trapped

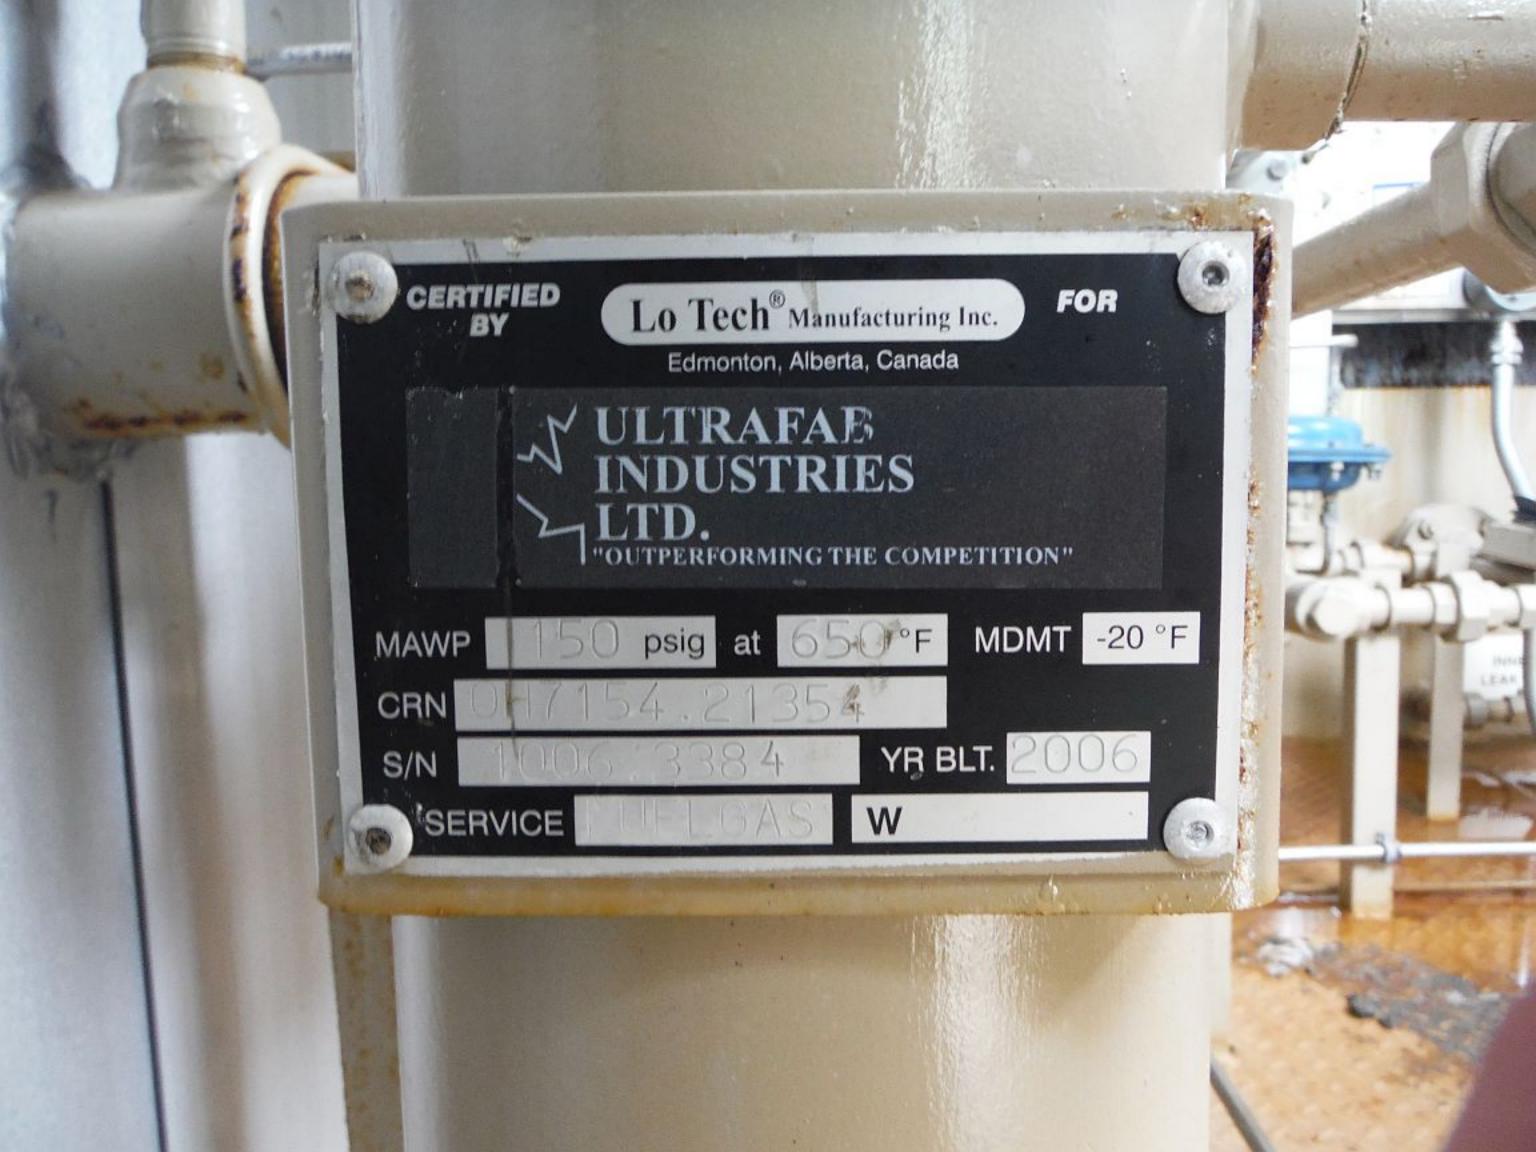
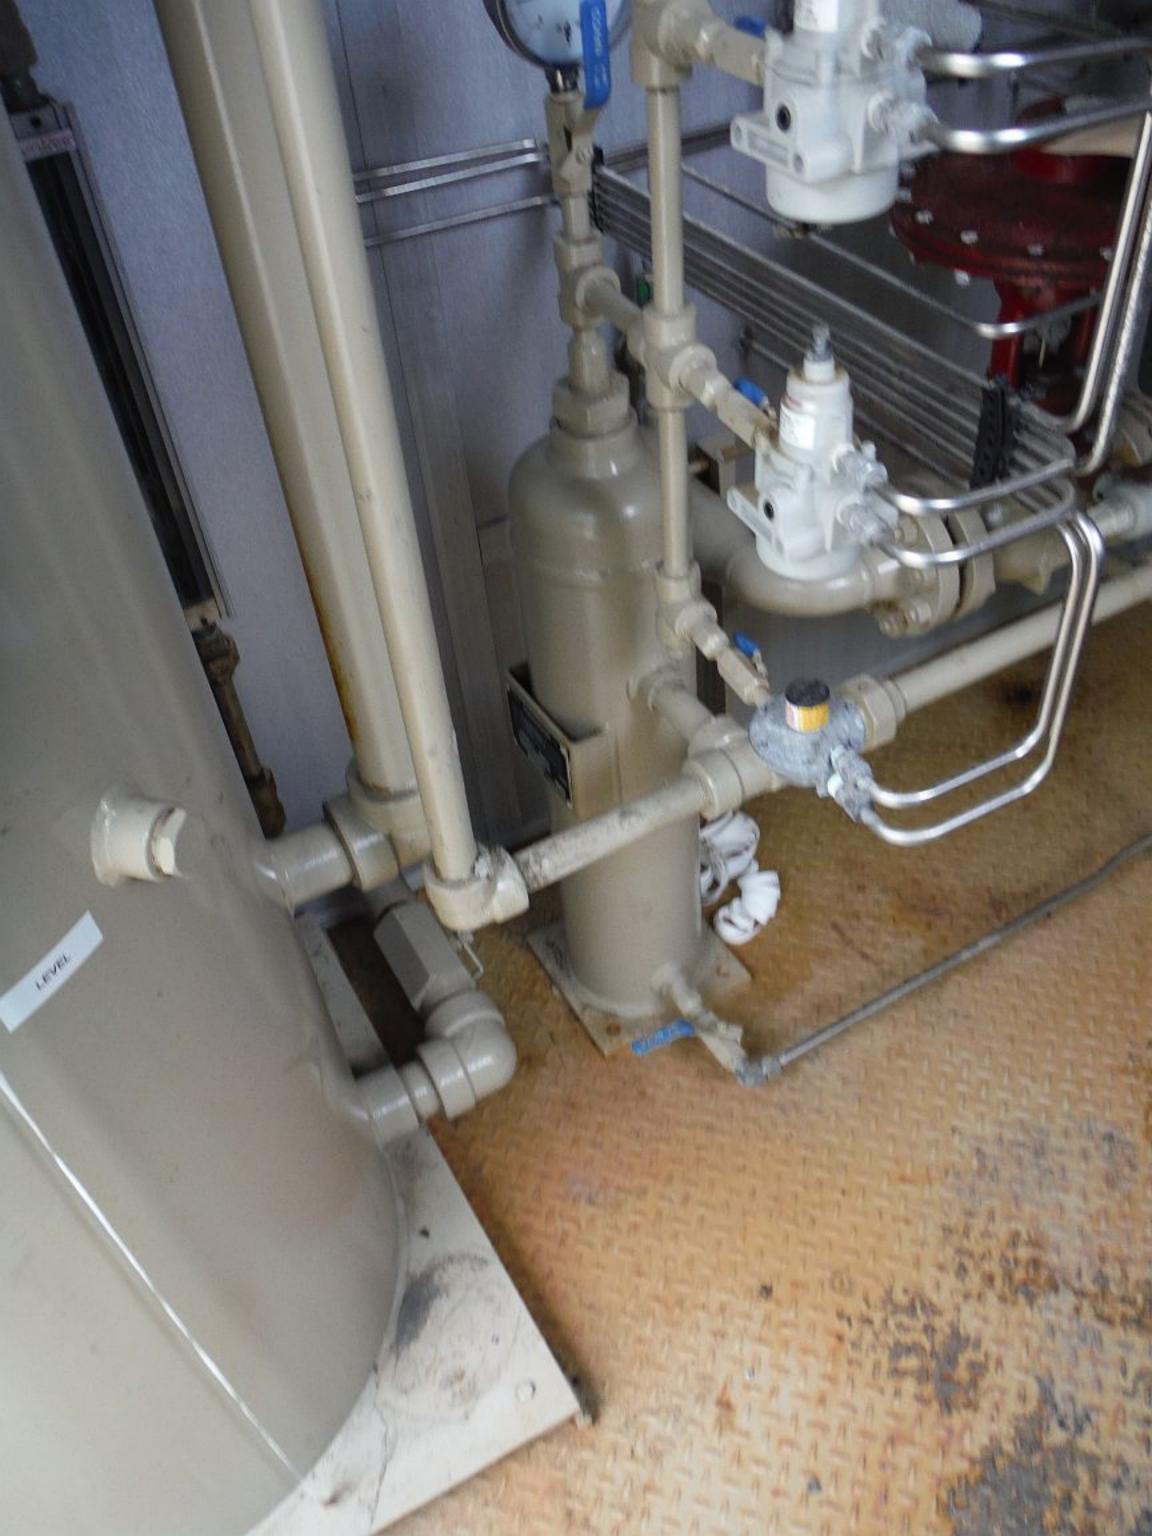
The vessel is located inside a building. The nameplate is legible and secure. The vessel is identified by a serial number stamped on the nameplate. The heads, shell, nozzles, and bolting appear in good condition. There is no damage or distortion evident. There appears to be no stress to piping or to nozzle connections. The vessel is supported by the bottom head and is welded to skid. The skid is welded to pilings and there is minimal risk of shifting. The vessel is fully painted and the paint has not deteriorated. There is no external corrosion or pitting. The vessel does not have structural attachments. The vessel is considered fit for continued service under present conditions. Piping:

The associated piping appears in generally good condition. There is no damage or distortion on piping. The piping is supported adequately by clamps. The primary piping is welded and flanged and secondary piping is mainly threaded. The piping is fully painted and the paint is in good condition. There is no external corrosion or pitting on piping. PSV:

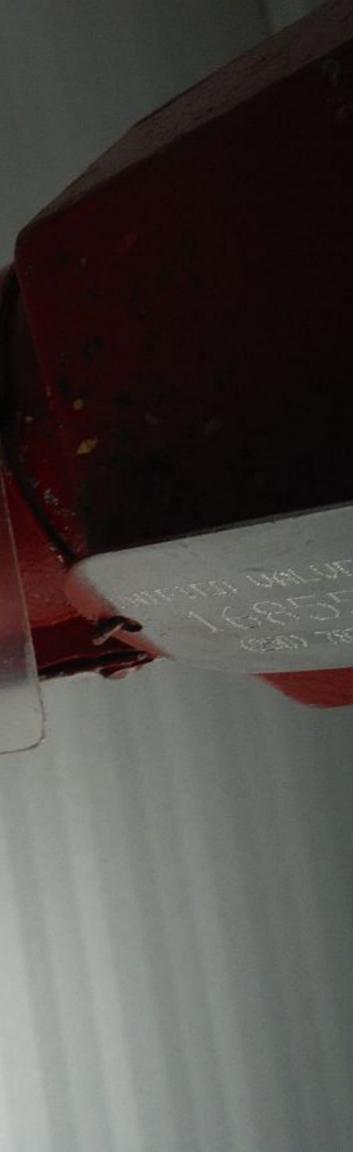
PSV was located on vessel piping and is in the vertical plane. PSV verified set at or below the MAWP of vessel. PSV does not require calibration as per AB-506. PSV nameplate secure and legible. Seal wires intact and secure, valve well supported with no body damage noted. Service report has not been reviewed. No valves in the critical path. No internal inspection of the valve was completed. PSV condition satisfactory and is considered fit for continued service under present conditions.

S N: S09627-33 Model: W9501-RSA 200 Capacity: 433 SCFM Back Press: X 1" FNPT
