R&L Pampjack Services

Date 2020-01-08

Company **Implay**

R&L Operator Trevor Letendre Serial # NYYT-91208-05JC

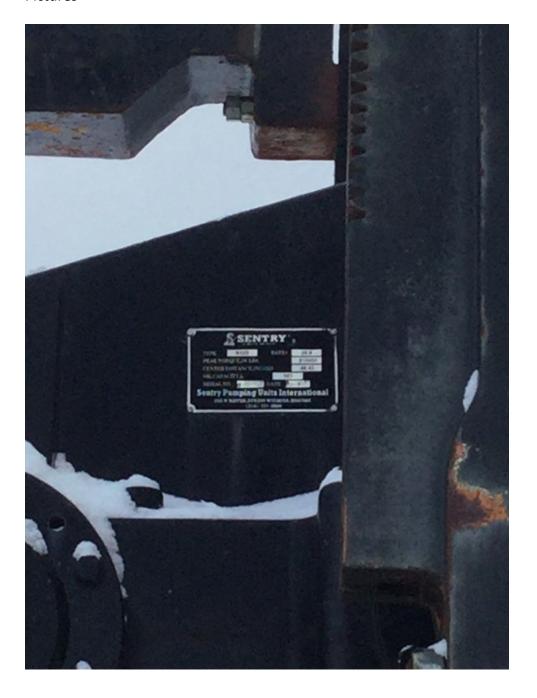
Pictures

Left Bearing Heavy Wear, Medium Wear, Repair
Right Bearing Heavy Wear, Medium Wear, Repair

Left Pin Yes corrosion reset
Right Pin Yes Corrosion reset

Comments Found filings in bearings

Repair wps and reset pins tighten saddle bolts / tighten tailbolts
