EQUIPMENT NO: 603FB001 RAMS ID: 433815

<b>Facility:</b> PLT/c-032-H/094-H-08	<b>Provincial Registration Number:</b> BCSA HP137064 (A0570539)
<b>Equipment Name:</b> Heat Medium Boiler	<b>OIP Tag:</b> 603FB001
<b>Size:</b> 1524 mm ID x 3962 mm L	<b>MAWP:</b> 1379kpa @ 343°C
<b>Items Inspected:</b> Manway, Nozzles, Shell, Heads, Stack	<b>Manway:</b> Yes
<b>Service Type:</b> Sweet	<b>Fluid:</b> Heat Medium Glycol.

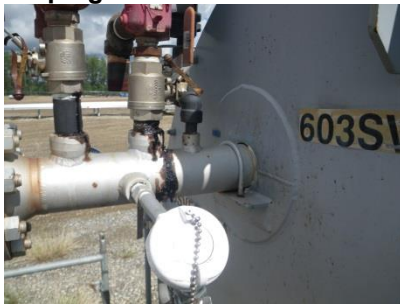
- No visible indication of distortion or deformation.
- Paint ~99%; Minor paint loss around top of manway where gasket had previously failed and scorched paint.
- No expansion slots; saddles welded directly to piles, no bolts.
- Evidence of glycol leak under PSV's, appears to be old. Operations to retape and tighten when installing new PSV's (To be delivered)
- PSV's < MAWP.
- PSV Inlet Valves car sealed open.
- Stack secure and aligned.
- Pressure Gauge spans MAWP.
- All bolting fully or acceptably engaged.
- ESD function tested at time of inspection and functioned successfully.

7) Thread Weeping on PSV's:

- Tighten weeping PSV piping threads (To be done week of Aug 2 2016)
- Forward Inspection to Will Rettman for Review.
- Return vessel to service.
- Re-inspect at regularly assigned interval.

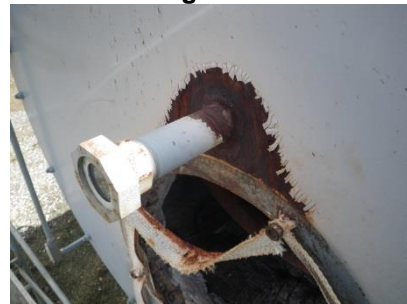
8) Previous Hot Gas fugitive emission on manway:
