# Pressure Equipment Integrity Management System External Visual Inspection Form

Owner: NuVista Energy Ltd District/Area: W5 Alberta West  
Facility: Sunchild Location (LSD) ♦: 11-29-43-11 W5M  
A Number ♦: 479077 Serial Number ♦: C1867A.C  
CRN ♦: P7798.2 Vessel Type: Separator  
Description ♦: Glycol Contactor Tower Process: Comp Stn Dehy  
Tag No: Status ♦: In Service

A#: 479077 Vessel Description: Glycol Contactor Tower Location(LSD): 11-29-43-11 W5M

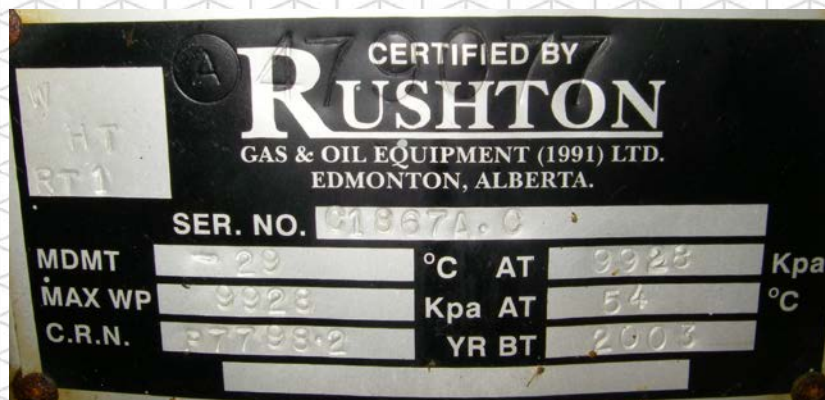
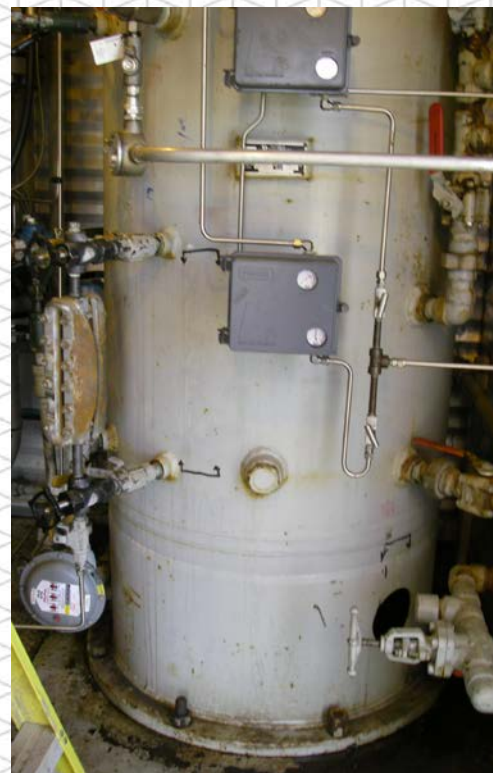
Sketch / Image Area

Paint/Coating Condition: ☒ Paint chips noted  
Insulation Condition: ☐ N/A  
External Condition: ☒ Minor general corrosion  
Foundation: ☒ Bolted  
Leaks/Drips/Seeping: ☒  
Bending/Warping/Distortion: ☒  
Dents/Cuts/Gouges: ☒  
Condition of Gauges: ☒  
Current operating pressure (shell): 850 ☒ psi ☐ kPa Range: 0 to 1500 ☒ psi ☐ kPa  
Current operating pressure (tube): ☐ psi ☐ kPa Range: ☐ psi ☐ kPa  
Current operating temperature: (shell): 78 ☒ °F ☐ °C Range: 0 to 120 ☒ °F ☐ °C  
Current operating temperature: (tube): ☐ °F ☐ °C Range: ☐ °F ☐ °C  
Ladders/Walkways: ☒  
Ground Wire Connection: ☒  
Other Equipment: ☒

External condition is acceptable to warrant continued service? yes ☒ no ☐
