**PRESSURE VESSEL  
VISUAL INSPECTION  
REPORT**

Report #: **155741-MD-24**  
 Inspect Date: 02/17/2012  
 Page: 1 of 11  
 Insp. Co. Job #: 155741

Insp. Comp: Matrix\_Inspection District: Grande Prairie - North Field: South Hamburg  
 Location: 12-29-096-11W6 Unit / Skid #: 7714 LSD: 12-29-096-11W6  
 Jurisdiction #: A3061910 Equip Tag #: V-2202 Serial #: 200355  
 CRN #: M8324.2 Nat'l Bd #: \_\_\_\_\_ Year Built: 1995  
 Manufacturer: LOCK PROCESS Systems Equipment Description: Other: OIL SEPARATOR  
 Status: In Service - Equip. Type: Vessel: Separator Service: Sweet  
 MAWP Shell: 245 Psi @ 250 °F Volume: \_\_\_\_\_ Code Stamp:  Y  N  
 MAWP Tube: \_\_\_\_\_ @ \_\_\_\_\_ Height/Length: 120 in. Insulated:  Y  N  
 MDMT: -20 °F RT: RT-2 Size/Diameter.: 30 in. O.D. PWHT:  Y  N  
 Support Saddle Vessel on Original CNRL Inventory List:  Y  N Manway:  Y  N  
 C.A.: 0.063 in. Coated: No Clad: No J.E.: 0.90 Remote Access:  - \_\_\_\_\_

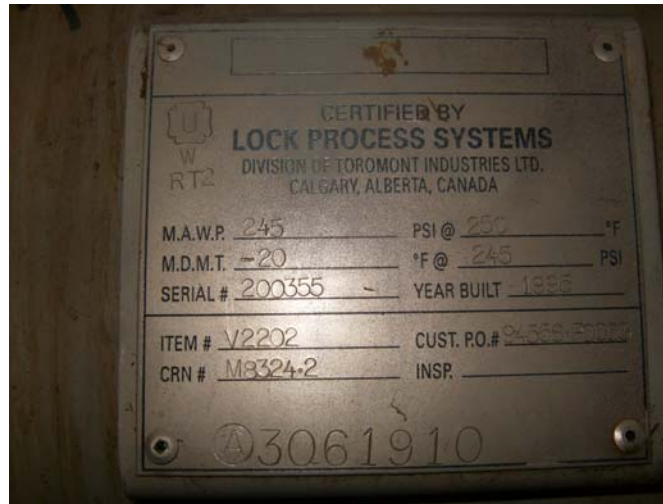
01 nameplate

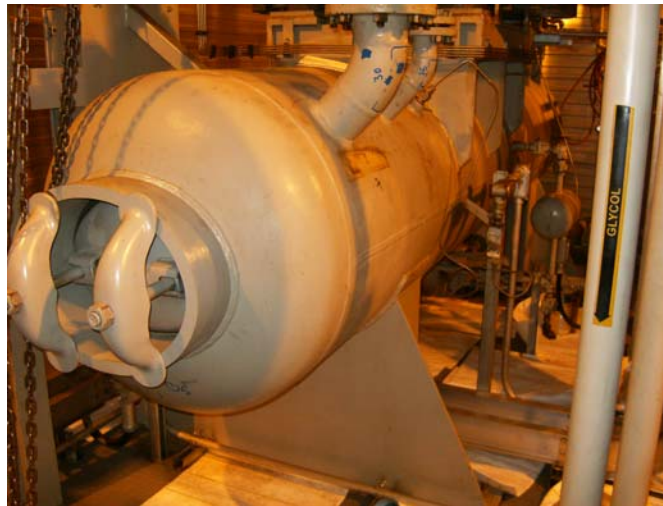
The vessel is on a small compressor skid that is well anchored to the building skid.

02 overview

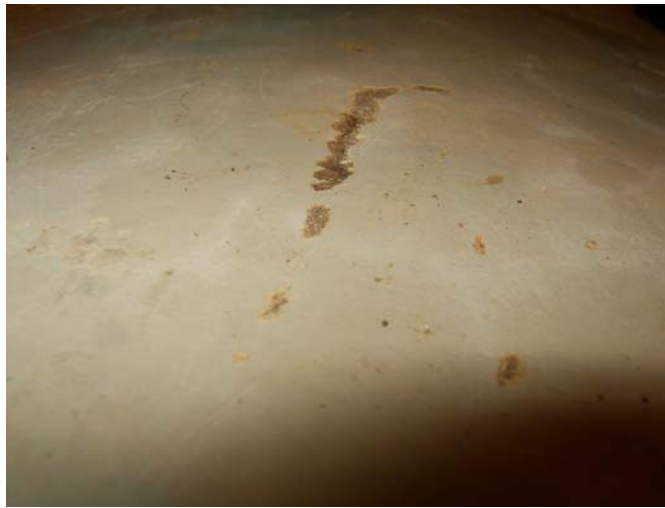
There is very minor coating deterioration (approximately 2%) noted on the shell and heads that has exposed the base metal to minor surface corrosion with no evidence of pitting.

03 chipped coating

Isolate the weeping leak from the Pre-lube pump  
 Remove broken electrical equipment  
 Clean and touch up the coating to aid in the protection against corrosion  
 Service the PSV

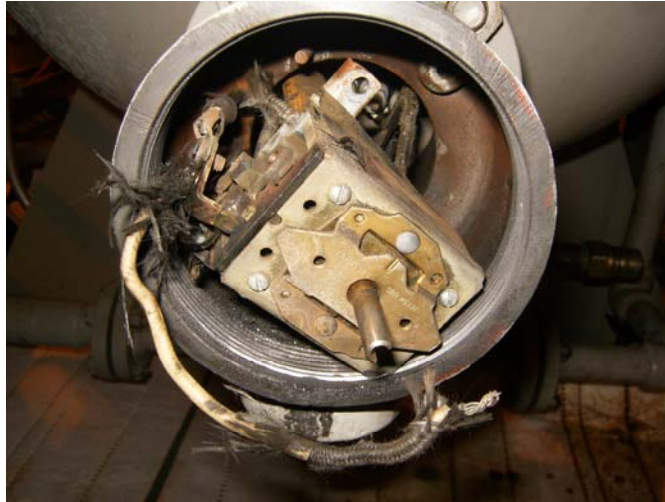
There is broken electrical equipment on the East head flanged connection. It should be noted the the conduit end is mareded and electrical taped for safety.

04 broken instrumentation

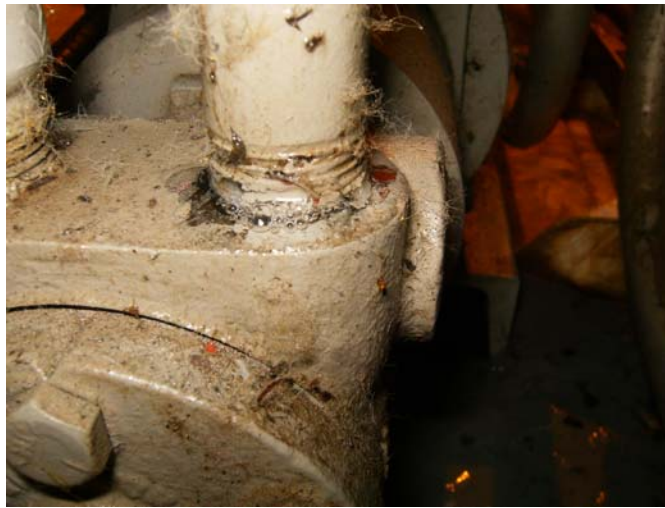
There is evidence of a bubbling, weeping leak from Pre-lube Oil Pump P-2200 inlet threaded connection.

05 leak on pump

Some absorbant pads were laid down on the floor near the pump

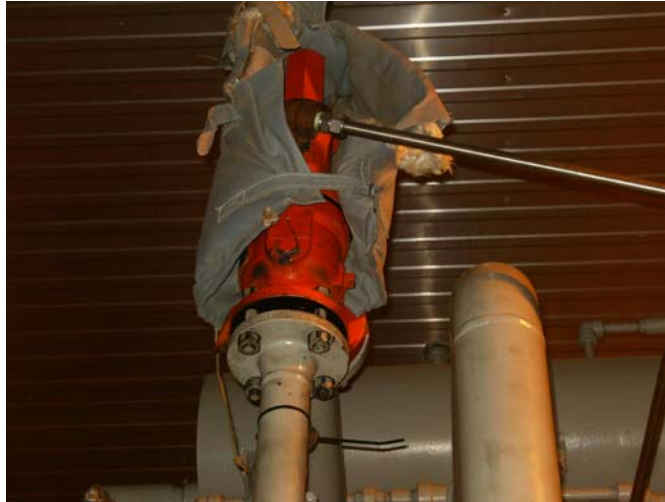
PSV is due for service

The PSV is due for service

06 PSV overview
