**PRESSURE VESSEL
VISUAL INSPECTION
REPORT**

Report #: **155741-MD-22**
 Inspect Date: 02/17/2012
 Page: 1 of 11
 Insp. Co. Job #: 155741

Insp. Comp: Matrix_Inspection District: Grande Prairie - North Field: South Hamburg
 Location: 12-29-096-11W6 Unit / Skid #: 7714 LSD: 12-29-096-11W6
 Jurisdiction #: A3090893 Equip Tag #: V-2200 Serial #: 95016C
 CRN #: M8243.2 Nat'l Bd #: _____ Year Built: 1995
 Manufacturer: DON BUCK FABRICATION CORP Equipment Description: Other: PROPANE SUCTION SCRUBBER
 Status: In Service - Equip. Type: Vessel: Separator Service: Sweet
 MAWP Shell: 285 Psi @ 413 °F Volume: _____ Code Stamp: Y N
 MAWP Tube: _____ @ _____ Height/Length: 58 in. Insulated: Y N
 MDMT: -18 °F RT: RT-3 Size/Diameter.: 24 in. O.D. PWHT: Y N
 Support: Skirt Vessel on Original CNRL Inventory List: Y N Manway: Y N
 C.A.: _____ Coated: No Clad: No J.E.: 0.85 Remote Access: - _____

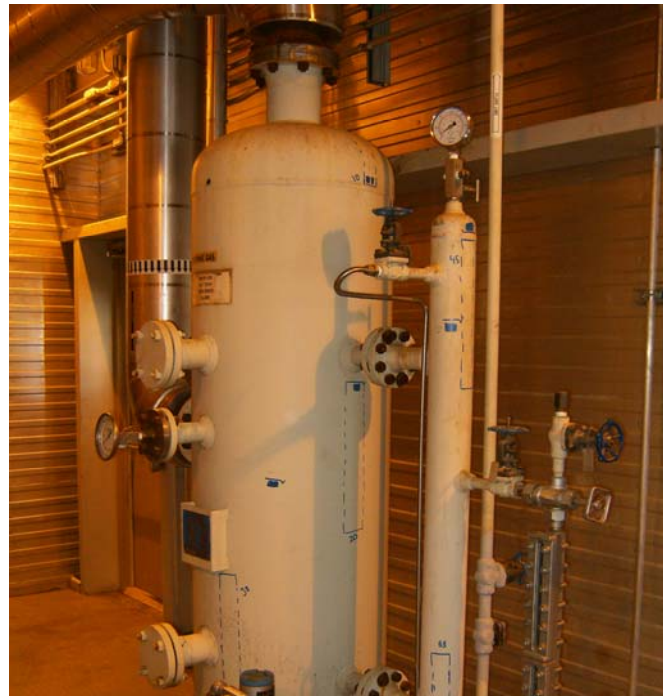
02 overview

Dirt and dust noted on the vessel top head and shell.

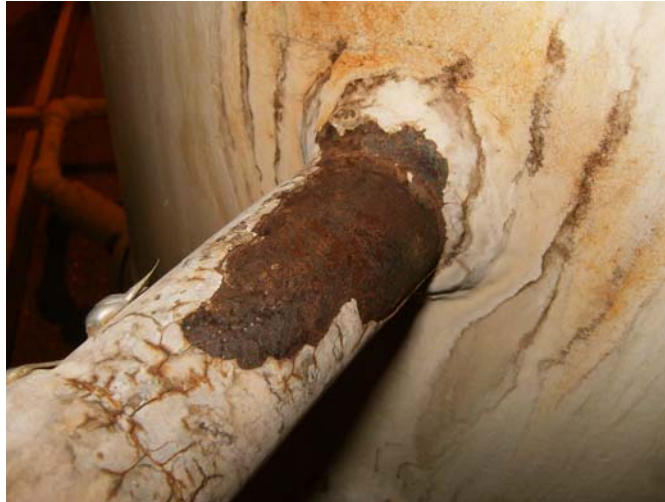
The outlet flange is taped which may accelerate corrosion between the flanges due to entrapped moisture.

There is minor surface corrosion build-up noted between the flanged connections.

04 minor surface corrosion

- Remove tape from flange
- Service the PSV
- Clean and touch-up coating to aid in corrosion protection
- Confirm with operations that the temperature does not exceed gauge rating; if so, replace as required

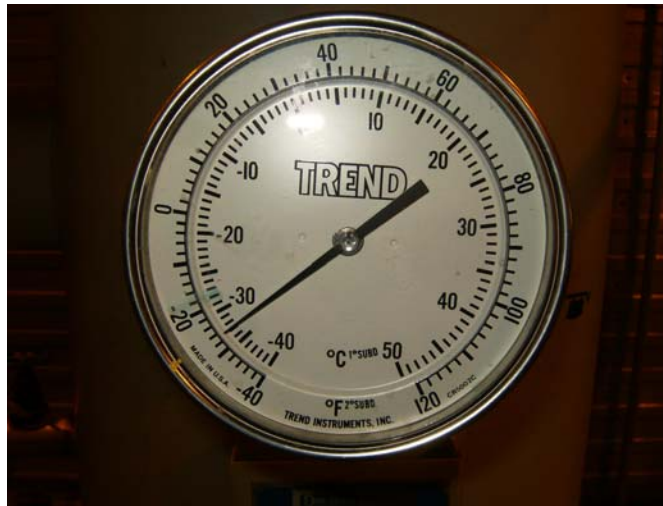
The temperature gauge is not within an acceptable range of the vessel. At the time of inspection the temperature noted was ~ -28° F

05 not within range

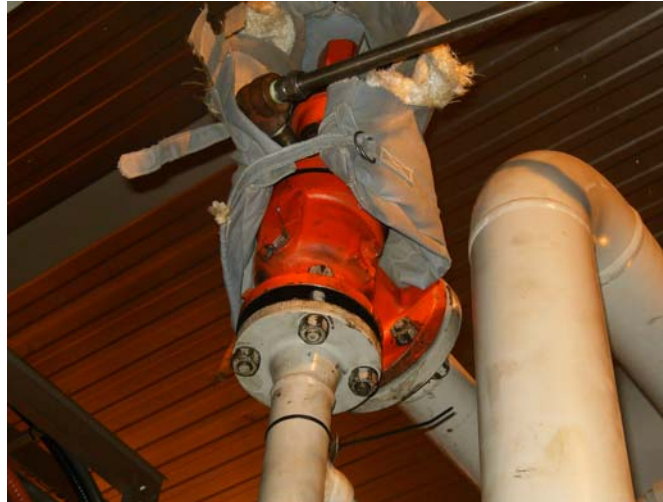
06 PSV overview

PSV is due for service
 PSV located on A3061910

The PSV is due for service
