**PRESSURE VESSEL
VISUAL INSPECTION
REPORT**

Report #: **155741-MD-29**
 Inspect Date: 02/17/2012
 Page: 1 of 11
 Insp. Co. Job #: 155741

Insp. Comp: Matrix_Inspection District: Grande Prairie - North Field: South Hamburg
 Location: 12-29-096-11W6 Unit / Skid #: 7714 LSD: 12-29-096-11W6
 Jurisdiction #: A3090903 Equip Tag #: V-2201 Serial #: 95 016 D
 CRN #: M8242.2 Nat'l Bd #: N/A Year Built: 1995
 Manufacturer: DON BUCK FABRICATION CORP Equipment Description: Other: PROPANE ACCUMULATOR
 Status: In Service - Equip. Type: Vessel: Accumulator Service: Sweet
 MAWP Shell: 1874 kPa @ 300 °C Volume: _____ Code Stamp: Y N
 MAWP Tube: _____ @ _____ Height/Length: 12 Ft. Insulated: Y N
 MDMT: -28 °C RT: RT-2 Size/Diameter.: 48 in. O.D. PWHT: Y N
 Support: Saddle Vessel on Original CNRL Inventory List: Y N Manway: Y N
 C.A.: 0.063 in. Coated: No Clad: No J.E.: 0.90 Remote Access: - _____

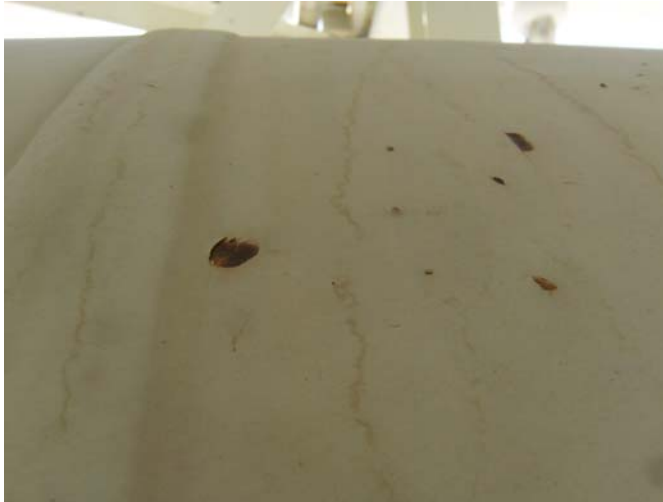
The accumulator has minor stains noted throughout with minor chipped coating exposing the base metal to minor surface corrosion with no pitting noted at the time of inspection.

04 minor surface corrosion

- Service the PSVs and ensure PSV #2 is installed in an upright position
 - Remove the tape from the flanges
 - Clean and touch-up the coating to aid in the protection against corrosion
- TA Recommendation:
 Open the manway and clean the accumulator for internal inspections.

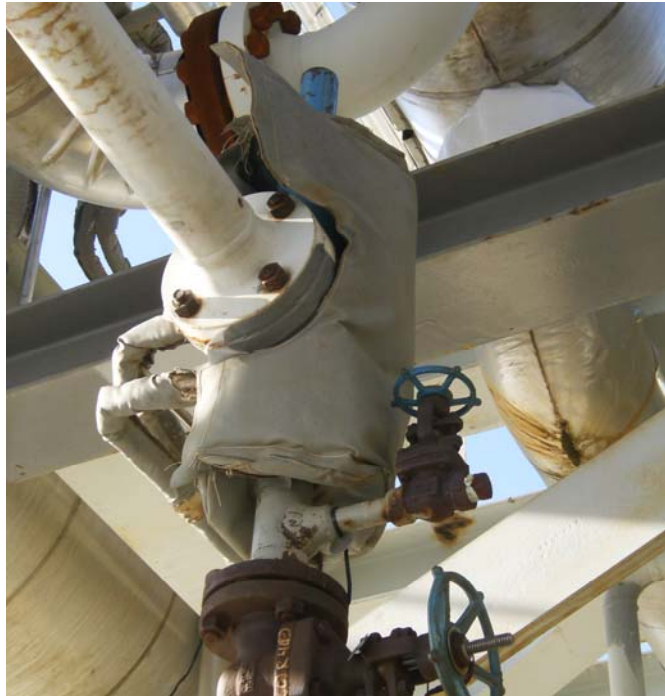
The PSV is due for service. The inlet flange to the PSV is taped which may accelerate corrosion between the flanges due to entrapped moisture.

05 accumulator PSV
