**PRESSURE VESSEL
VISUAL INSPECTION
REPORT**

Report #: **155741-MD-46**
 Inspect Date: 02/19/2012
 Page: 1 of 10
 Insp. Co. Job #: 155741

Insp. Comp: Matrix_Inspection District: Grande Prairie - North Field: South Hamburg
 Location: 12-29-096-11W6 Unit / Skid #: Glycol Reboiler LSD: 12-29-096-11W6
 Jurisdiction #: A3106404 Equip Tag #: V-2400 Serial #: 95-1677
 CRN #: M8555.2 Nat'l Bd #: N/A Year Built: 1995
 Manufacturer: I. P. Constructors Equipment Description: Other: Rich Glycol Flash Drum
 Status: In Service - Equip. Type: Vessel: Separator Service: Sweet
 MAWP Shell: 150 Psi @ 200 °F Volume: 25 ft³ Code Stamp: Y N
 MAWP Tube: @ Height/Length: 24 in. Insulated: Y N
 MDMT: -20 °C RT: RT-3 Size/Diameter.: 8.625 in. O.D. PWHT: Y N
 Support Skirt Vessel on Original CNRL Inventory List: Y N Manway: Y N
 C.A.: 0.062 in. Coated: No Clad: No J.E.: 0.85 Remote Access: -

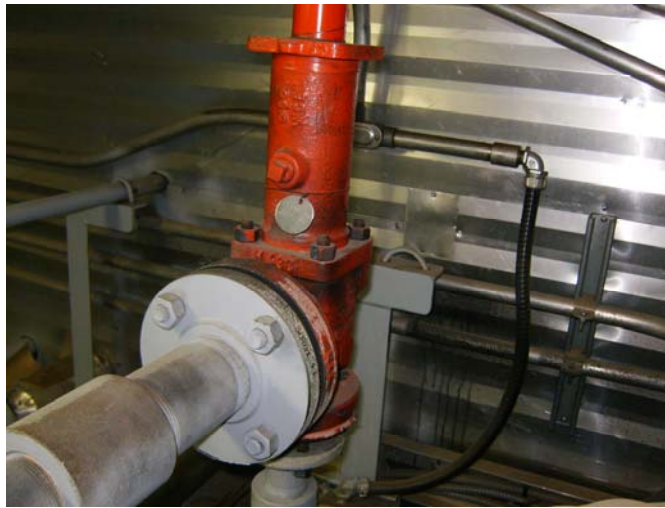
03 PSV overview

PSV is due for service

Service tag is missing

The PSV service tag is missing and should be due for service.

Clean and touch up the coating on the bottom head
 Service the PSV
