Plant ID:	N-COMP-STN	Equipment Type:	Vessel
Equipment Number:	V12-JN02	Equipment Name:	HYDROCARBON WATER SEPARATOR
ERP Number:	CA.CRL.NCS-V12-JN02	In Service:	<input type="checkbox"/>
Classification:	Equipment

Integrity Report

IR Memo No:	10169	Title:	2010 NCS TA INTERNAL INSPECTION
Report Number:		Date Inspected:	9/18/2010
Date Created:	9/18/2010	Date Completed:	2/15/2013
Job File Number:		Assigned User:	
Workorder No:	23008430		
Created By:		Completed:	<input checked="" type="checkbox"/>
Extent:	Full	Stream:	Internal
A I Name:	H Fear	Visual External:	<input type="checkbox"/>
Chief Inspector:		Reason for Inspection:	Routine
Chief Insp. Date:		Work Event:	
Operating Time:		Reset Operating Time:	<input type="checkbox"/>
Regulatory Comment:

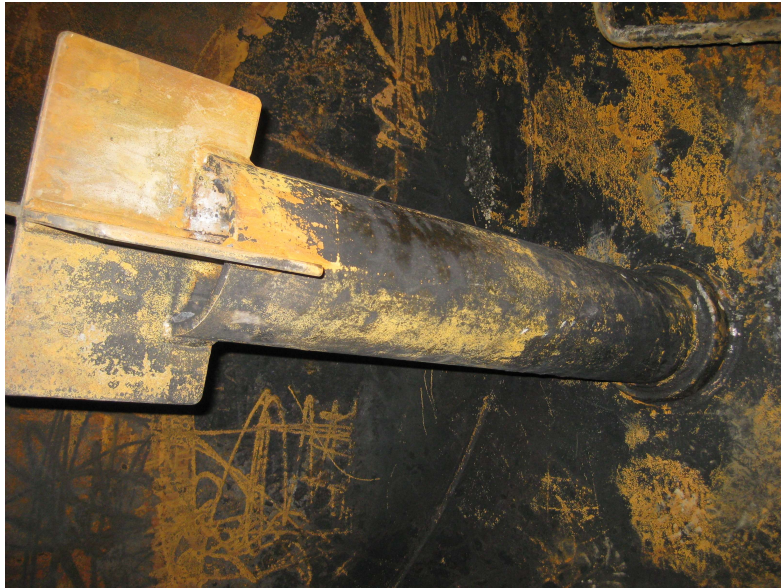
Attachment No:	1	File Size:	3058 KB
Attach Type:	Embedded	File Name:	IMG_2592.JPG
Description:	STAND PIPE AS FOUND BEFORE MODIFICATIONAS

The stand pipe was lengthened to facilitate better hydrocarbon separation.

The standpipe was cut and new section added to allow for better condensate separation. The total height from bottom of the standpipe(vessel shell) to the top of the standpipe is 56 1/4".

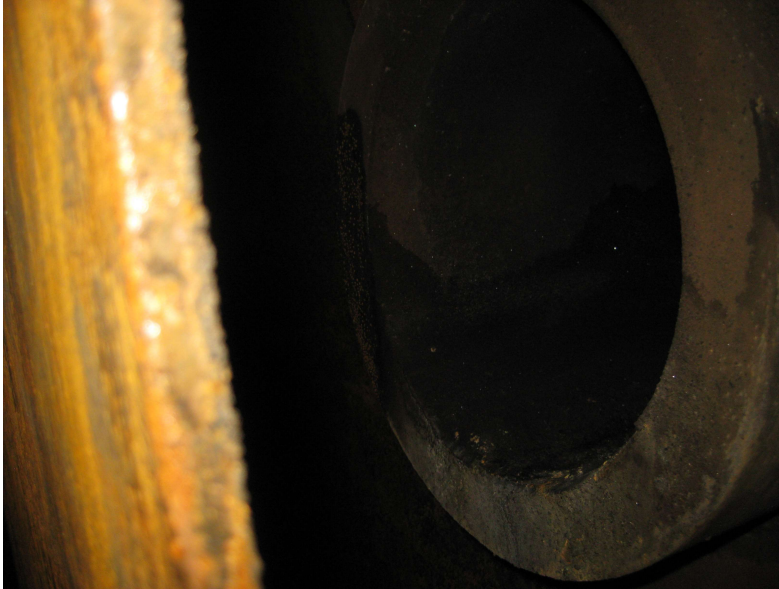
File Size: 1483 KB  
 File Name: IMG\_2591.JPG

- No areas of corrosion observed on vessel shell or in boot.
- All nozzles appeared to be clean with no notable corrosion observed.
- Inlet nozzle and deflector plate sound, no erosion or corrosion observed.
- Mill marks observed on shell to 1mm in depth throughout.
- Standpipe and vortex breaker sound with no corrosion observed.
- All welds visualy inspected were found in good condition with no defects observed.
- Manway nozzle and cover flange good-no corrosion identified.
- Both heads in good condition-no notable corrosion observed.

Attachment No: 2  
 Attach Type: Embedded  
 Description: Inlet Nozzle and Deflector Plate

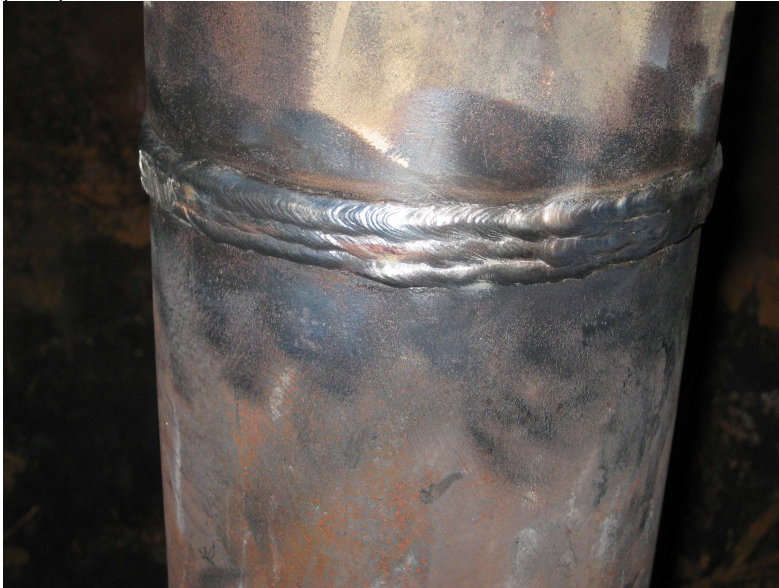
File Size: 2501 KB  
 File Name: IMG\_2601.JPG

Attachment No: 6  
 Attach Type: Embedded  
 Description: Stand Pipe Repair

During the repair part of QC which called for MPI of weld was waved by

Engineering and only a visual inspection of the finished weld was completed.

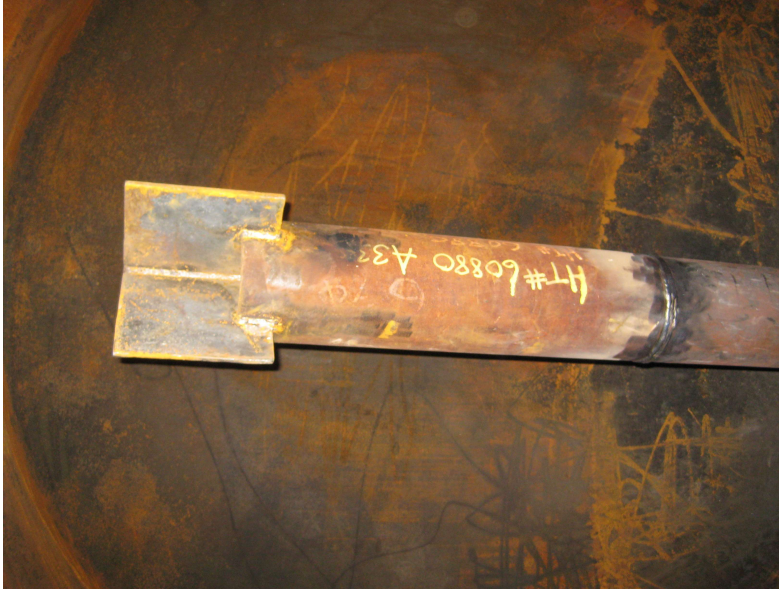
File Size: 2090 KB  
 File Name: IMG\_2603.JPG

Attachment No: 4  
 Attach Type: Embedded  
 Description: Stand Pipe Repair

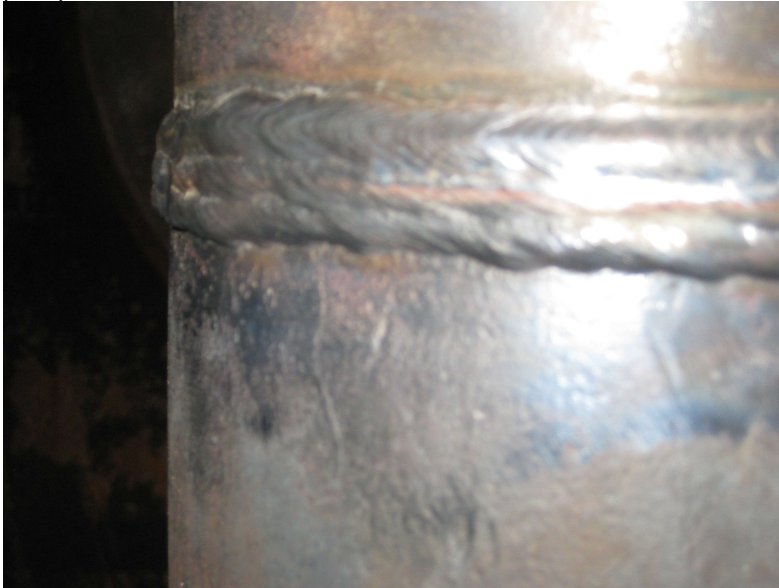
File Size: 1423 KB  
 File Name: IMG\_2602.JPG

Attachment No: 5  
 Attach Type: Embedded  
 Description: Stand Pipe Repair

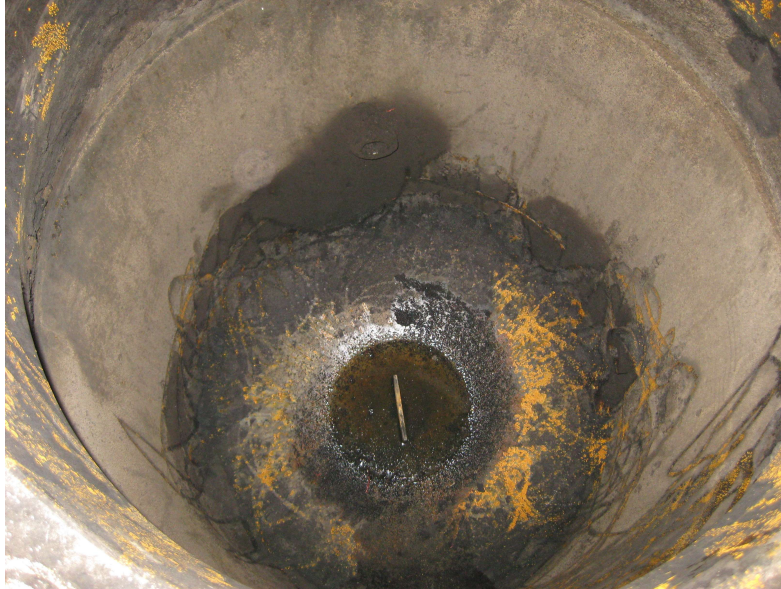
File Size: 2896 KB  
 File Name: IMG\_2590.JPG

Attachment No: 3  
 Attach Type: Embedded  
 Description: Boot Section of Vessel after cleaning
