<b>Client</b>	Murphy Oil Company Ltd.	<b>Inspection Date</b>	Nov 13, 2017		
<b>Prov. Reg. #</b>	AB 0614452	<b>Inspection Type</b>	VE / UT / PSV		
<b>Equipment Type</b>	Separator	<b>Location</b>	Kaybob - West		
<b>Tag/Equip.</b>	V-100	<b>LSD</b>	AB 14-34-062-19W5		
<b>Status</b>	Not In Service	<b>Downhole LSD</b>			
<b>Manufacturer</b>	Penfabco Ltd.	<b>Area</b>	FOX CREEK		
<b>Serial Number</b>	PE-12760	<b>Year Built</b>	2013		
<b>CRN #</b>	V7852.213	<b>Service</b>	Sour		
<b>Comp/Unit Id</b>		<b>Manway</b>	None		
<b>Nat.Board #</b>		<b>Coating</b>	No		
<b>Interim Insp'n</b>		<b>Interim Type</b>			
<b>Next Thorough Insp</b>		<b>Next Insp Type</b>	VE / UT / PSV		
<b>Length</b>		<b>Height</b>	144 in		
<b>Volume</b>	Capacity	<b>Client Reference</b>			
<b>Owner</b>	Murphy Oil Company Ltd.	<b>RT</b>	1	<b>HT</b>	YES
<b>Foreman</b>		<b>RAE Job No.</b>	0010.17.004.014		
<b>ABSA</b>	<b>Plant:</b> H <b>Vessel:</b> P <b>Process:</b> W <b>Special:</b> S	<b>ASME</b>	Sec. VIII div. 1

RAE Engineering and Inspection Ltd 4810 - 93 Street Edmonton, AB, T6E 5M4 ph: 780-469-2401 fx: 780-468-2422		Inspection Date:	14-Aug-17	<b>Ultrasonic Thickness Examination</b>
			Page:	1 of 4	
Client: Murphy Oil Compa

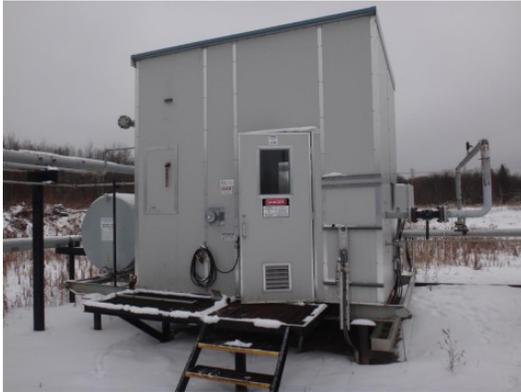
Figure: 2

The building was generally in good condition and well supported.  
The building had adequate lighting for visual inspection.  
The doors and windows functioned well and were in good condition.  
There was generally good access to the equipment in the building.  
The ground wire was securely attached to the building structure.  
The building was situated on a transportation skid that was supported by the ground.

Building General

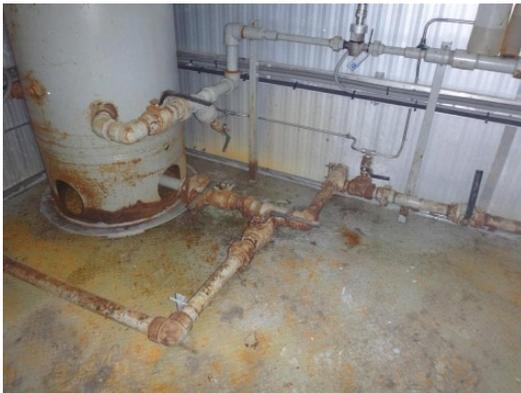
Figure: 3

The attached piping was generally in good condition.

The piping was sufficiently supported.

There was no damage, distortion or stress evident on the piping.

The piping outside the building was insulated and the cladding appears to be in good condition.

The piping inside the building was painted the paint appears to be in good condition.

The pipe flanges and bolting appeared to be in good condition.

Piping General

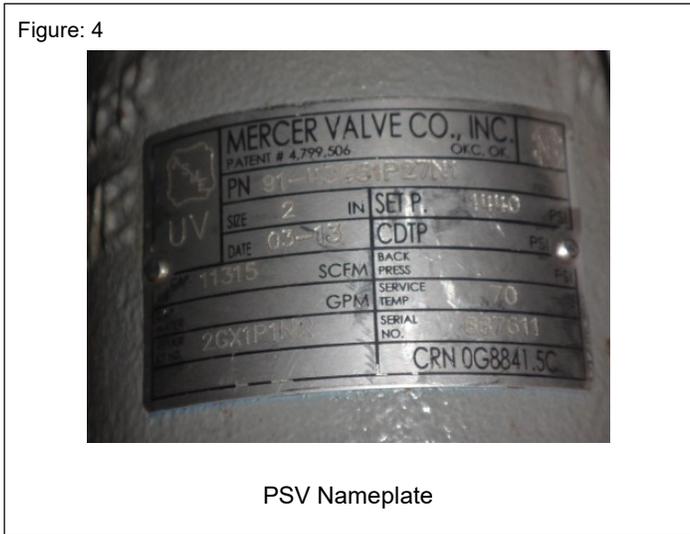
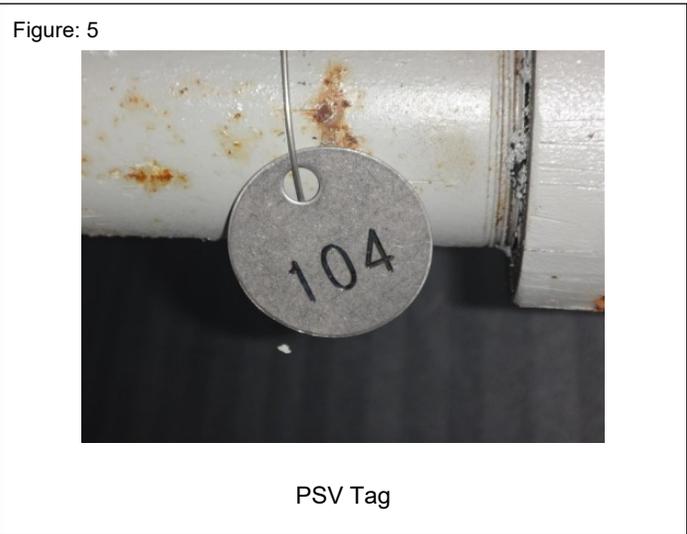
The PSV was located on associated piping.  
 The nameplate was securely attached and legible.  
 The set pressure was acceptable for the vessel.  
 The service tag was securely attached.  
 The PSV seal wire was attached and intact.  
 The outlet piping provided positive drainage for the PSV.  
 There were no valves located on PSV piping.

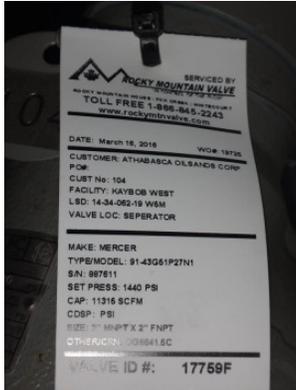
Figure: 6

PSV Service Tag

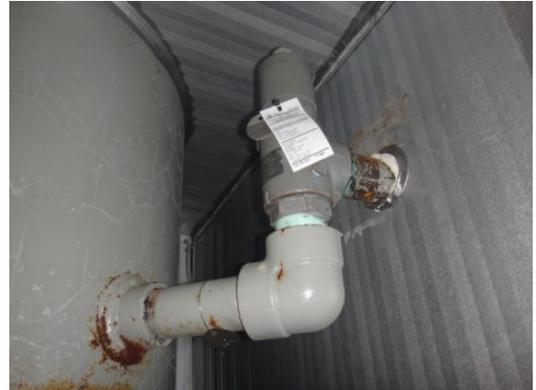
Figure: 7

PSV General

1. The vessel is fit for service.
2. No PSV capacity calculation found at the time of inspection, therefore conduct calculations to close out NCR.

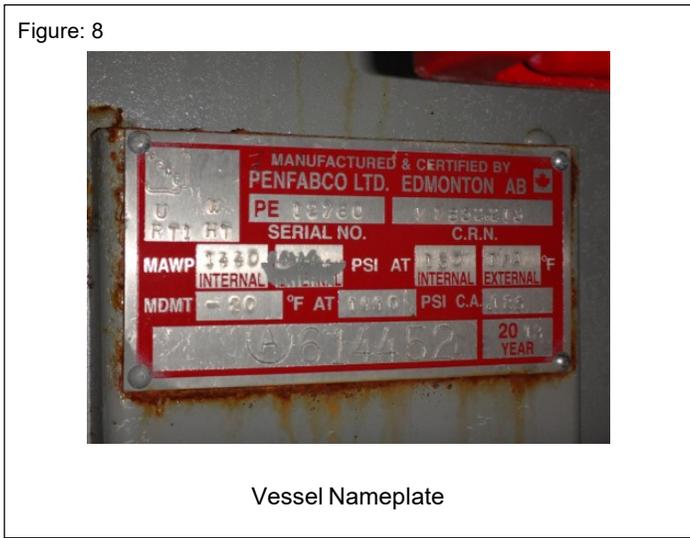
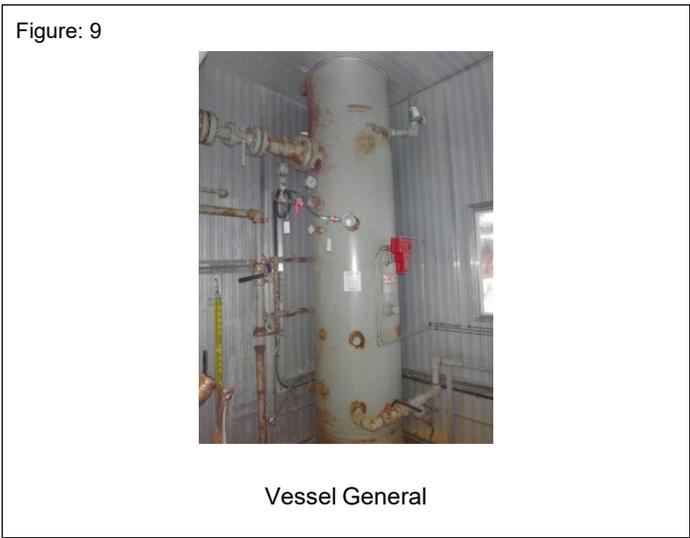
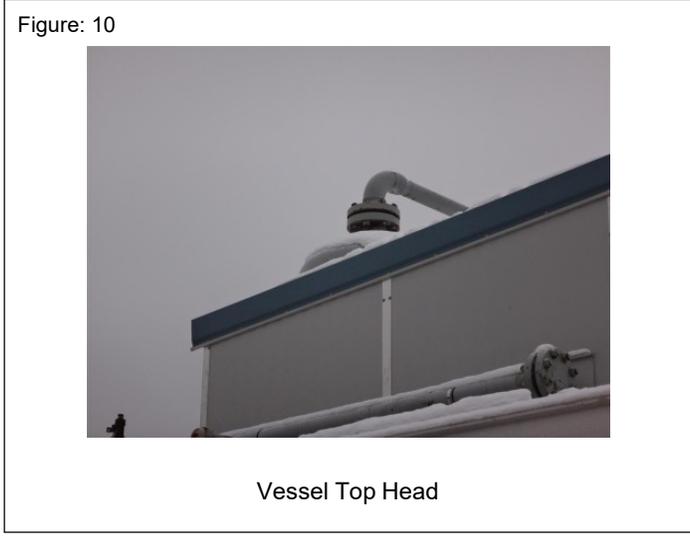
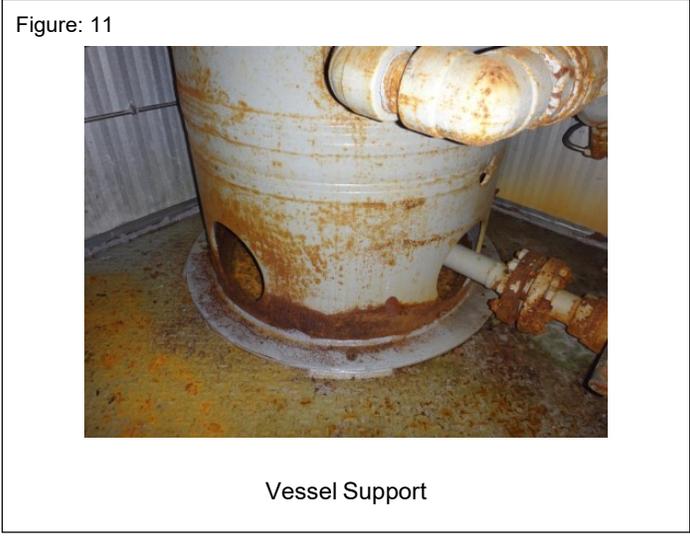
The nameplate was legible and securely mounted to the vessel.  
The vessel was identified per A-number and serial number stamped on the nameplate of the vessel.  
The heads, shell, nozzles and bolting appeared to be in good condition.  
The gauges were in good condition.

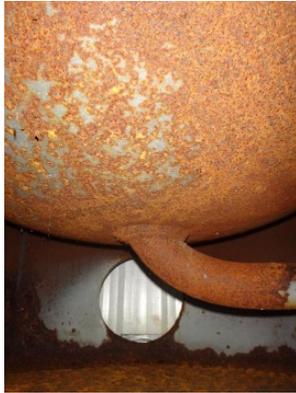
Figure: 12

Vessel Bottom Head

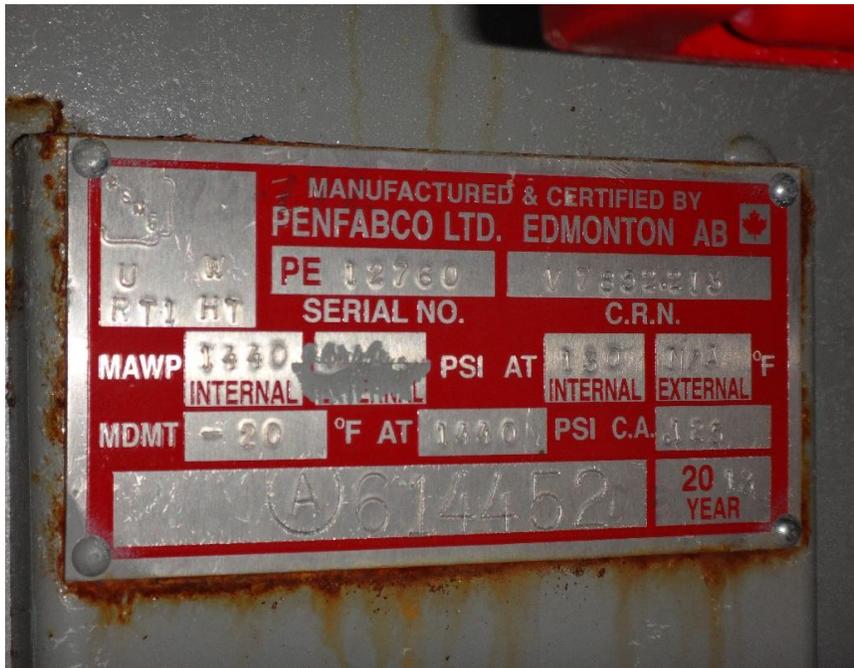
**Nameplate**

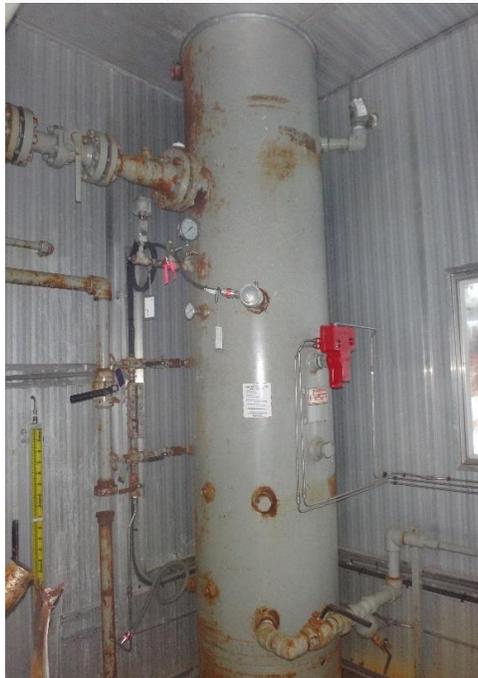
**Overall View of Equipment**

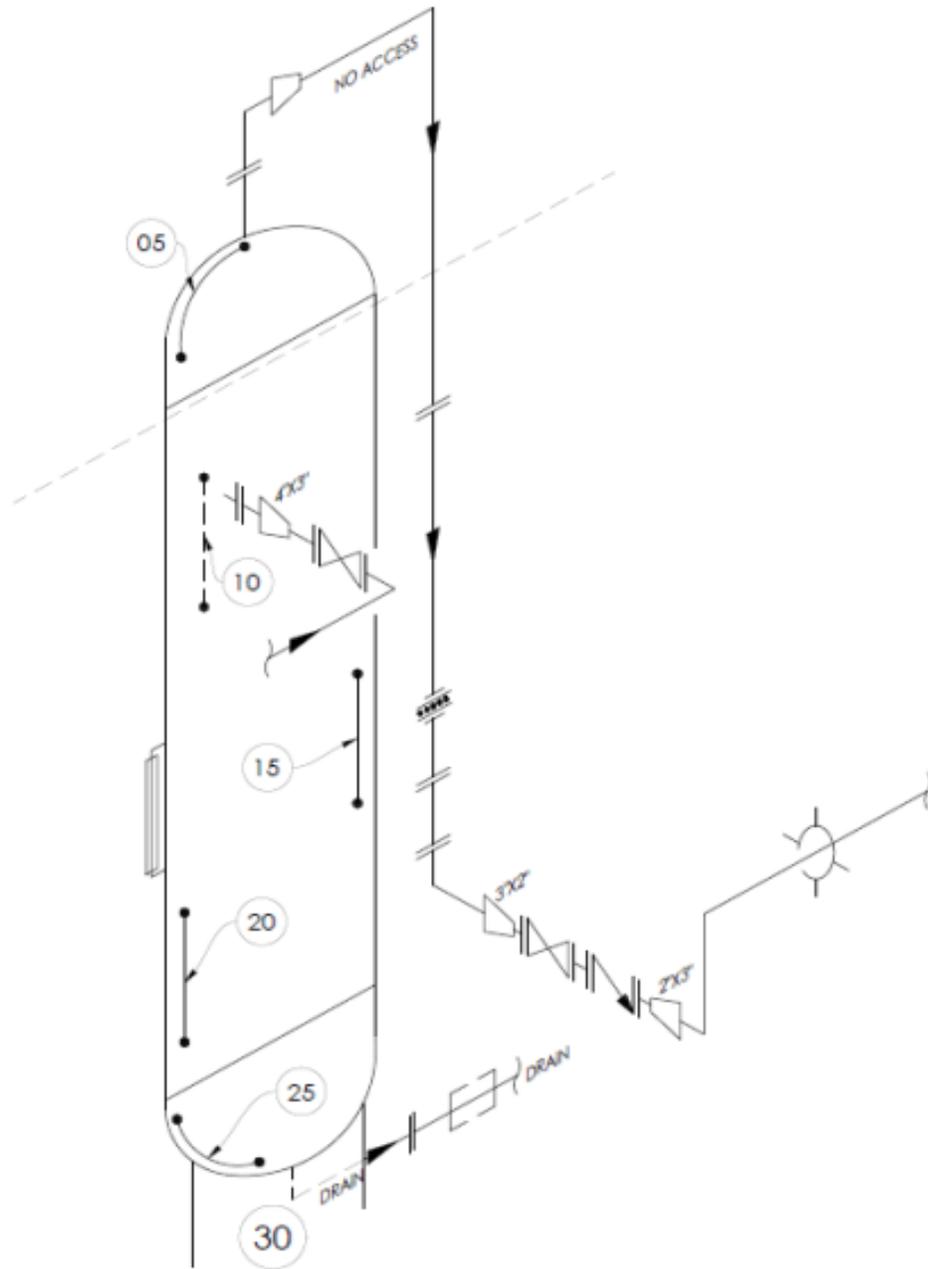
ISO Drawing of Equipment and TMLs

**Results:** Nominal and minimum measurements were not provided. The measurements obtained show the thickness to be consistent throughout scan locations.

There were no signs of wall thinning, internal corrosion, erosion, laminations or inclusions at the time of inspection.
