Existing Equipment Integrity Assessment Report

Inspect Date: July 27, 2023	Client: Yoho Resources	District: Inga, BC	LSD: 10-19-087-23W6
Facility:	Client Ref #	IRM Ref #	P004
Equipment #:	Description: BPV-066731 – 2 nd Stg Aerial Cooler	Jur# A0552589	CRN: T4388.213
MFR: Air-X-Changers	Mfr S/N: 055572.4	Mfr Date:	Status: Operating

<table><tr><th colspan="6">VESSEL DATA</th></tr><tr><td colspan="6">Vessel Description: 2nd Stage Aerial Cooler</td></tr></table>

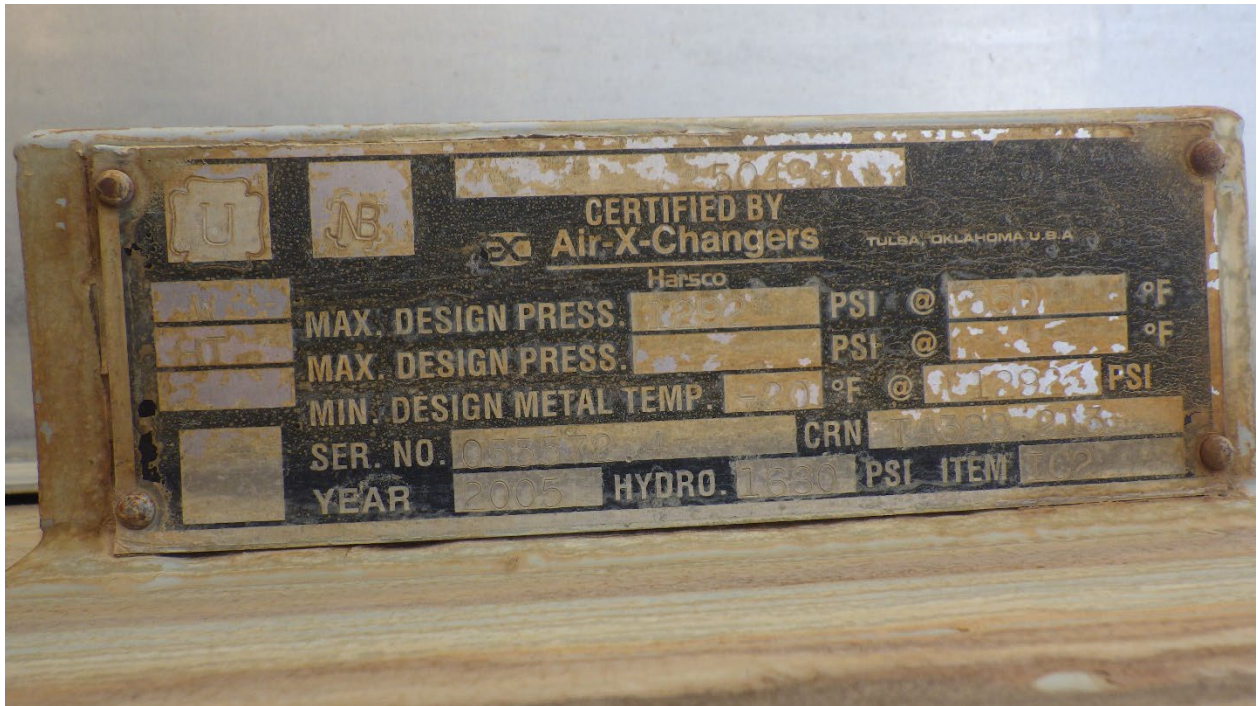
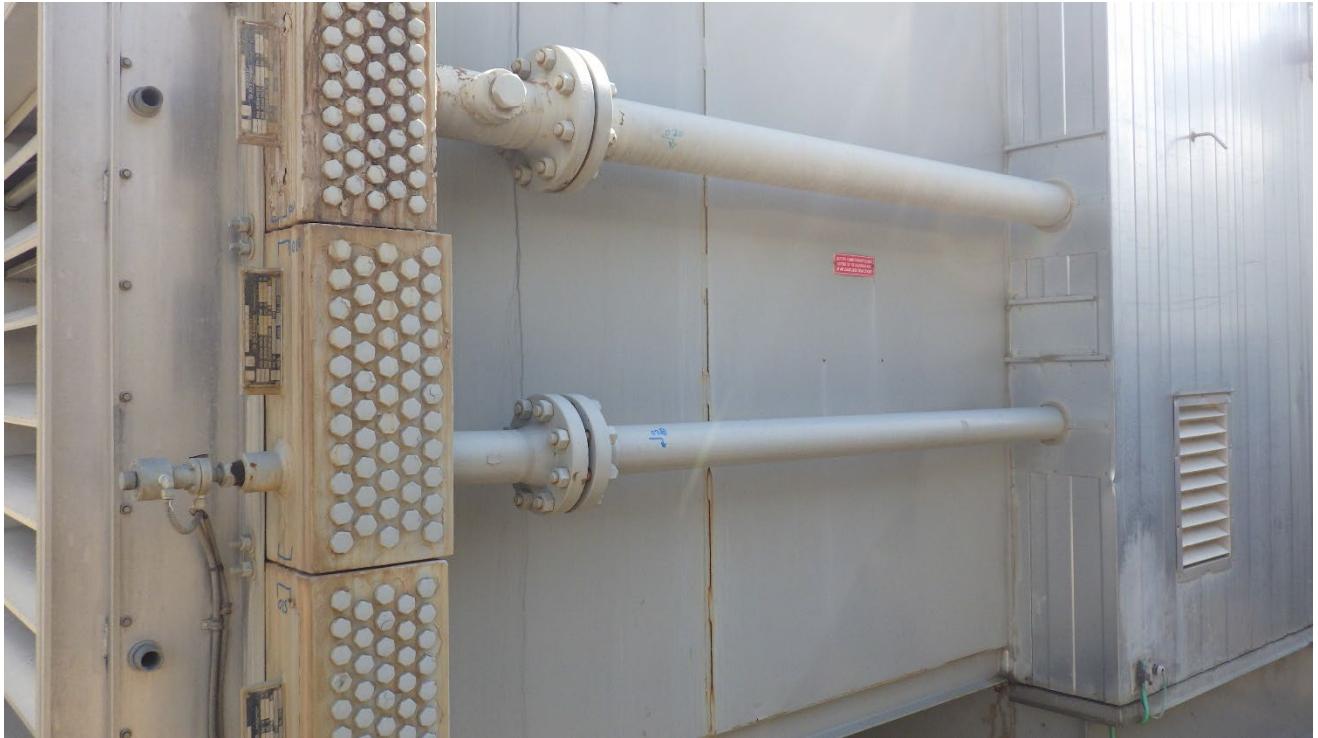
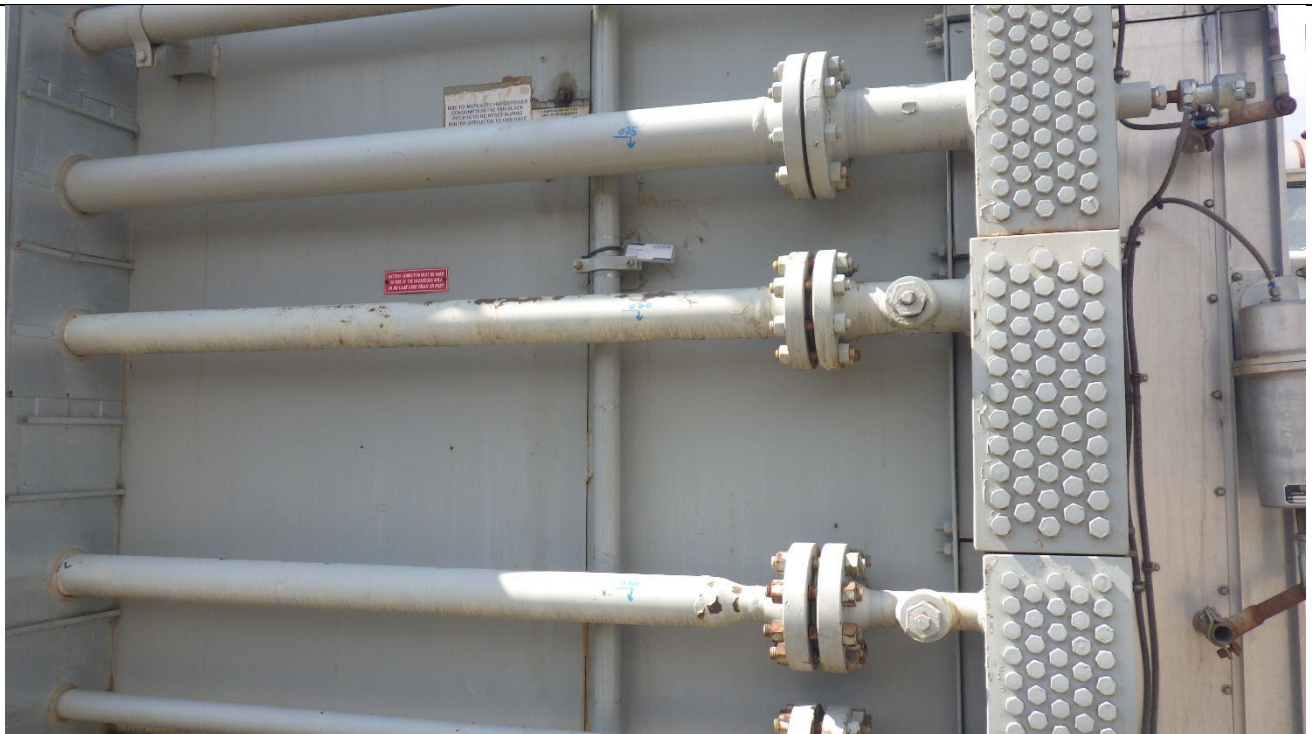
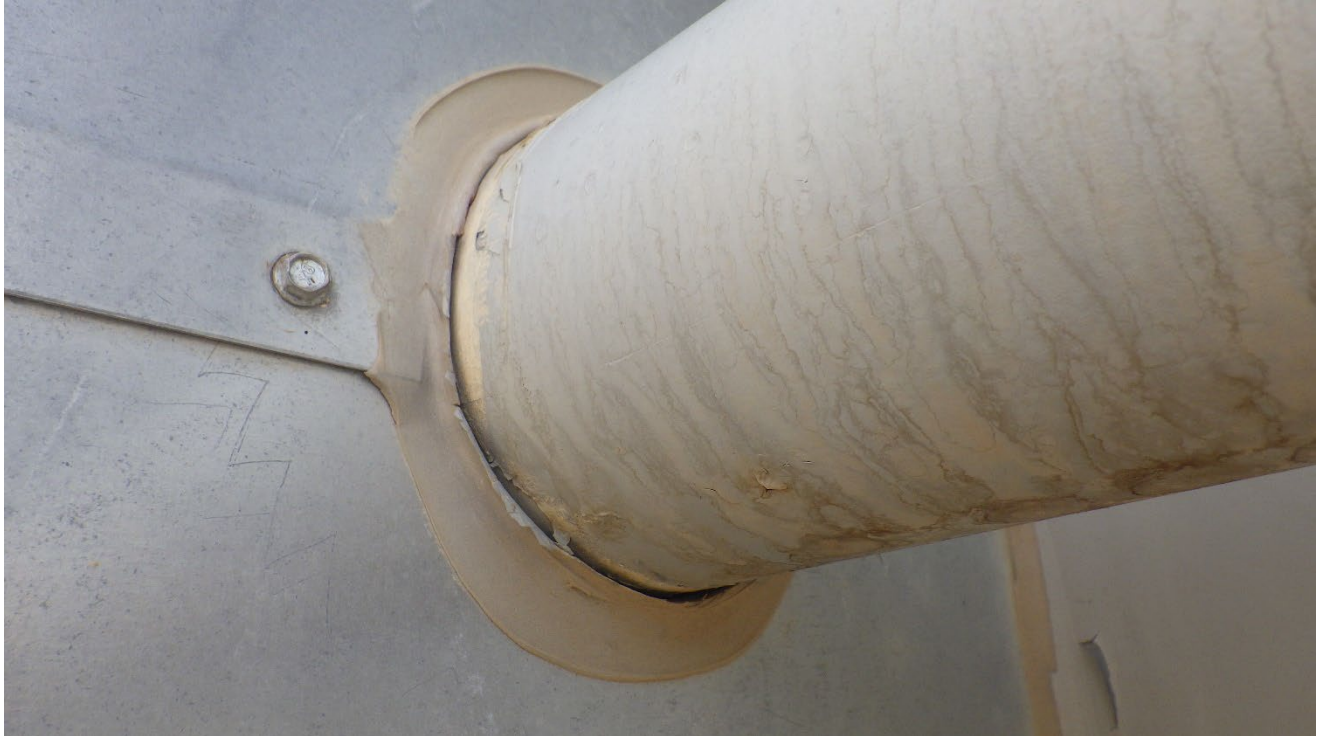
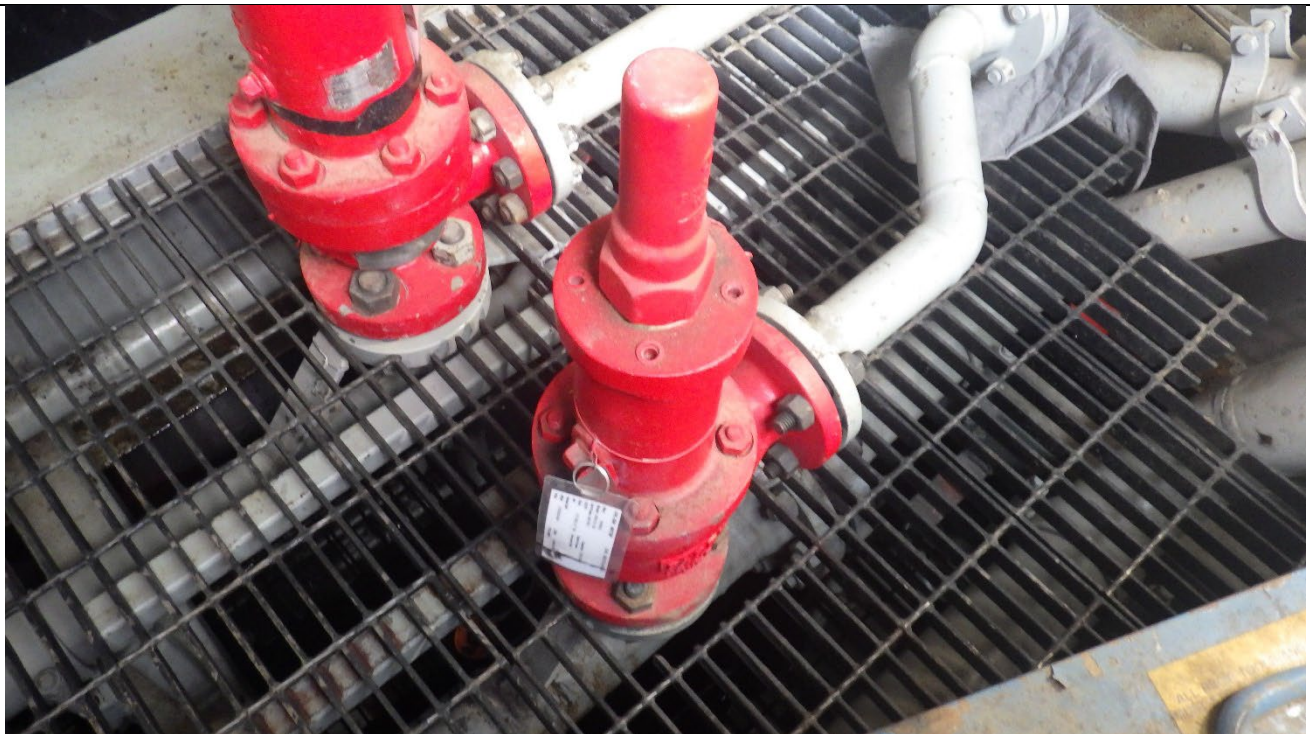
PHOTOS

Comments:				
1. The caulking at the outlet piping to building interface has failed.				
<input checked="" type="checkbox"/> In Service <input type="checkbox"/> Idle <input type="checkbox"/> Blinded/Disconnected	Signature
