Existing Equipment Integrity Assessment Report

S-5

Inspect Date: July 27, 2023	Client: Yoho Resources	District: Inga, BC	LSD: 10-19-087-23W6
Facility:	Client Ref #	IRM Ref #	P003/P004
Equipment #: S-5	Description: Fuel Gas Scrubber	Jur# N/A	CRN: L9476.213
MFR: Larsen & D'Amico	Mfr S/N: S-14287	Mfr Date: 2009	Status: Operating

Corrosion Survey Report

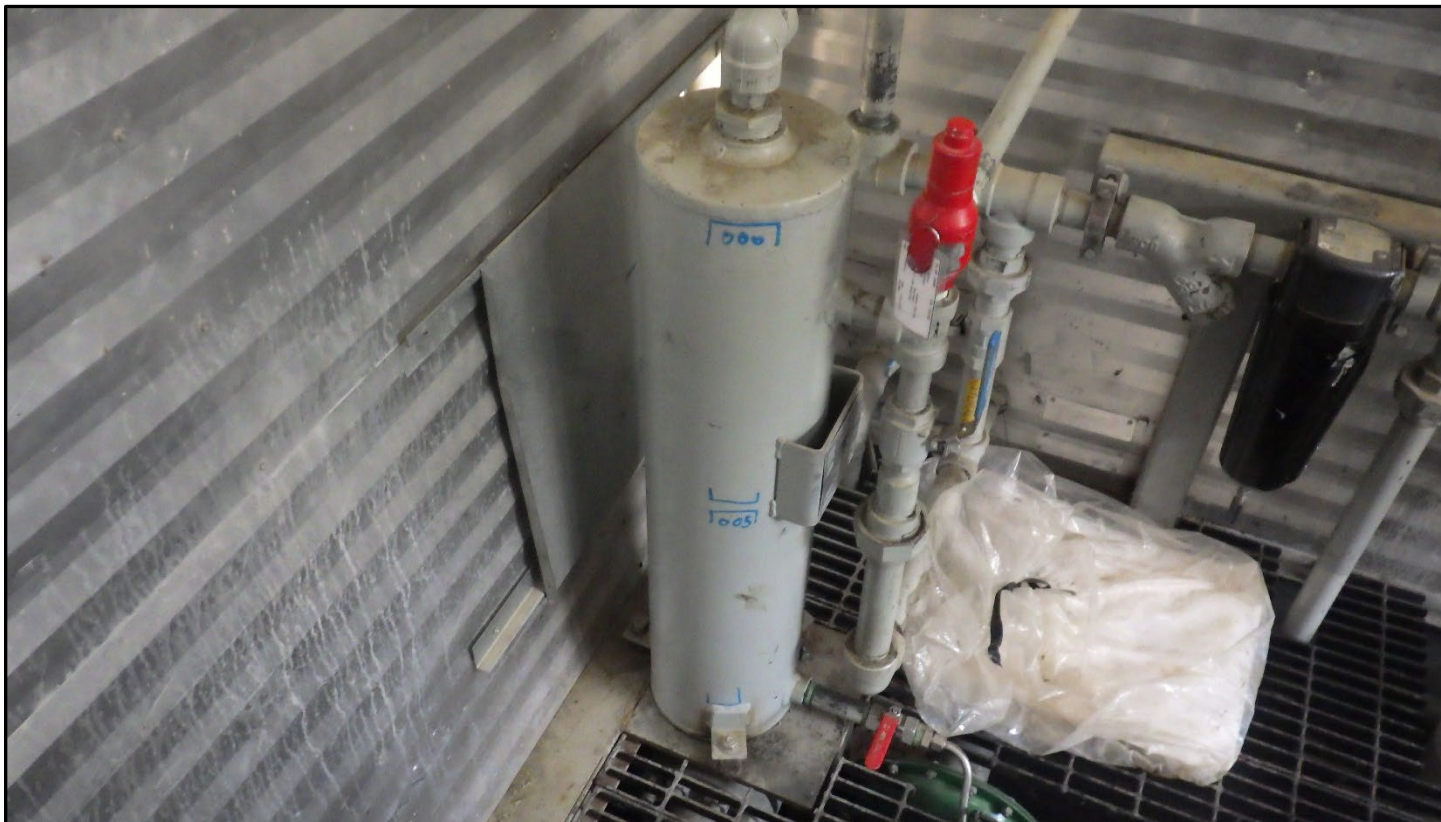
Vessel Overview

The vessel is located inside the Waukesah H24GL Comp Skid (#050954-01)

The external surfaces of the vessel are painted. The paint is in new-like condition. No corrosion or deformations were visible on the shell of the vessel. No cracks or deterioration were identified in the vessel welds.

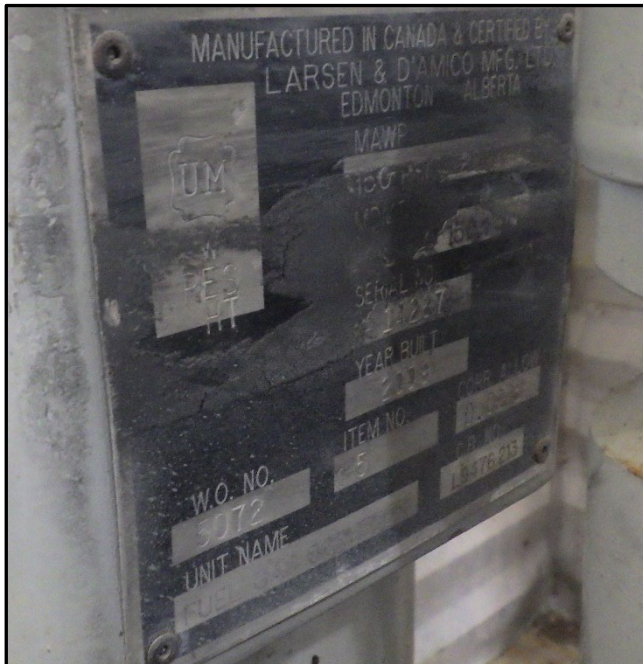
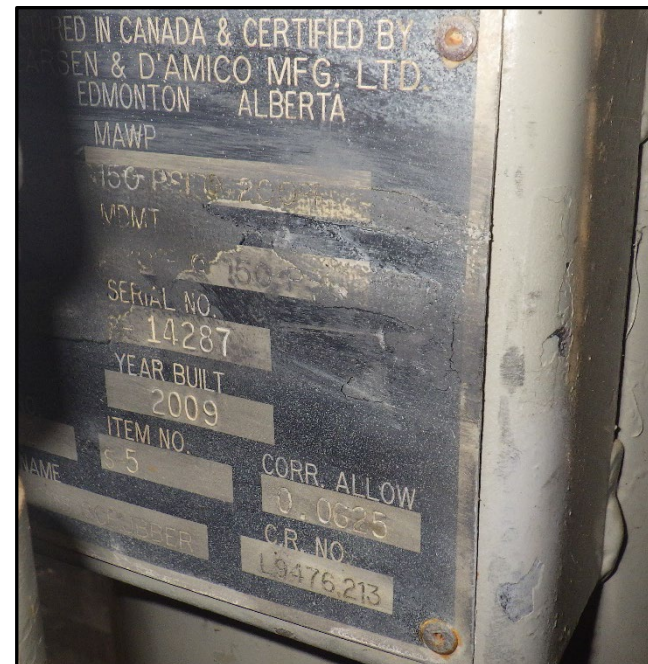
Nameplate

The nameplate is securely attached to the nameplate bracket and is legible. The ground cable is securely connected to the skid.

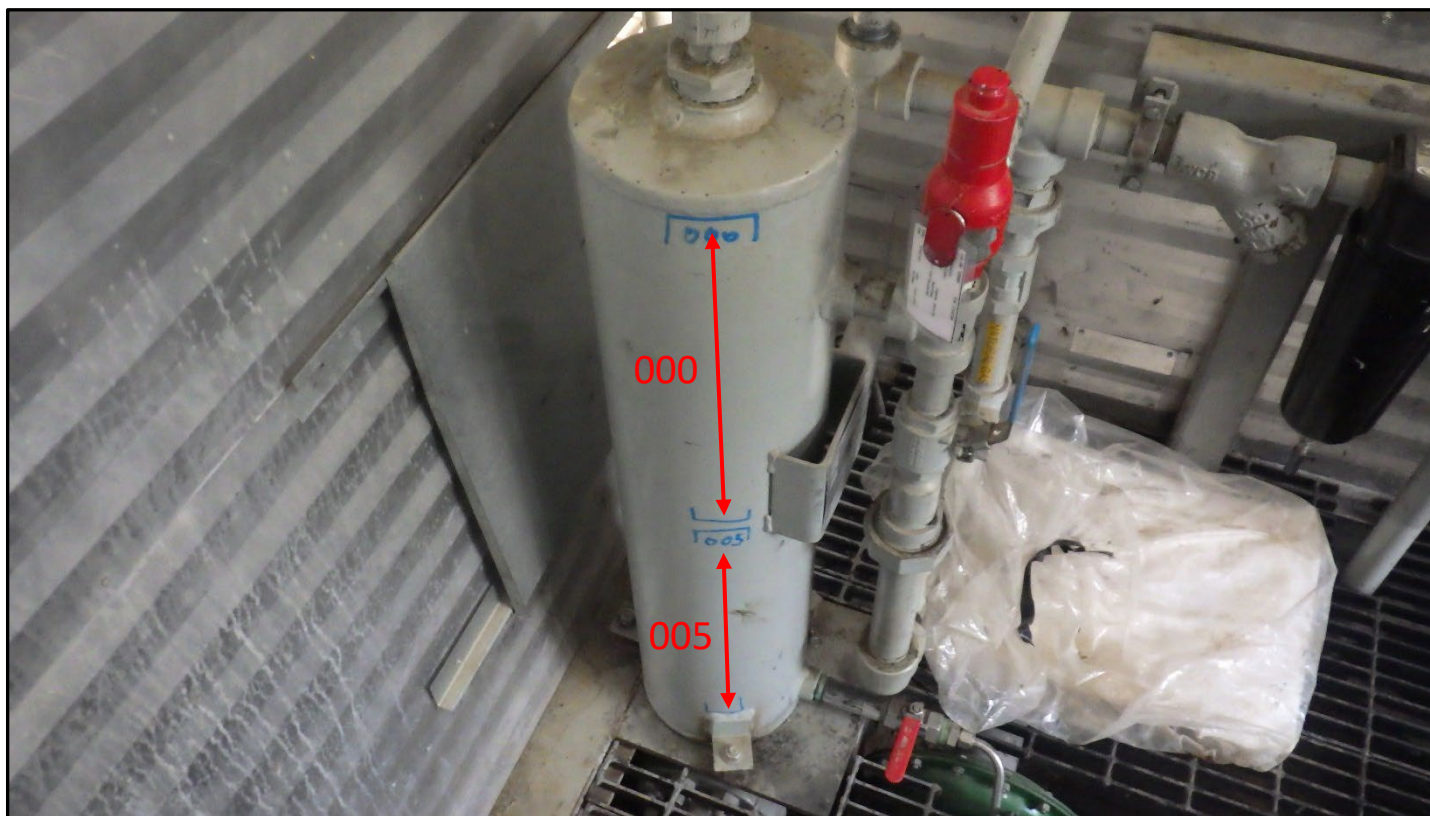
TML Locations

Band ID	Location	Direction	Material	Nominal (in)	CA (in)		Baseline (in)	Previous (in)	Current (in)	% Wall Loss	Tmin (in)	STCR (mpy)	LTCR (mpy)	Years Remaining	
000	Top Shell	T - B	Carbon Steel	0.250	0.063	Year:	2009		2023						Acceptable
						Min:	0.250		0.233	6.80%	0.187	0.00	1.21	20	
						Avg:			0.234						
Comments:															
005	Bottom Shell	T - B	Carbon Steel	0.250	0.063	Year:	2009		2023						Acceptable
						Min:	0.250		0.232	7.20%	0.187	0.00	1.29	20	
						Avg:			0.234						
Comments:															
						Year:									#DIV/0!
						Min:				#DIV/0!	0.000	#DIV/0!	#DIV/0!	#DIV/0!	
						Avg:									
Comments:															
						Year:									#DIV/0!
						Min:				#DIV/0!	0.000	#DIV/0!	#DIV/0!	#DIV/0!	
						Avg:									
Comments:															
						Year:									#DIV/0!
						Min:				#DIV/0!	0.000	#DIV/0!	#DIV/0!	#DIV/0!	
						Avg:									
Comments:															
						Year:									#DIV/0!
