# Existing Equipment Integrity Assessment Report

BPV-066727

Inspect Date: July 27, 2023	Client: Yoho Resources	District: Inga, BC	LSD: 10-19-087-23W6
Facility:	Client Ref #	IRM Ref #	P004
Equipment #: BPV-066727	Description: 1st Stage Liquids Boot	Jur# A0545047	CRN: P7515.213
MFR: EFX Compression	Mfr S/N: 05051-01	Mfr Date: 2005	Status: Operating

**WET VISIBLE BLACK ON WHITE MAGNETIC PARTICLE INSPECTION OF “D” CATEGORY WELDS  
ASSOCIATED WITH COMPRESSOR C-100, C-200 & C-300 BOTTLLES AT THE INGA LAKE 10-19-87-23  
W6 SITE**

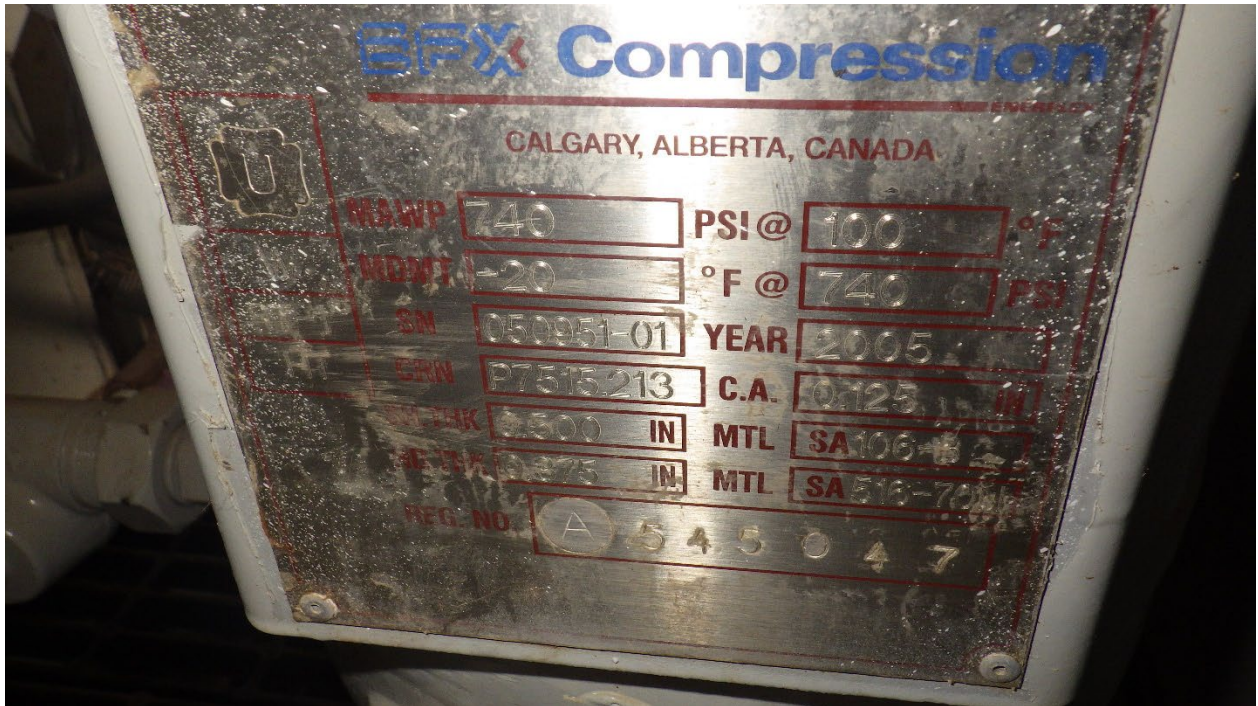
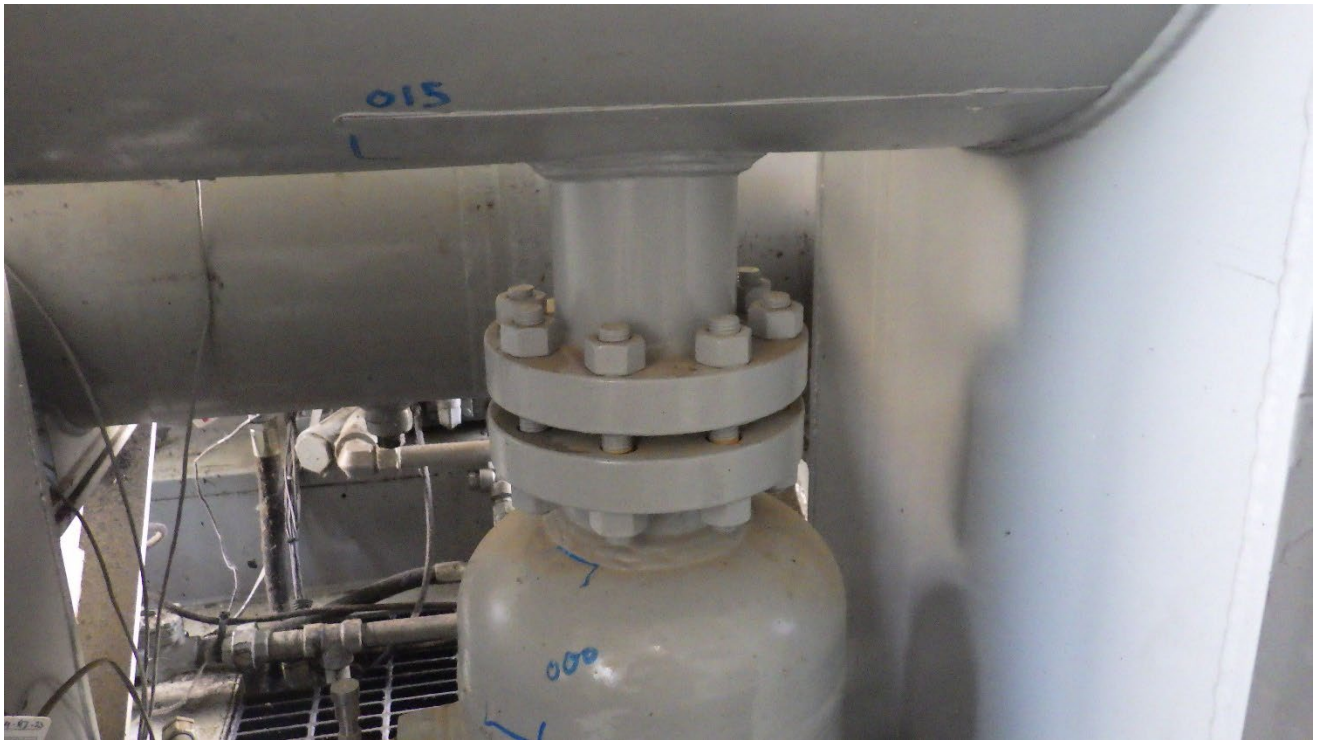
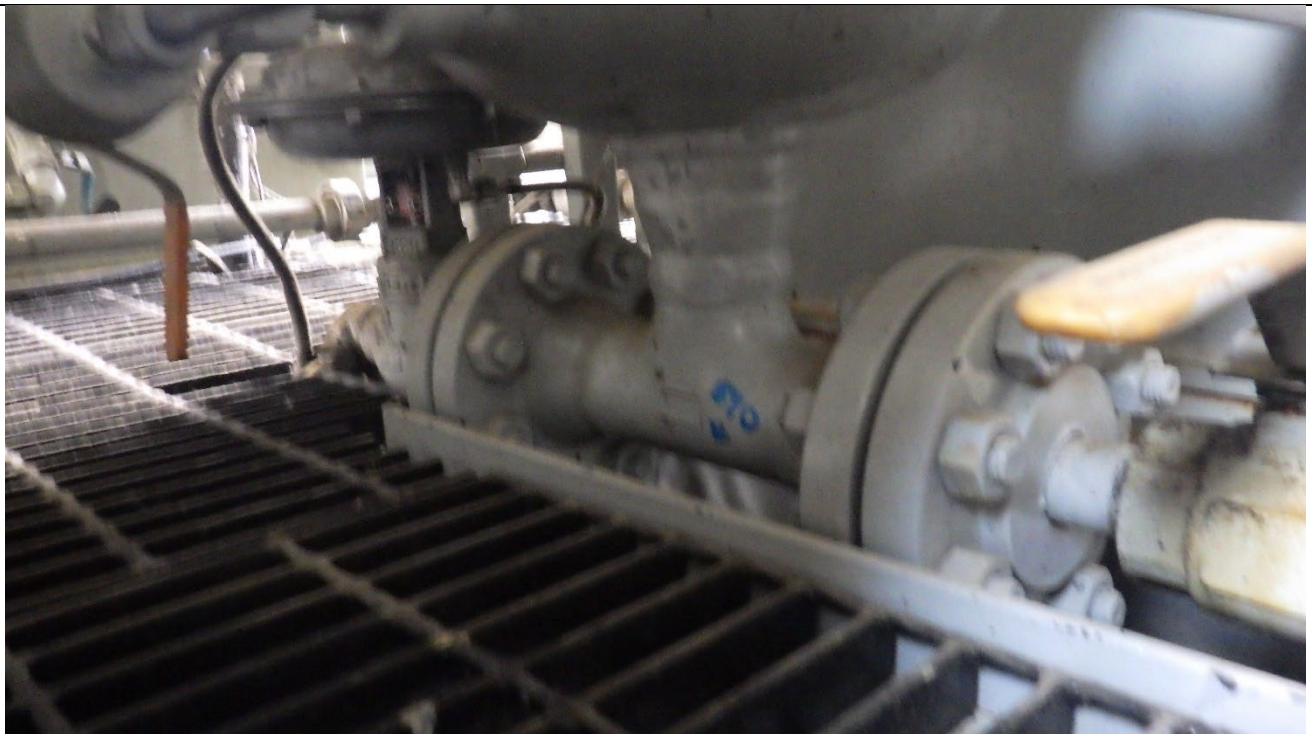
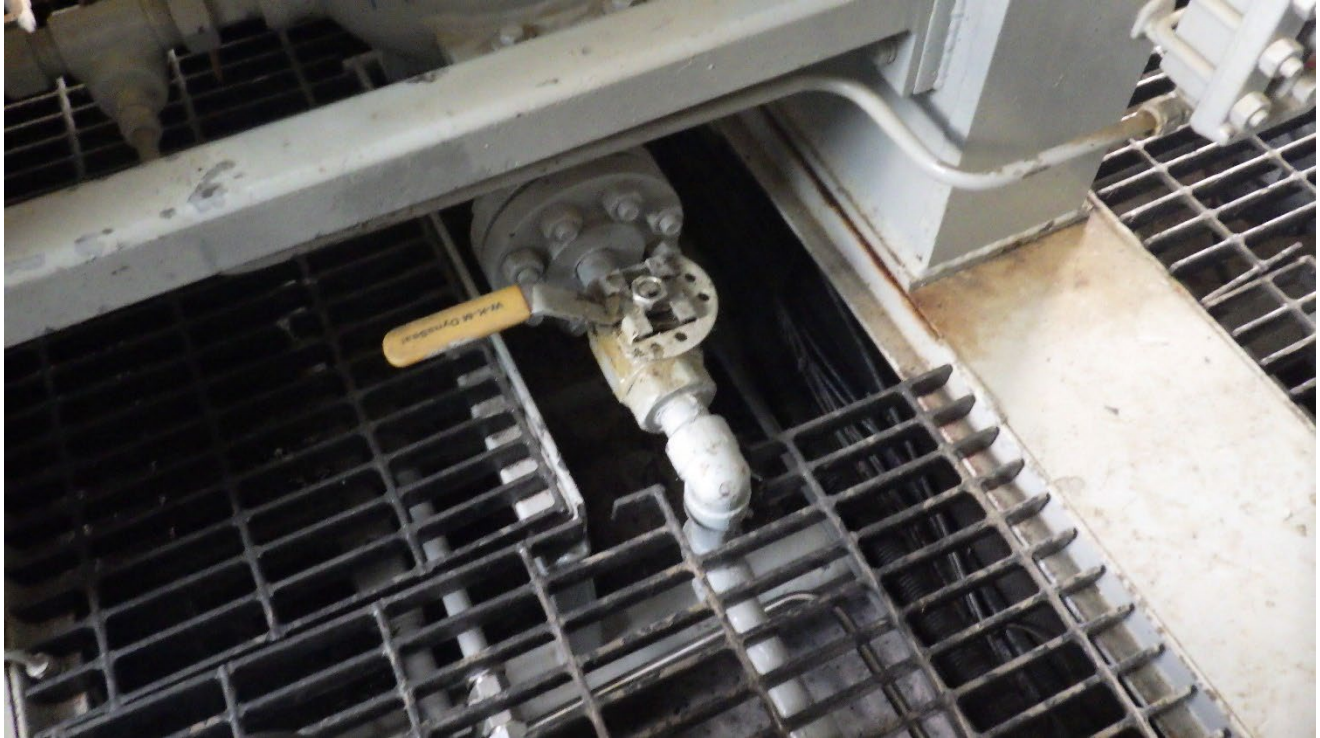
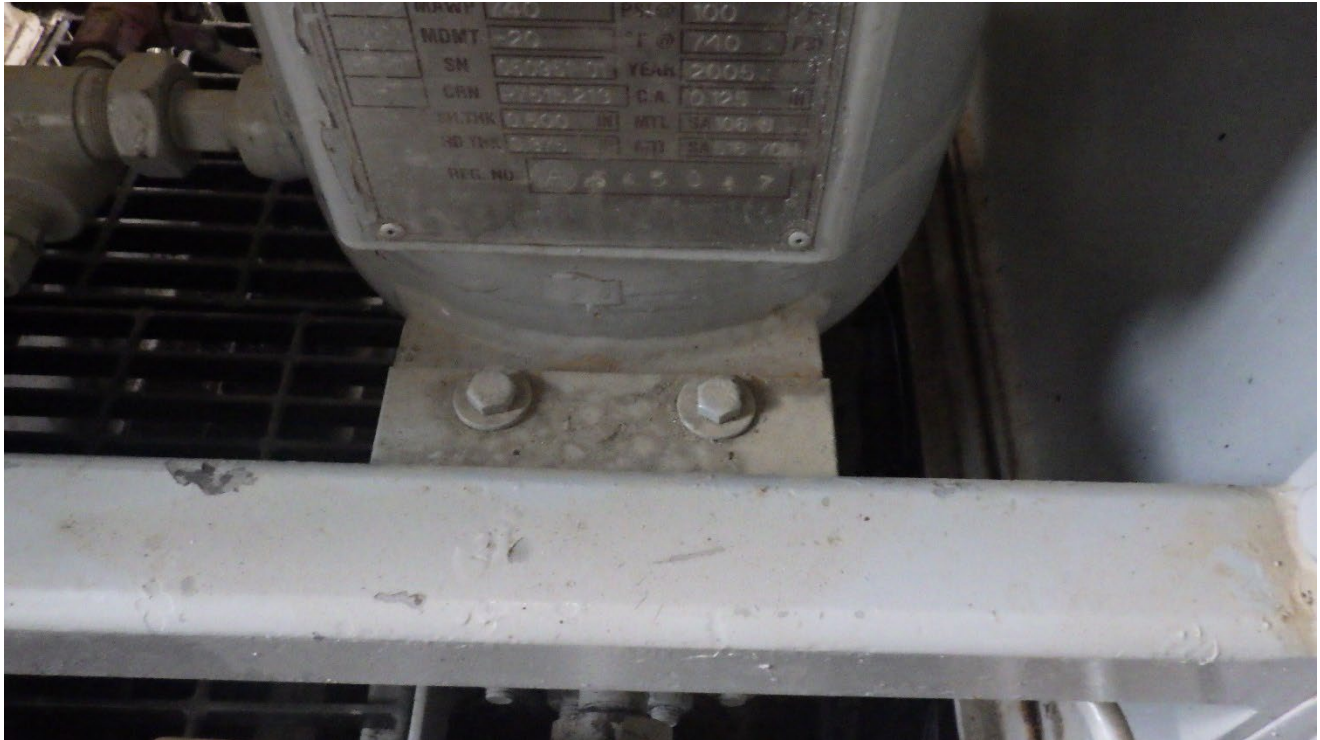
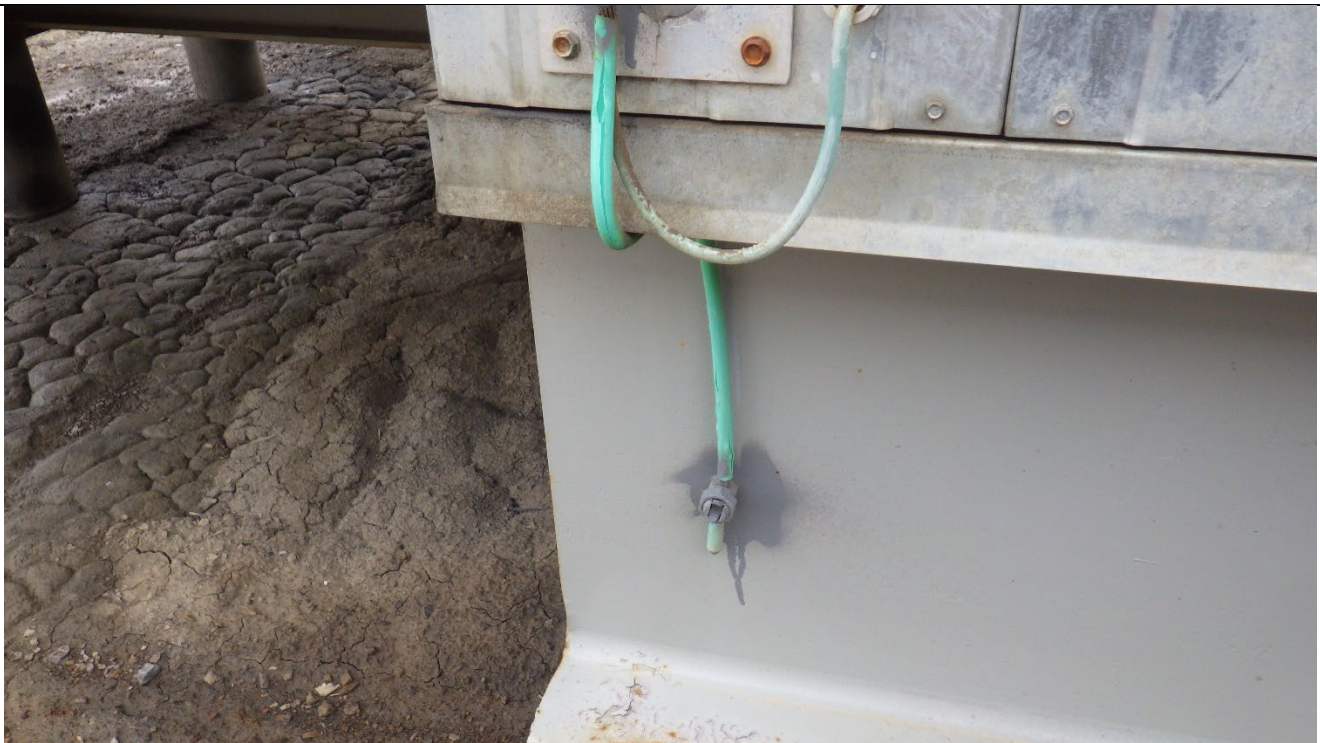
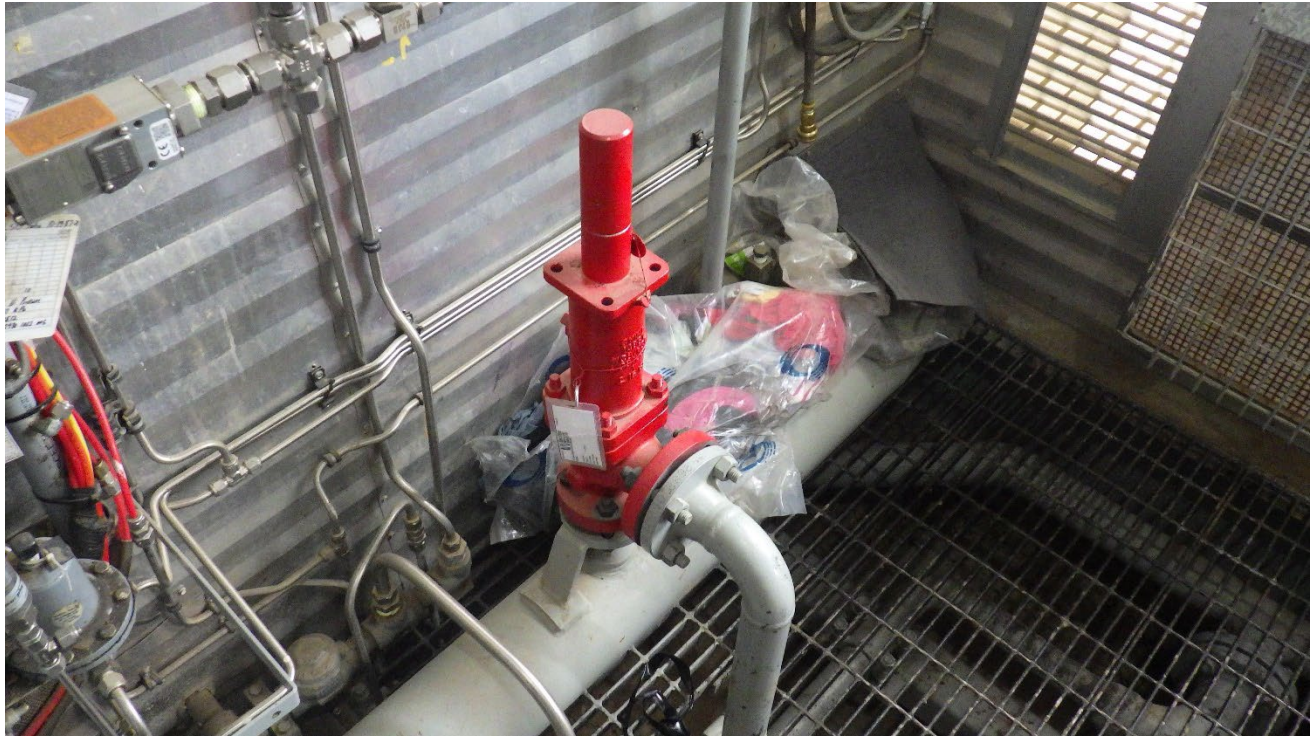
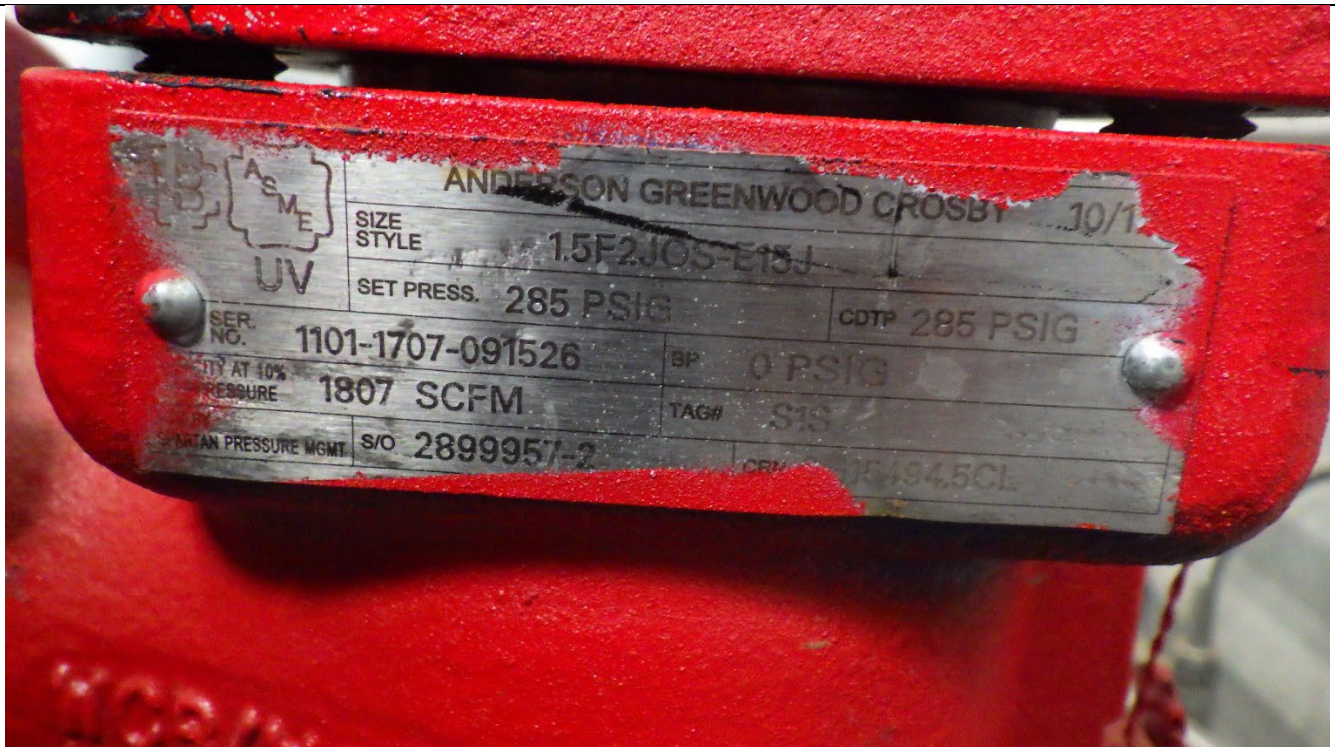
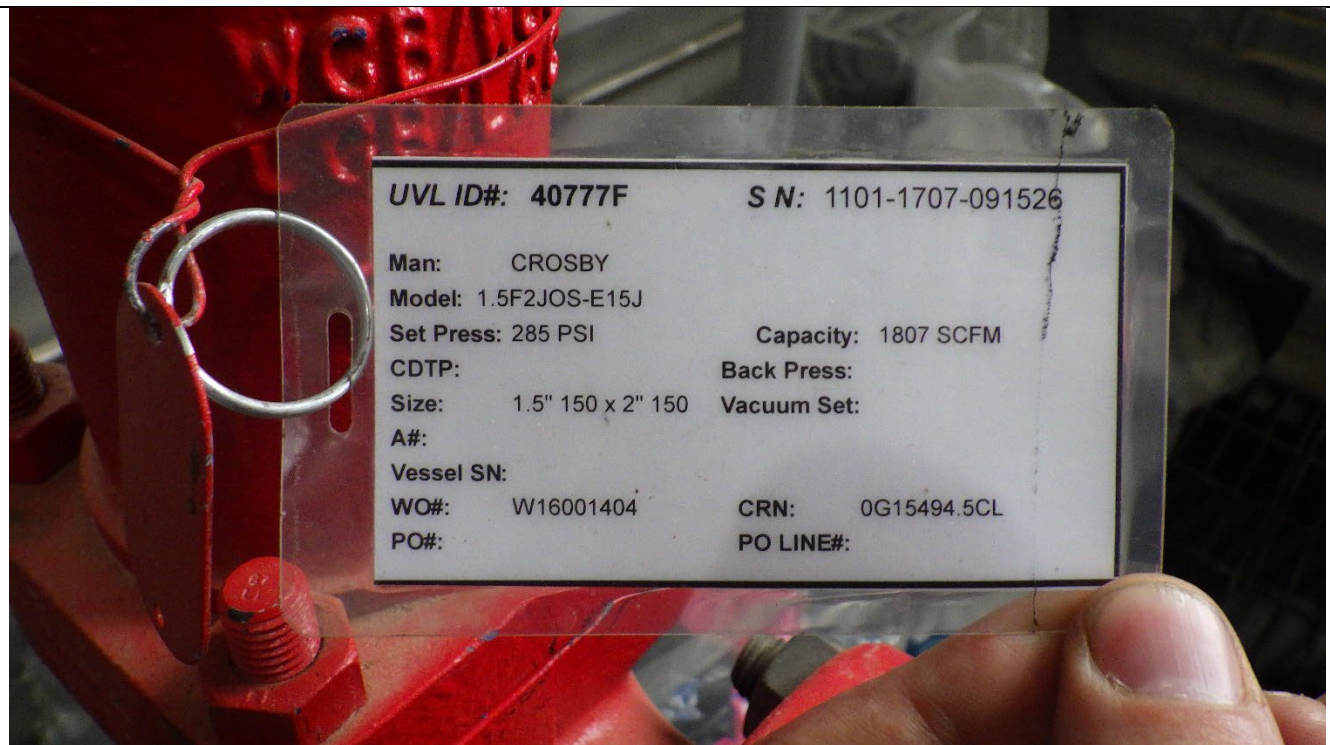
UT readings above Nom-C.A and MIL tolerance Tmin (12.5%),. No issues on concerns noted. 5 year / 60 month acceptable. VE reviewed; no major concerns noted. AJB.

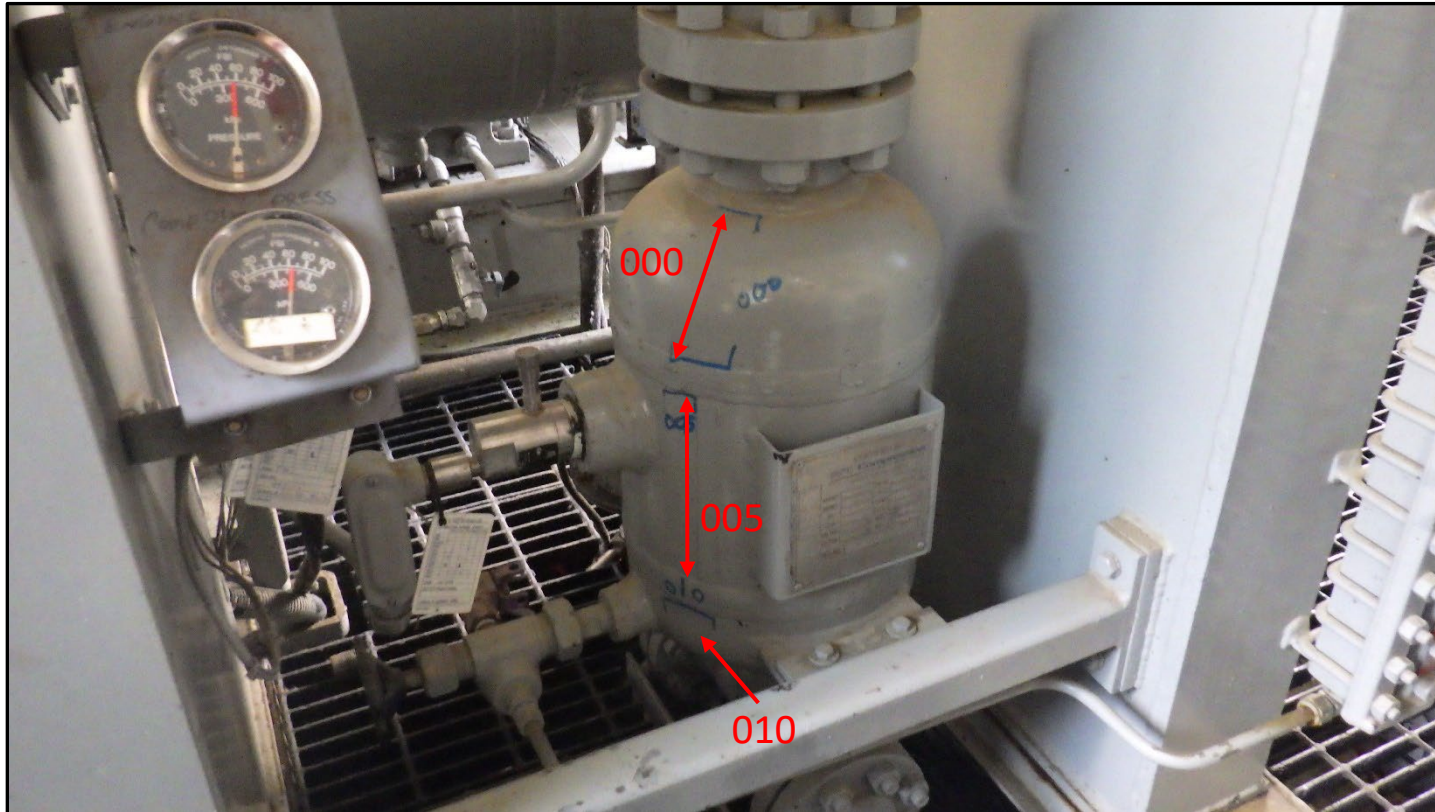
TML Locations

Band ID	Location	Direction	Material	Nominal (in)	CA (in)	Year:	Baseline (in)	Previous (in)	Current (in)	% Wall Loss	Tmin (in)	STCR (mpy)	LTCR (mpy)	Years Remaining	
000	Top Head	T - B	SA516 - 70N	0.375	0.125	2005	0.375		2023	0.00%	0.250	0.00	0.00	20	Acceptable
	Min: 0.375 Avg: 0.511														
Comments:															
005	Shell	T - B	SA106 - B	0.500	0.125	2005	0.500		2023	0.00%	0.375	0.00	0.00	20	Acceptable
	Min: 0.500 Avg: 0.508														
Comments:															
010	Btm Head	T - B	SA516 - 70N	0.375	0.125	2005	0.375		2023	0.00%	0.250	0.00	0.00	20	Acceptable
	Min: 0.375 Avg: 0.501														
Comments:															
						Year:				#DIV/0!	0.000	#DIV/0!	#DIV/0!	#DIV/0!	#DIV/0!
	Min: Avg:														
Comments:															
						Year:				#DIV/0!	0.000	#DIV/0!	#DIV/0!	#DIV/0!	#DIV/0!
	Min: Avg:														
Comments:															
						Year:				#DIV/0!	0.000	#DIV/0!	#DIV/0!	#DIV/0!	#DIV/0!
	Min: Avg:

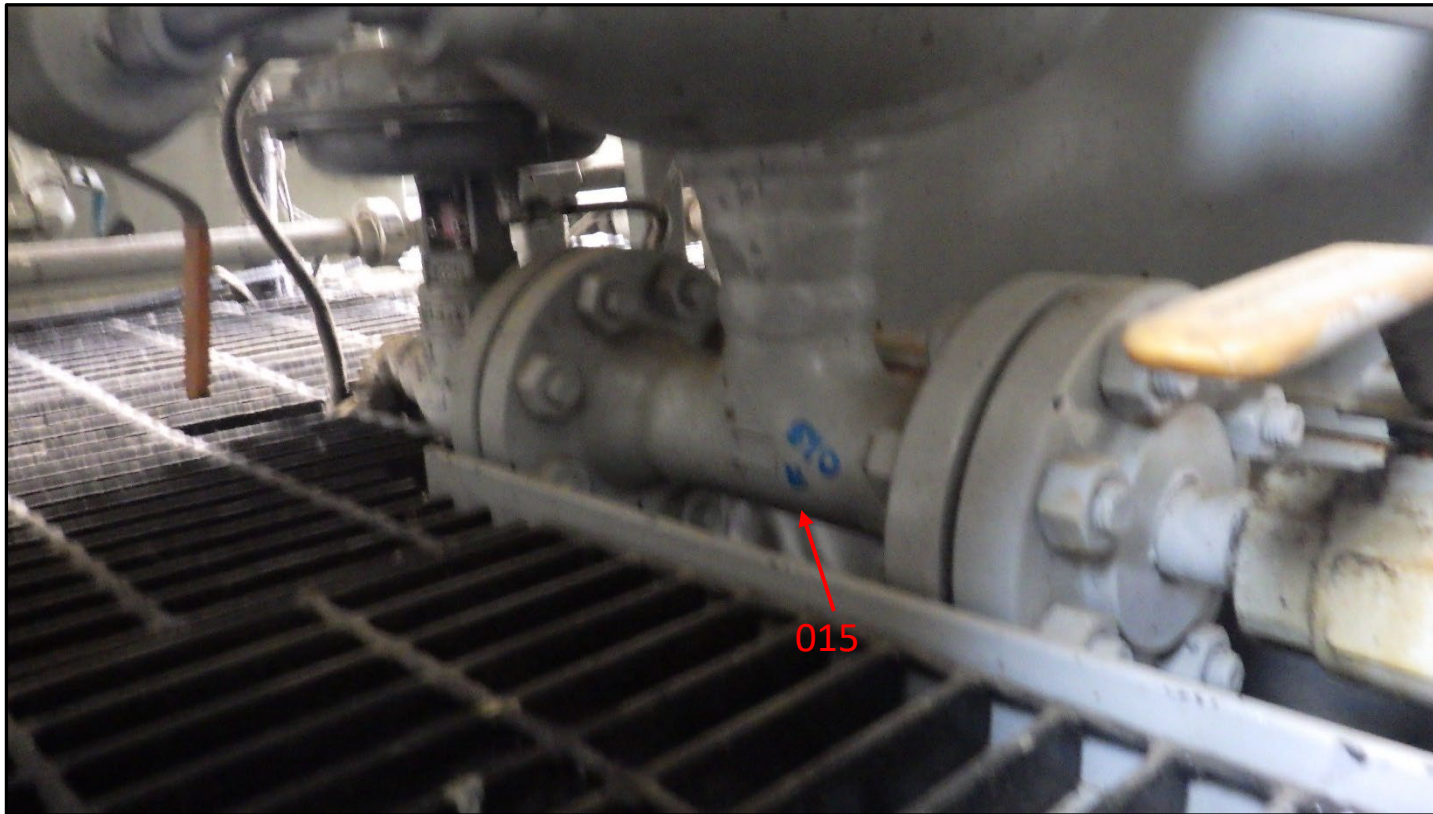
TML Locations

Band ID	Location	Direction	Material	Nominal (in)	CA (in)	Year:	Baseline (in)	Previous (in)	Current (in)	% Wall Loss	Tmin (in)	STCR (mpy)	LTCR (mpy)		
015	2" XXS Drain Tee	N - S	Carbon Steel	0.436	0.055	Year:	2005		2023	0.00%	0.382	0.00	0.00		
						Min:	0.436		0.607						
						Avg:			0.611						Acceptable
Comments: 12.5% used for C.A															
						Year:				#DIV/0!	0.000	#DIV/0!	#DIV/0!		
						Min:									#DIV/0!
						Avg:									
Comments:															
						Year:				#DIV/0!	0.000	#DIV/0!	#DIV/0!		
						Min:									#DIV/0!
						Avg:									
Comments:															
						Year:				#DIV/0!	0.000	#DIV/0!	#DIV/0!		
						Min:									#DIV/0!
						Avg:									
Comments:															
						Year:				#DIV/0!	0.000	#DIV/0!	#DIV/0!		
						Min:									#DIV/0!
						Avg:									
Comments:

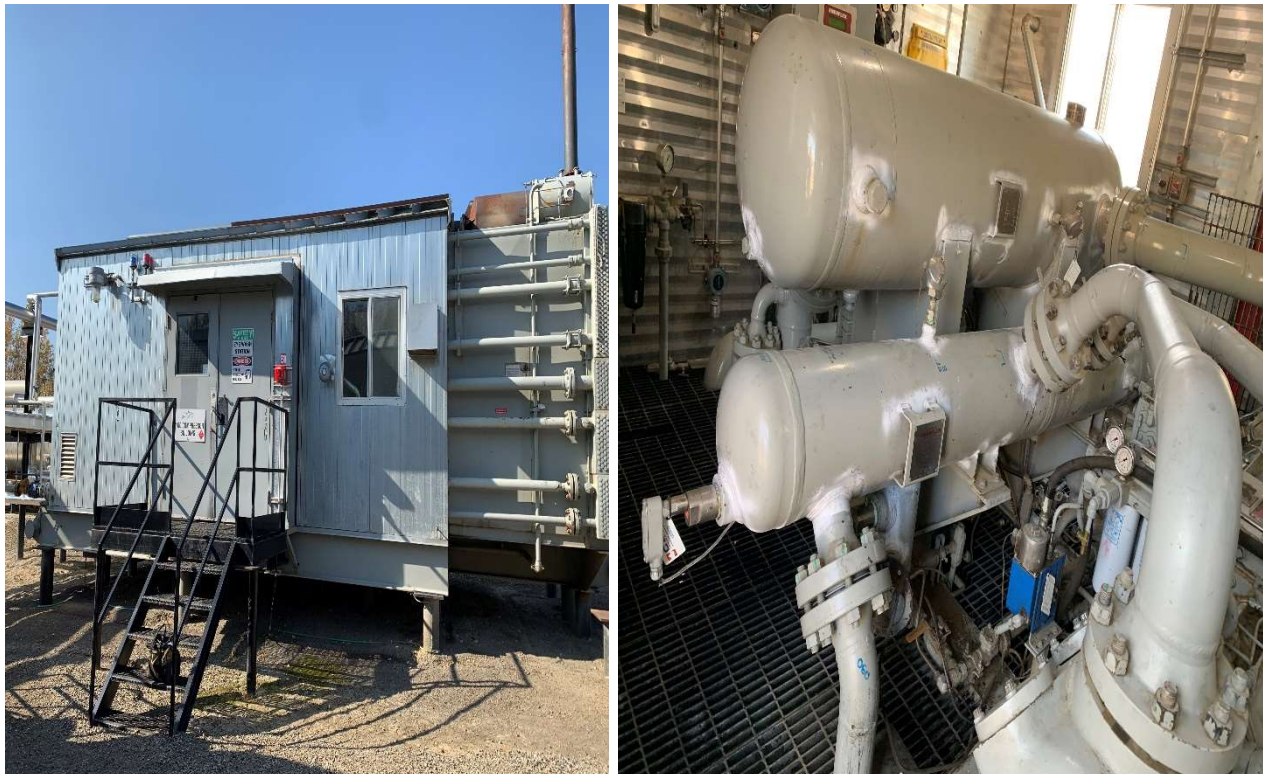
### **Compressor C-100:**

**Items Inspected:** D category welds associated with C-100, C-200 & C-300 compressor bottles and gusset welds associated with the pressure release device.

All the areas inspected did not exhibit any relevant indications of defects/discontinuities at the time of inspection.
