# Existing Equipment Integrity Assessment Report

Inspect Date: July 27, 2023	Client: Yoho Resources	District: Inga, BC	LSD: 10-19-087-23W6
Facility:	Client Ref #	IRM Ref #	P004
Equipment #: BPV-066729	Description: 1st Stage Aerial Cooler	Jur# A0552588	CRN: T4387.213
MFR: Air-X-Changers	Mfr S/N: 055572.3	Mfr Date: 2005	Status: Operating

# Vessel External Inspection

## Corrosion Survey Report

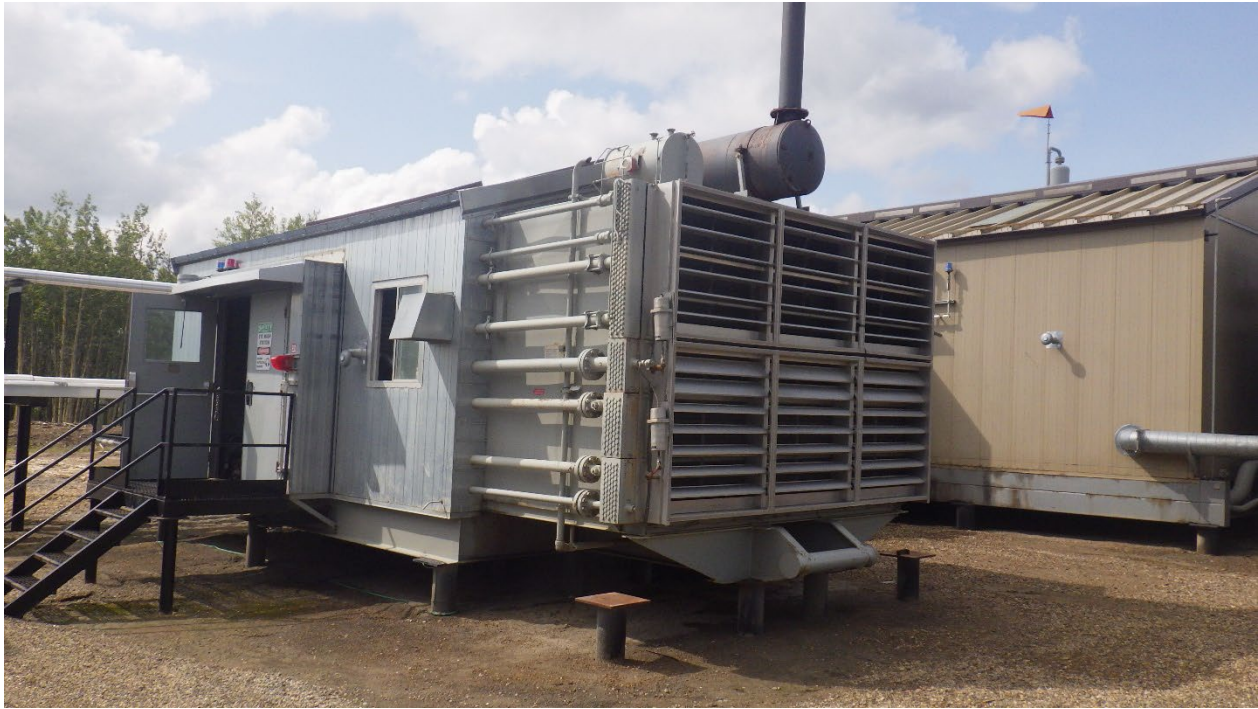
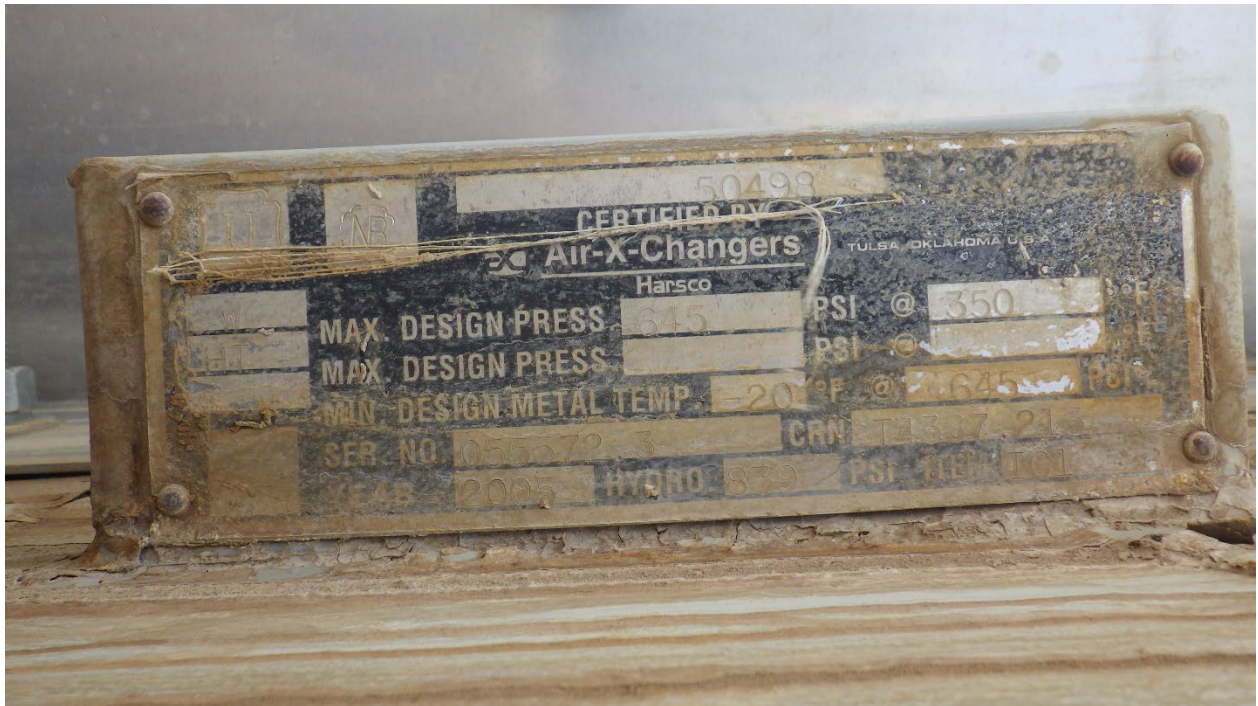
Report No.:

<b>Comments:</b> 1. The caulking around the piping to building interface has failed.				
<input checked="" type="checkbox"/> In Service <input type="checkbox"/> Idle <input type="checkbox"/> Blinded/Disconnected		Signature
