| <b>Inspection Report for:</b> HS-0024 Separator | <b>Date Last Inspected:</b> 09/27/2018 |

**FMC Technologies Completion HS-0024 Separator**

**FMC Technologies Completion HS-0024 Fuel Gas Scrubber**

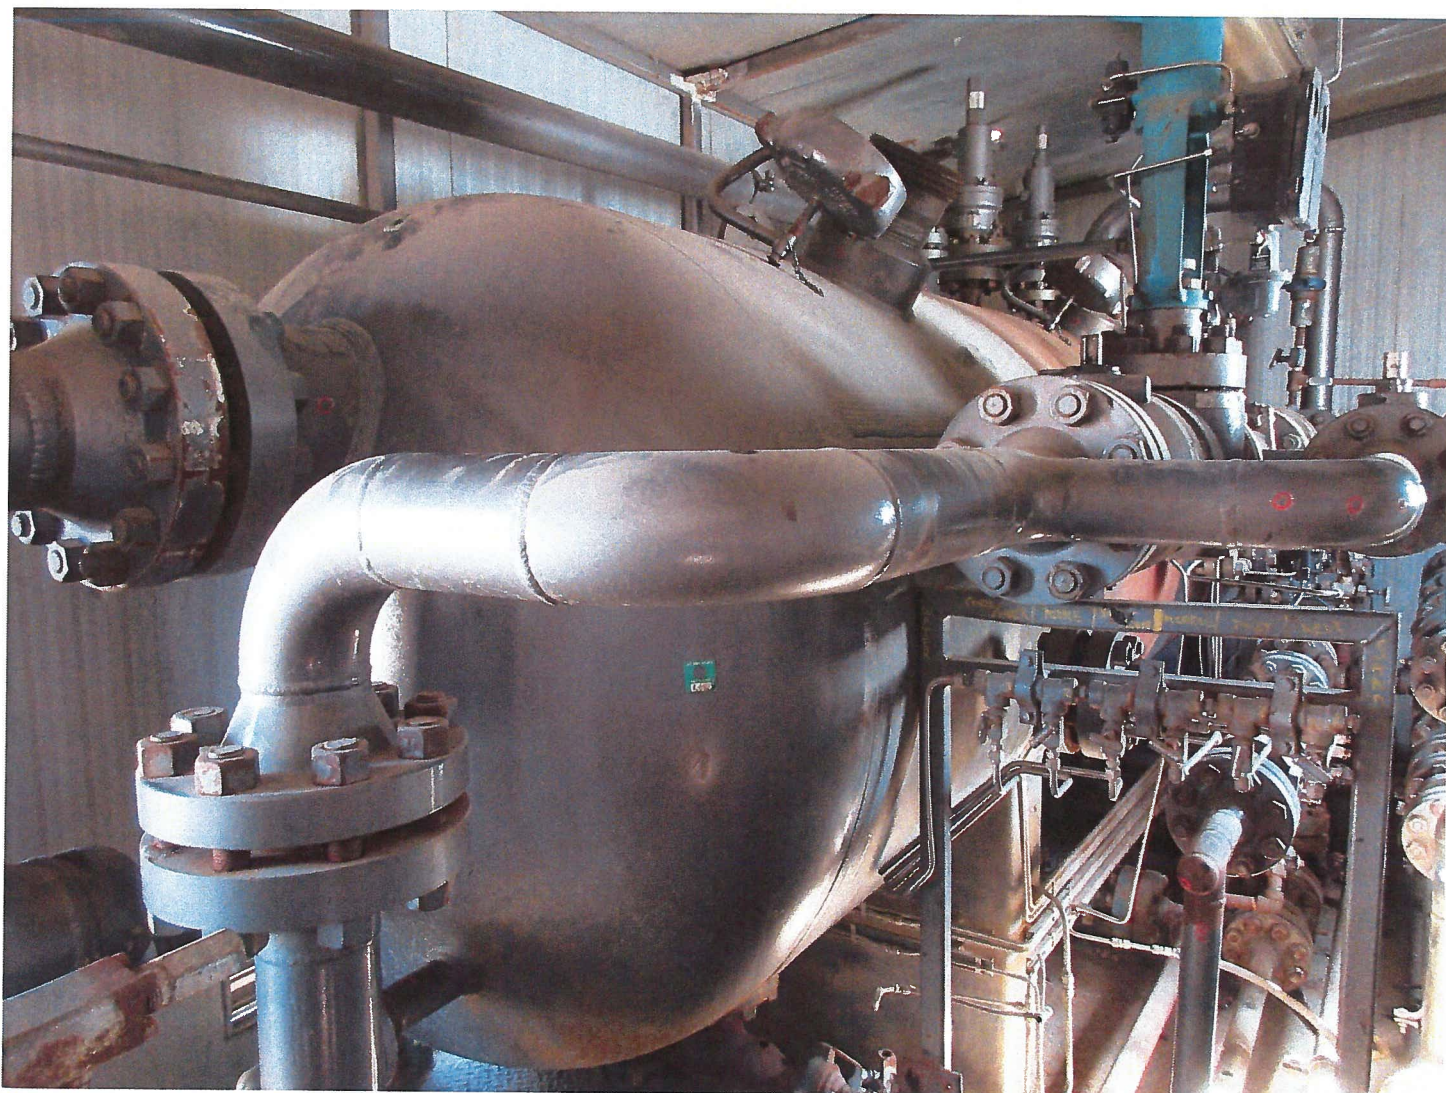
**Condition of Foundation and Anchor Bolts:** There are no anchor bolts. The (2) vertical support base plates are welded to the skid deck/frame. Base plate-to-frame attachment welds have no visual weld defects.

**Condition of Steel Supports, Saddles, and Bolting:** The (2) vertical supports have no corrosion or distortion. All support welds appear sound. The support saddle-to-shell attachment welds have no visual weld defects. Light to moderate chipping and peeling on the saddles. Light surface corrosion on support saddles.

**Condition of Paint and/or Insulation:** The paint is in poor condition. Approximately 50% of paint is missing. The vessel is not insulated.

**Condition of Nozzles, Flanges, Repads, and Weepholes:** Nozzle and flanges are in good condition. All flange bolting is in place and secure. Flange bolts appear secure (not in service). Coating on 50% of nozzles and flanges is missing. Flange bolts show light surface corrosion.

**Condition of Welds; Head and Shell Metal Surfaces:** The pressure boundary welds have no visual weld defects. Light surface corrosion is visible on approximately 50% of the vessel.

Sand blast and re-coat where coating is missing.

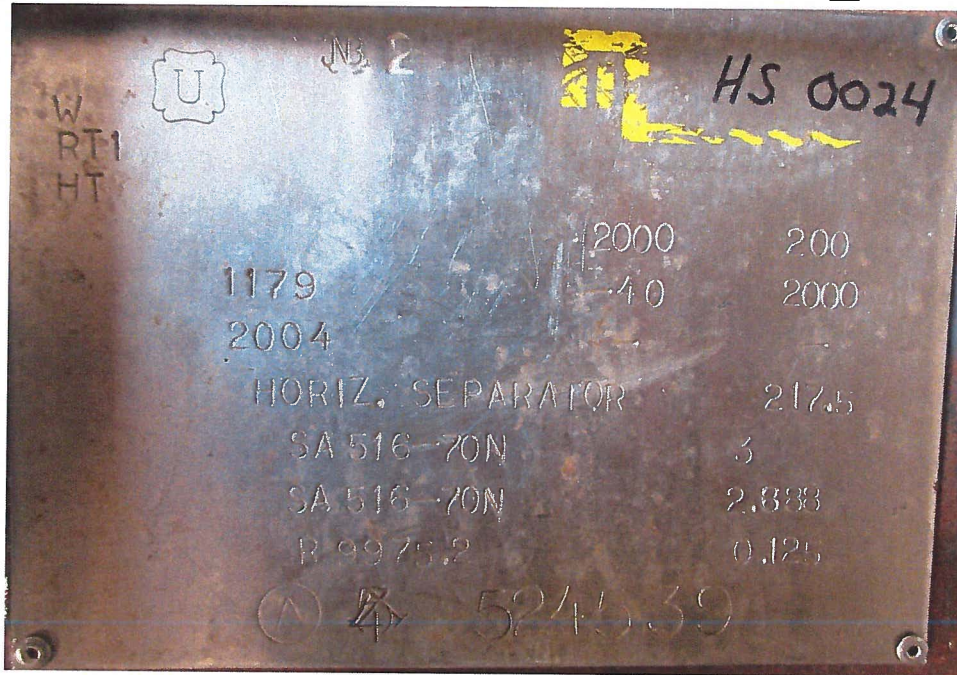
**Condition of Nameplate and/or Bracket:** Nameplate is intact. The nameplate bracket is securely attached. There are (2) nameplates. One is held with duct tape. The stamping is legible, but the wording is worn off.

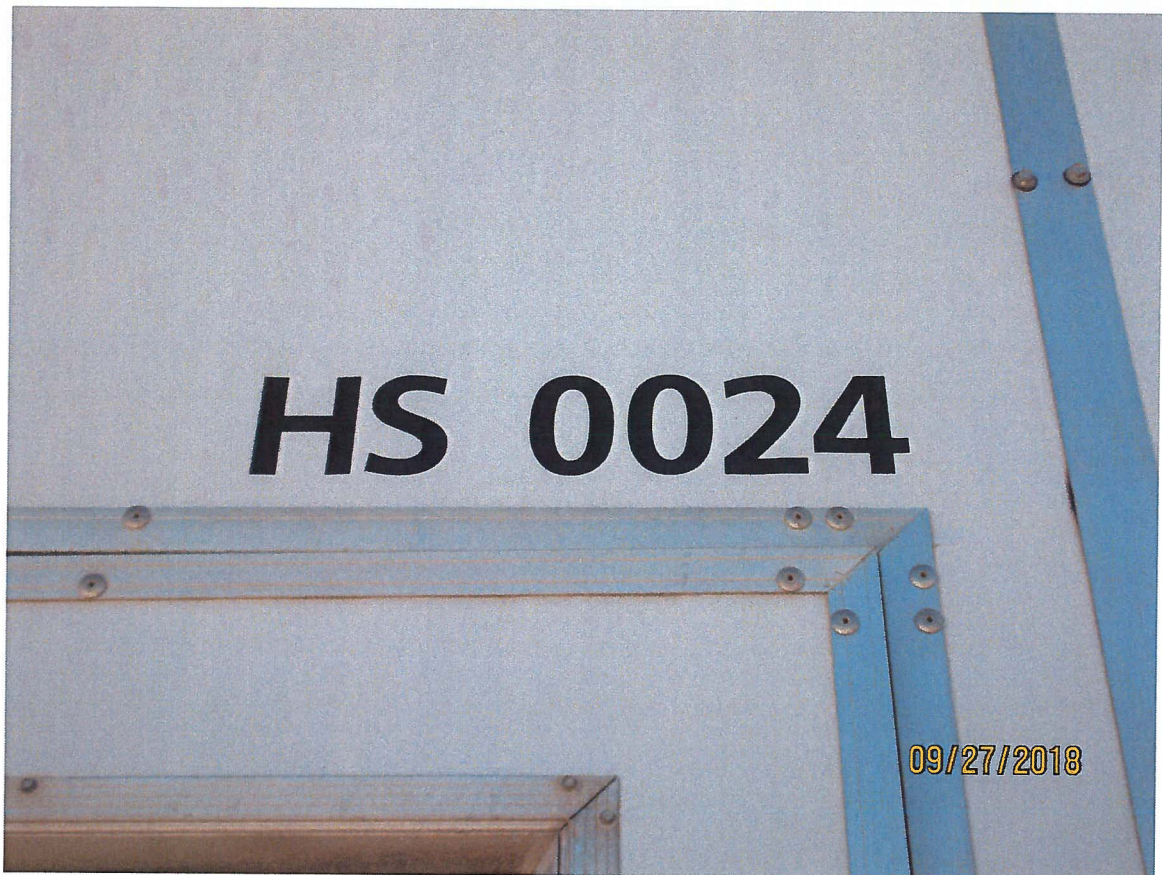
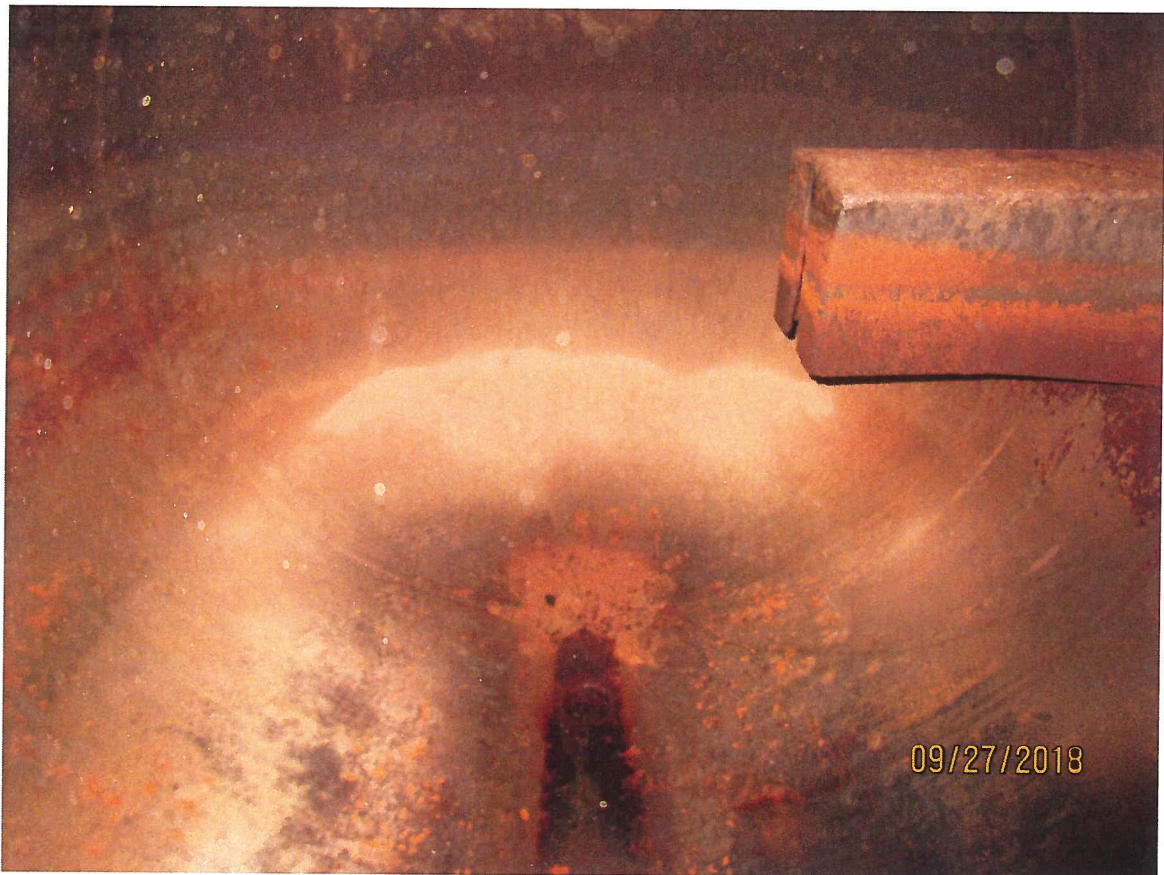
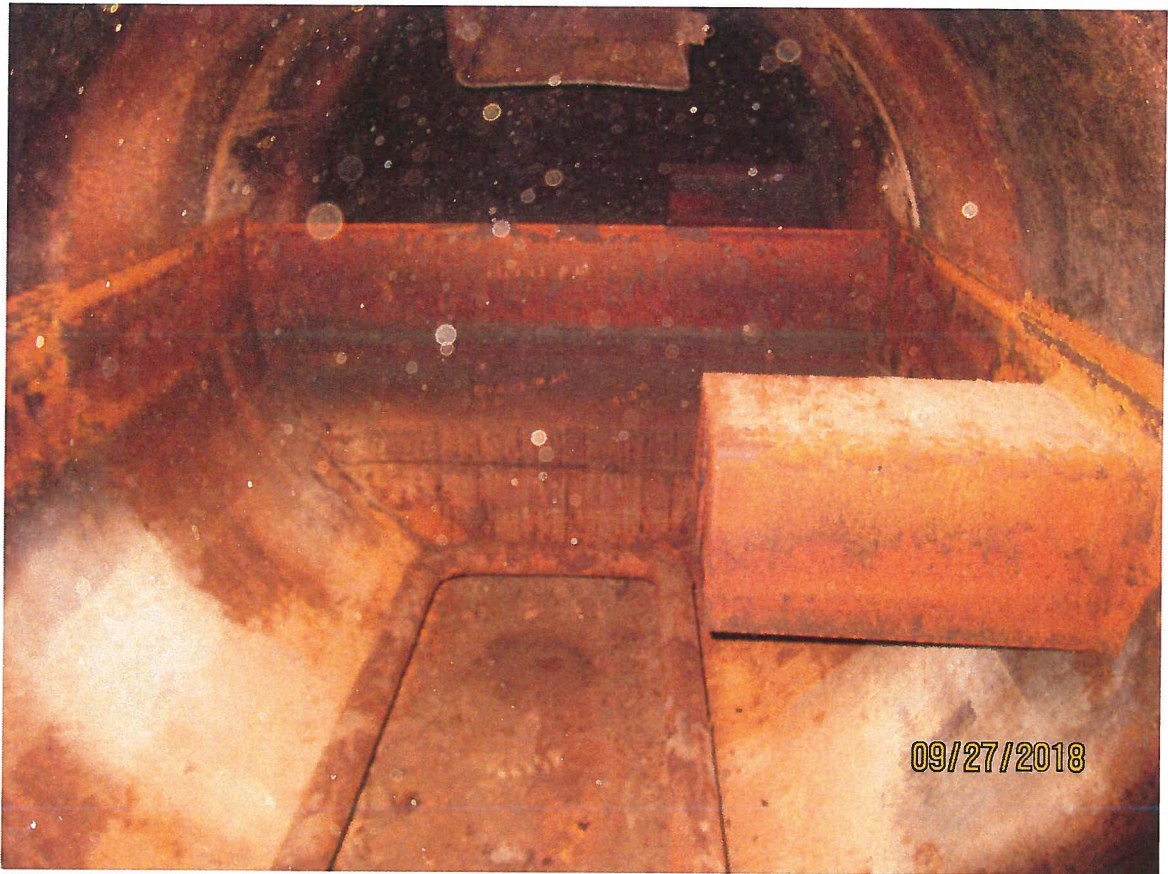
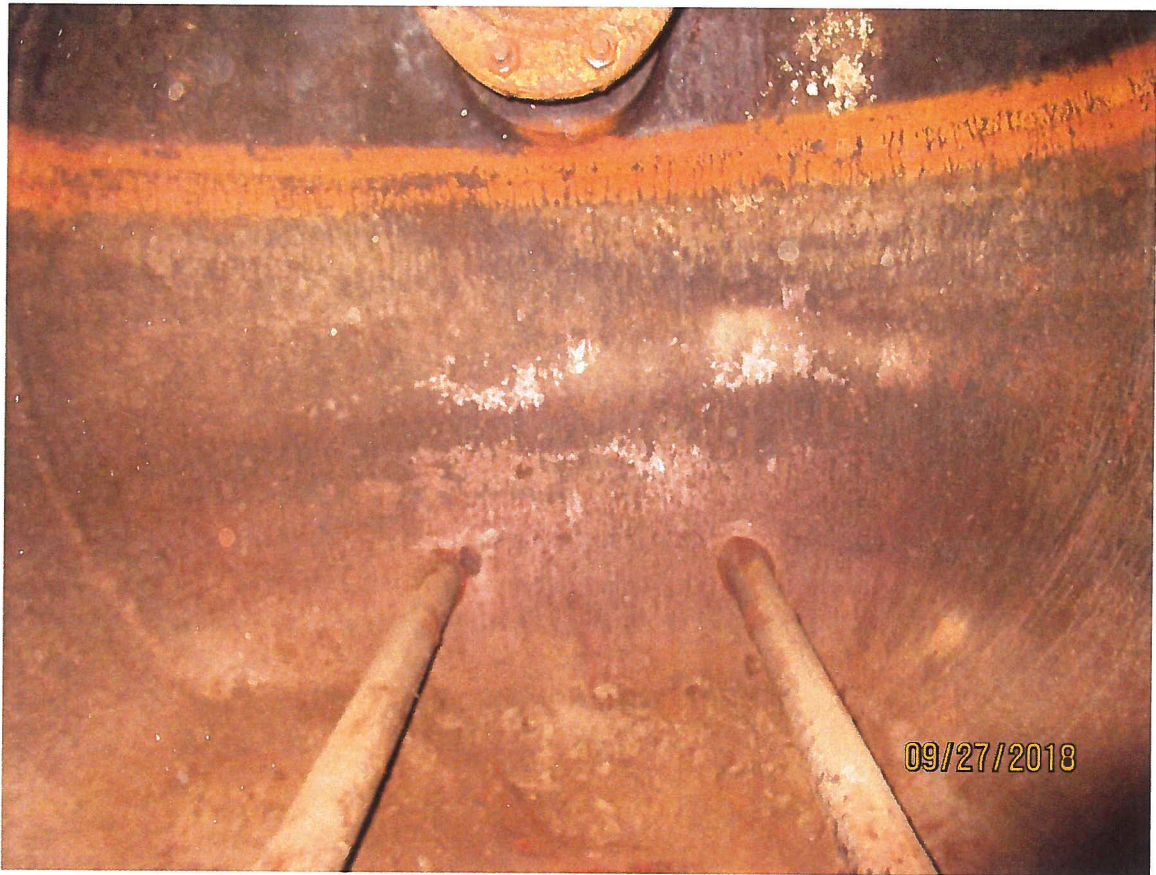
**Manway entrance and gasket seating area:** Chipped and peeling coating with light surface corrosion. Sealing surface appears acceptable.

**Shell** (note pitting, corrosion, laminations, blisters, etc. - size and location). Shell is in acceptable condition. Coating has chipping and flaking with light surface corrosion present. There is some scaling present as well. Very minor pitting on bottom of shell, nothing that is measurable.

**Heads** (note pitting, corrosion, laminations, blisters, etc. - size and location) Heads are in acceptable condition. Chipped and flaking coating with light surface corrosion and scaling present.

**Internal Circumferential and Long seam Welds:** (include type and condition welds). Long seams and circumferential welds are visually acceptable. Light rust present.

**Internal Nozzle Welds:** (include type and condition welds) Nozzle welds are visually acceptable. No signs of preferential corrosion or defects. Light rust present.

**Condition of Internal Attachments and Welds:** Attachments/weir plates are secure. Light rust and surface corrosion on the welds.

Moderate scaling and surface corrosion on diffuser and demister. Minor chipped coating with light surface corrosion on steam lines.

The internal vessel is in acceptable condition.

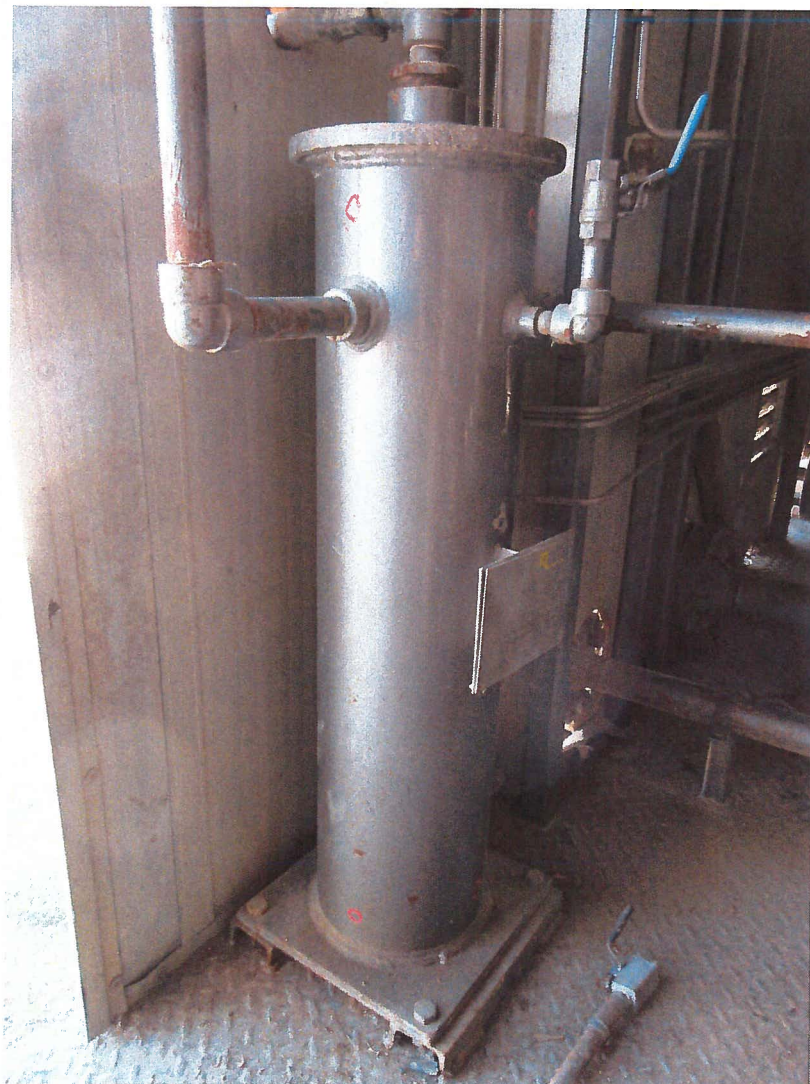
**Condition of Foundation and Anchor Bolts:** Anchor bolts are in place and secure. Baseplate-to-deck/frame attachment welds appear sound. Baseplate is bolted (4) to (2) channel iron which is welded to the skidplate. Baseplate and anchor bolts show light surface corrosion.

**Condition of Steel Supports, Saddles, and Bolting:** All support structural welds appear sound.

**Condition of Paint and/or Insulation:** The paint is in acceptable condition with minor chipping or peeling. The vessel is not insulated.

**Condition of Nozzles, Flanges, Repads, and Weepholes:** All threaded couplings. Threaded connections show light surface corrosion.

**Condition of Welds; Head and Shell Metal Surfaces:** All (exposed) metal surfaces are painted. There is no distortion or indication of corrosion under the paint coating. The pressure boundary welds have no visual weld defects.

Vessel appears to be in acceptable condition.
