| <b>Inspection Report for:</b> LH-0011-C1/C2 Line Heater | |

**FMC Technologies Completion LH-0011 Line Heater**

## Corrosion Monitoring Eq/Circ ID Analysis Report

**Fuel Gas Scrubber on LH-0011 Line Heater**

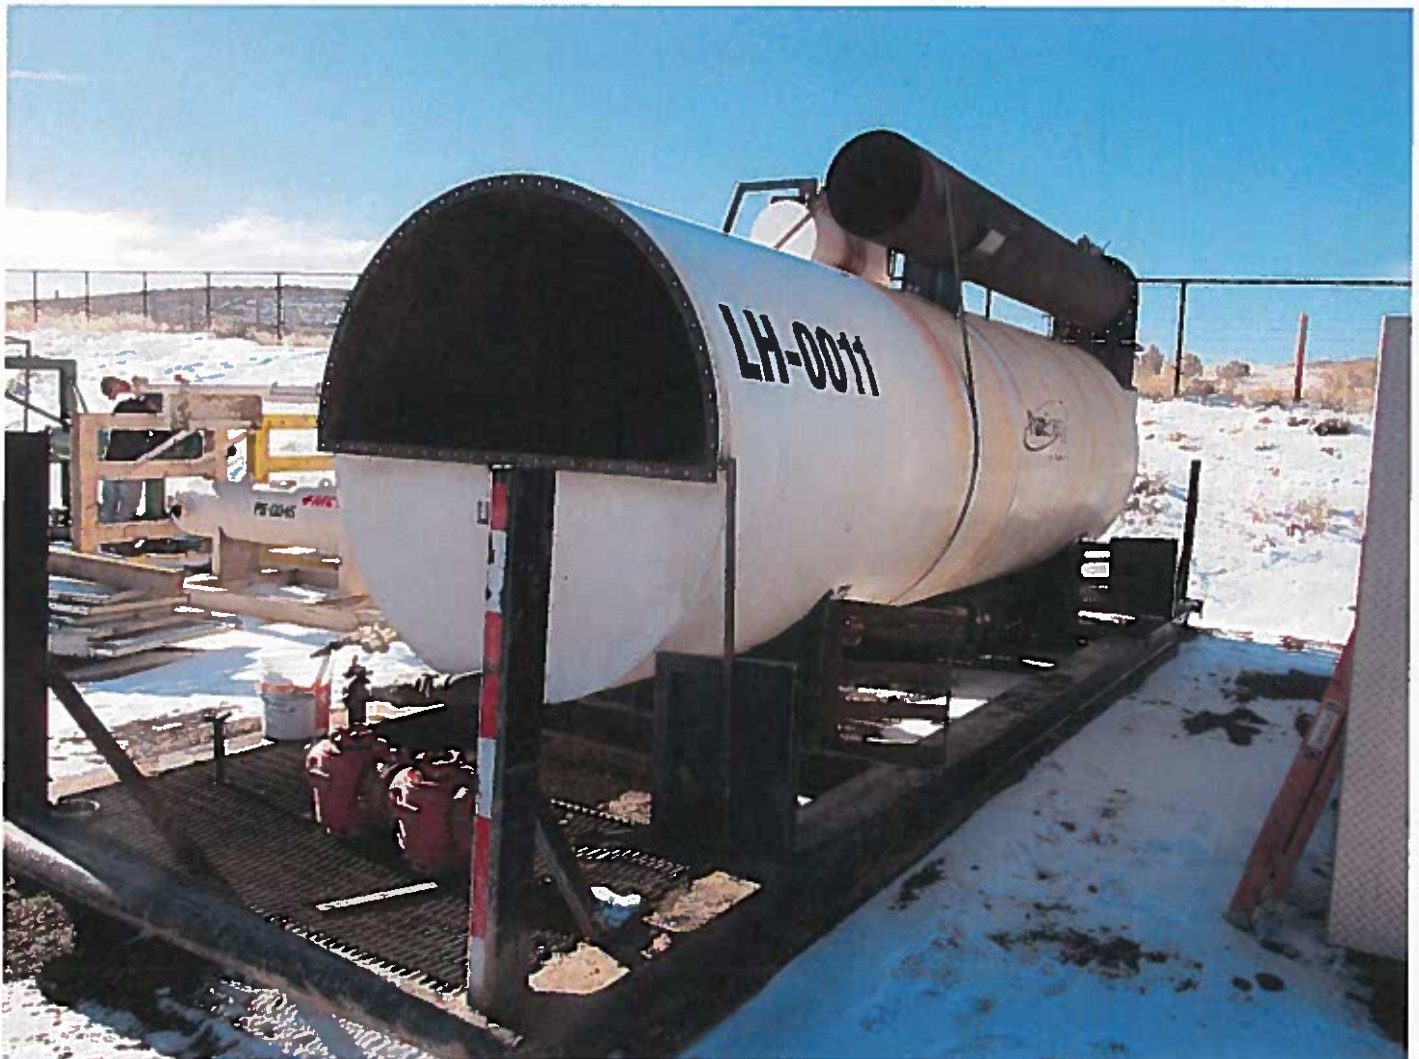
| Insulation Observations: | Comments: |
|---|---|
| <input type="checkbox"/> Serviceable<br><input checked="" type="checkbox"/> Not Insulated<br><input type="checkbox"/> Missing/Damaged<br><input type="checkbox"/> CUI Identification<br><input type="checkbox"/> Corrosion Present (Describe)<br><input type="checkbox"/> Other<br><input checked="" type="checkbox"/> No Issues | Coils are not insulated. |

| Coating Condition: | Comments: |
|---|---|
| <input type="checkbox"/> Good<br><input checked="" type="checkbox"/> Fair, Some Blistering/Peeling<br><input checked="" type="checkbox"/> Corrosion Present (Describe)<br><input checked="" type="checkbox"/> Other<br><input type="checkbox"/> No Issues | Coils have heavy surface corrosion present, but no pitting located. |

| Condition of Welds: | Comments: |
|---|---|
| <input checked="" type="checkbox"/> Welds Are Full, Smooth and Well Profiled<br><input type="checkbox"/> Incomplete Fusion/Penetration<br><input type="checkbox"/> Crack Located Near Weld Seam<br><input type="checkbox"/> Weld Does Not Appear to Be Original<br><input type="checkbox"/> Joints-Misaligned<br><input type="checkbox"/> Undercut<br><input checked="" type="checkbox"/> Other<br><input type="checkbox"/> No Issues | Heavy surface corrosion was present on some welds. |

| Supports/Hangers: | Comments: |
|---|---|
| <input checked="" type="checkbox"/> In Serviceable Condition<br><input type="checkbox"/> Foundation Is Damaged<br><input type="checkbox"/> Additional Support Needed<br><input type="checkbox"/> Hanger/Support Is Distorted/Broken/Missing<br><input type="checkbox"/> Pipe Slide Or Shoe Is Off Of The Support<br><input type="checkbox"/> Makeshift Support<br><input type="checkbox"/> Loose Support Needed To Be Tightened<br><input type="checkbox"/> Fireproofing Missing Or Damaged<br><input type="checkbox"/> Support/Hanger Is Corroded<br><input type="checkbox"/> Other<br><input checked="" type="checkbox"/> No Issues | There are (2) vertical supports. Welds are full with a good weld profile. |

| Flanged Connections: | Comments: |
|---|---|
| <input checked="" type="checkbox"/> Bolting Serviceable<br><input type="checkbox"/> Short, Missing Or Damaged Bolting<br><input type="checkbox"/> Nuts Lack Full Engagement<br><input checked="" type="checkbox"/> Flanges Serviceable<br><input type="checkbox"/> Flange Material Or Rating Inconsistent For System<br><input type="checkbox"/> Flanges Deformed Or Damaged<br><input checked="" type="checkbox"/> Corrosion Present (Describe)<br><input type="checkbox"/> Gaskets<br><input type="checkbox"/> Flange Rating Issues<br><input type="checkbox"/> Other<br><input checked="" type="checkbox"/> No Issues | Surface corrosion is present on bolting. |

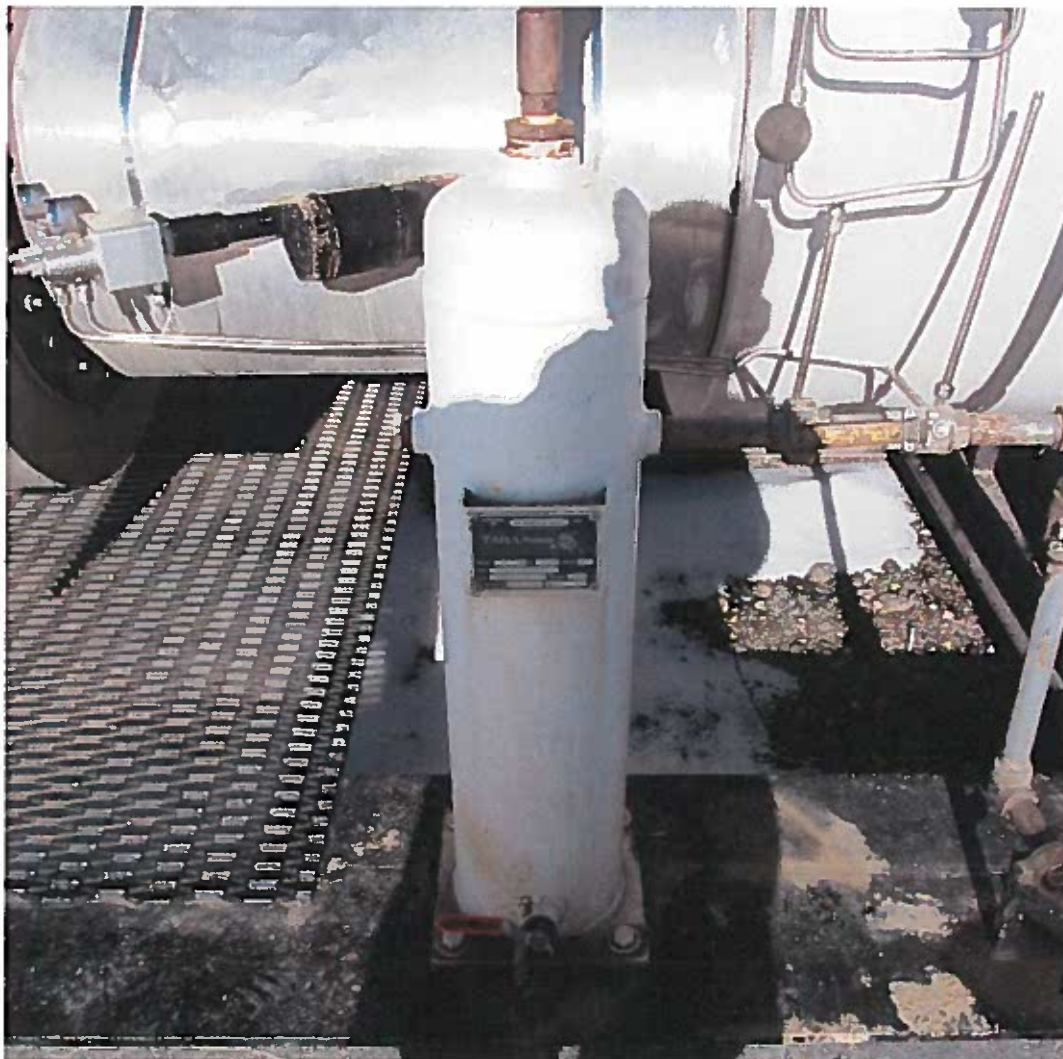
**Condition of Foundation and Anchor Bolts:** All (4) anchor bolts and nuts are in place and secure. The vessel has a flat bottom head which also serves as a baseplate. Baseplate has light surface corrosion present.

**Condition of Steel Supports, Saddles, and Bolting:** Shell to head attachment weld is smooth with a good weld profile.

**Condition of Paint and/or Insulation:** The paint is in good condition with no chipping or peeling. Vessel coating is in acceptable condition.

**Condition of Nozzles, Flanges, Repads, and Weepholes:** There is no evidence of flange leaks or leaks at any of the threaded connections. All threaded connections. Threaded coupling attachment welds are smooth with a good weld profile.

**Condition of Welds; Head and Shell Metal Surfaces:** All (exposed) metal surfaces are painted. There is no distortion or indication of corrosion beneath the paint coating. The pressure boundary welds have no visual weld defects.
