| <b>Inspections Performed for:</b> FMC Technologies Completion | |
| <b>Inspection Report for:</b> LH-0011-C1/C2 Line Heater | |

# LINE HEATER EXTERNAL INSPECTION REPORT

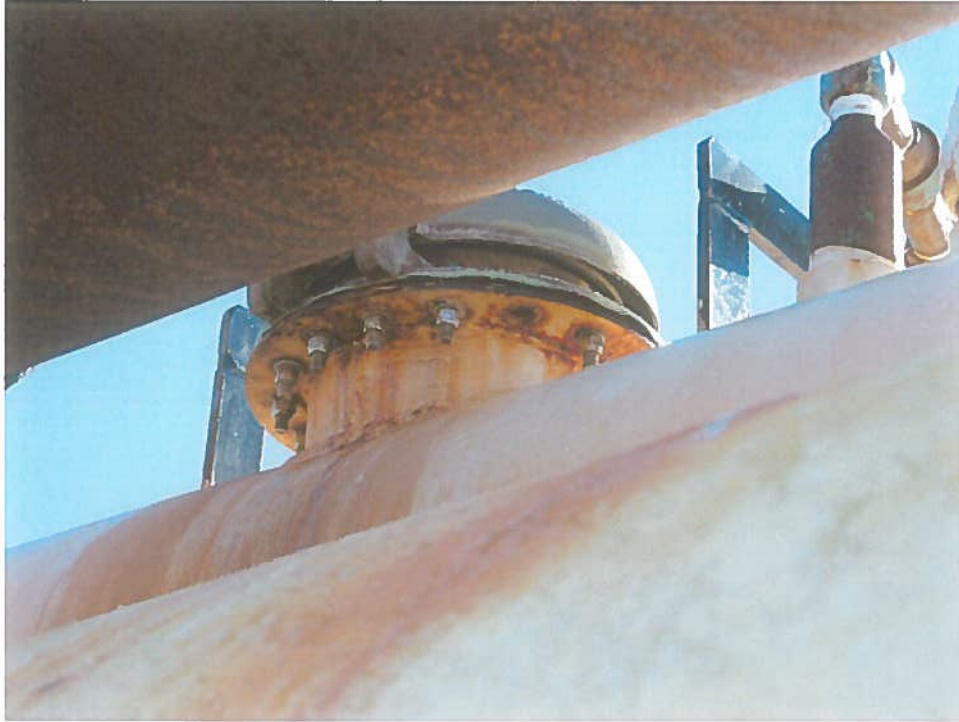
**Top Reservoir Tank:** Hatch is missing a bolt.

Top Reservoir hatch missing bolt and nuts.

- 1) Replace the wing nuts and the gasket on flame arrested burner.
- 2) Replace the missing bolt and nut on the top reservoir hatch.

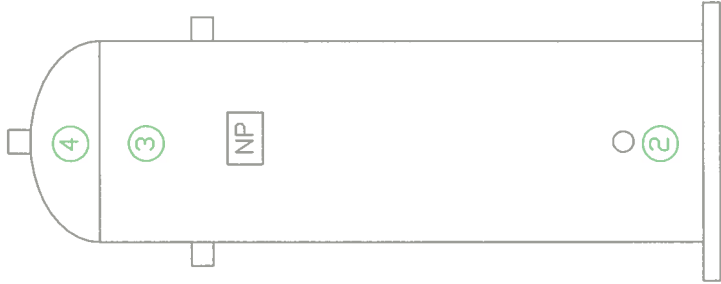
TC-560

- #2. 01- BTM SHELL-FRONT 0. 313 TC
- #2. 02- BTM SHELL-LEFT 0. 315 TC
- #2. 03- BTM SHELL-BACK 0. 310 TC
- #2. 04- BTM SHELL-RIGHT 0. 323 TC
- #3. 01- TOP SHELL-FRONT 0. 313 TC
- #3. 02- TOP SHELL-LEFT 0. 307 TC
- #3. 03- BTM SHELL-BACK 0. 313 TC
- #3. 04- TOP SHELL-RIGHT 0. 312 TC
- #4. 01- TOP HD-FRONT 0. 328 TC
- #4. 02- TOP HD-LEFT 0. 318 TC
- #4. 03- TOP HD-BACK 0. 323 TC
- #4. 04- TOP HD-RIGHT 0. 315 TC
