| <b>Inspections Performed for:</b> FMC Technologies Completion | |
| <b>Inspection Report for:</b> LH-0011-C1/C2 Line Heater | |
| <b>Remaining Life:</b> 3.4 YRS | <b>Date last Inspected:</b> 09/22/2014 |

**FMC Technologies Completion LH-0011 Line Heater**

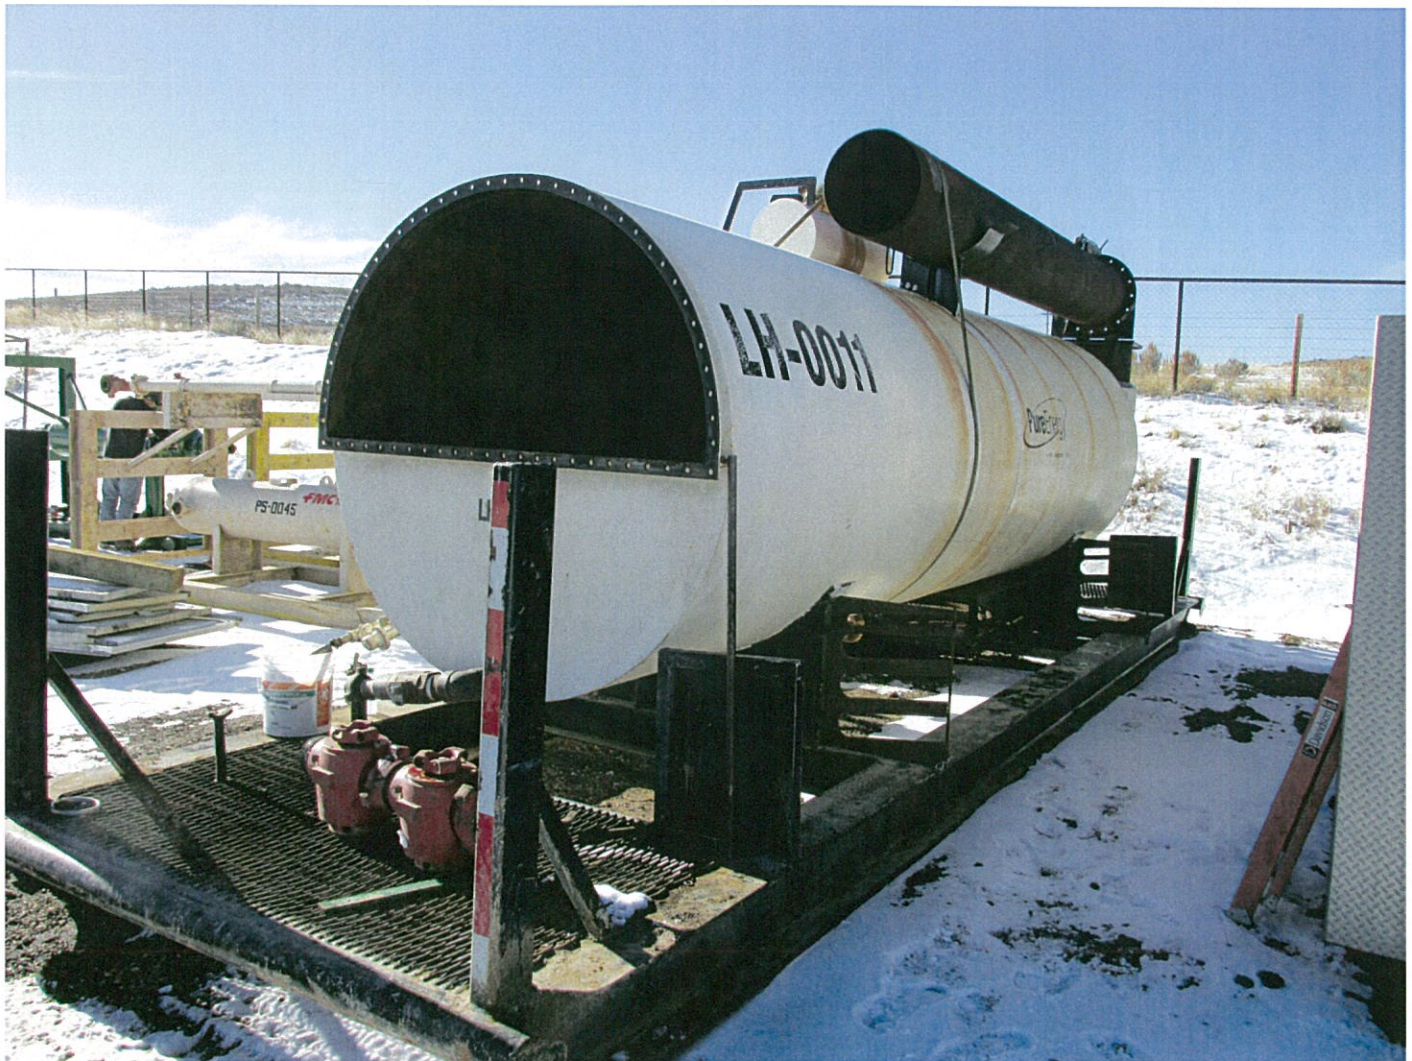
**Type of Vessel:** Horizontal Line Heater

**Vessel Size:** 3.5" O.D. Coils

| Coating Condition: | Comments: |
|---|---|
| <input type="checkbox"/> Good<br><input checked="" type="checkbox"/> Fair, Some Blistering/Peeling<br><input checked="" type="checkbox"/> Corrosion Present (Describe)<br><input checked="" type="checkbox"/> Other<br><input type="checkbox"/> No Issues | Coils have heavy surface corrosion present, but no pitting located. |

| Condition of Welds: | Comments: |
|---|---|
| <input checked="" type="checkbox"/> Welds Are Full, Smooth and Well Profiled<br><input type="checkbox"/> Incomplete Fusion/Penetration<br><input type="checkbox"/> Crack Located Near Weld Seam<br><input type="checkbox"/> Weld Does Not Appear to Be Original<br><input type="checkbox"/> Joints-Misaligned<br><input type="checkbox"/> Undercut<br><input checked="" type="checkbox"/> Other<br><input type="checkbox"/> No Issues | Heavy surface corrosion was present on some welds. |

| Supports/Hangers: | Comments: |
|---|---|
| <input checked="" type="checkbox"/> In Serviceable Condition<br><input type="checkbox"/> Foundation Is Damaged<br><input type="checkbox"/> Additional Support Needed<br><input type="checkbox"/> Hanger/Support Is Distorted/Broken/Missing<br><input type="checkbox"/> Pipe Slide Or Shoe Is Off Of The Support<br><input type="checkbox"/> Makeshift Support<br><input type="checkbox"/> Loose Support Needed To Be Tightened<br><input type="checkbox"/> Fireproofing Missing Or Damaged<br><input type="checkbox"/> Support/Hanger Is Corroded<br><input type="checkbox"/> Other<br><input checked="" type="checkbox"/> No Issues | There are (2) vertical supports. Welds are full with a good weld profile. |

| Flanged Connections: | Comments: |
|---|---|
| <input checked="" type="checkbox"/> Bolting Serviceable<br><input type="checkbox"/> Short, Missing Or Damaged Bolting<br><input type="checkbox"/> Nuts Lack Full Engagement<br><input checked="" type="checkbox"/> Flanges Serviceable<br><input type="checkbox"/> Flange Material Or Rating Inconsistent For System<br><input type="checkbox"/> Flanges Deformed Or Damaged<br><input checked="" type="checkbox"/> Corrosion Present (Describe)<br><input type="checkbox"/> Gaskets<br><input type="checkbox"/> Flange Rating Issues<br><input type="checkbox"/> Other<br><input checked="" type="checkbox"/> No Issues | Surface corrosion is present on bolting. |
