**HAWKEYE INSPECTION, LLC**  
*Consulting and Services - Evanston, Wyoming*

**Inspection Report for:** LH-0011 Line Heater

## API 510 PRESSURE VESSEL EXTERNAL INSPECTION REPORT

**Reason for Inspection:** Initial API-510 on Stream Inspection

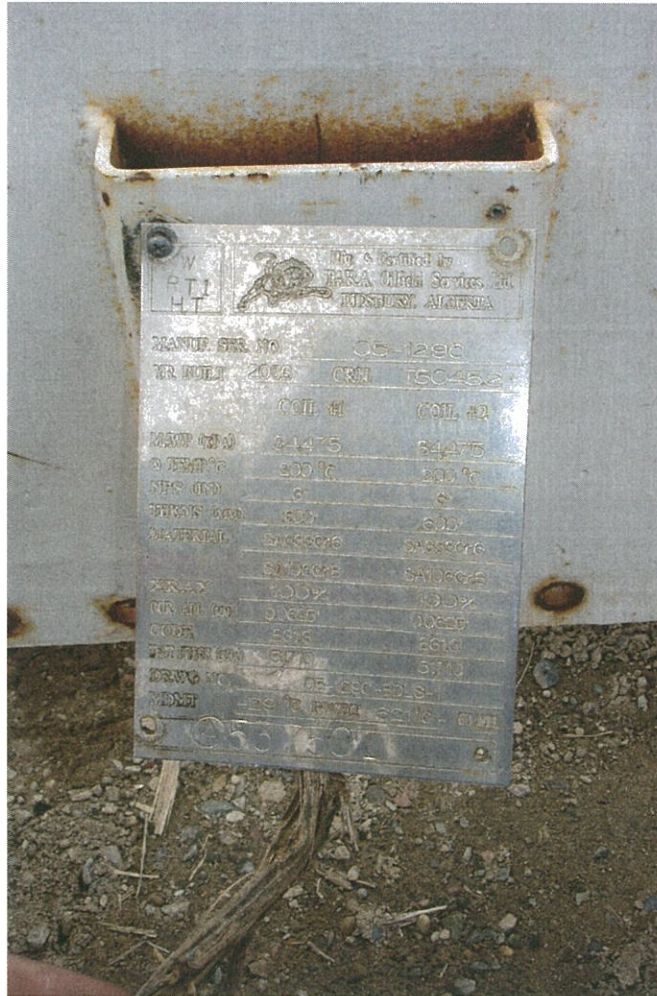
## ORIGINAL VESSEL NAMEPLATE/STAMPING INFORMATION

Code stamp: ☐ U stamp ☐ U2 stamp ☐ UM stamp ☐ API-ASME ☒ No stamp

**Condition of Nameplate and/or Bracket:** The nameplate is attached to the nameplate bracket by (1) sheet metal screw. The nameplate is legible.

- Securely attach nameplate to nameplate bracket (rivot).
- Sandblast coils to remove scale
- Sandblast or hydro blast heater internals to remove loose scale from shell wall and fire tube.

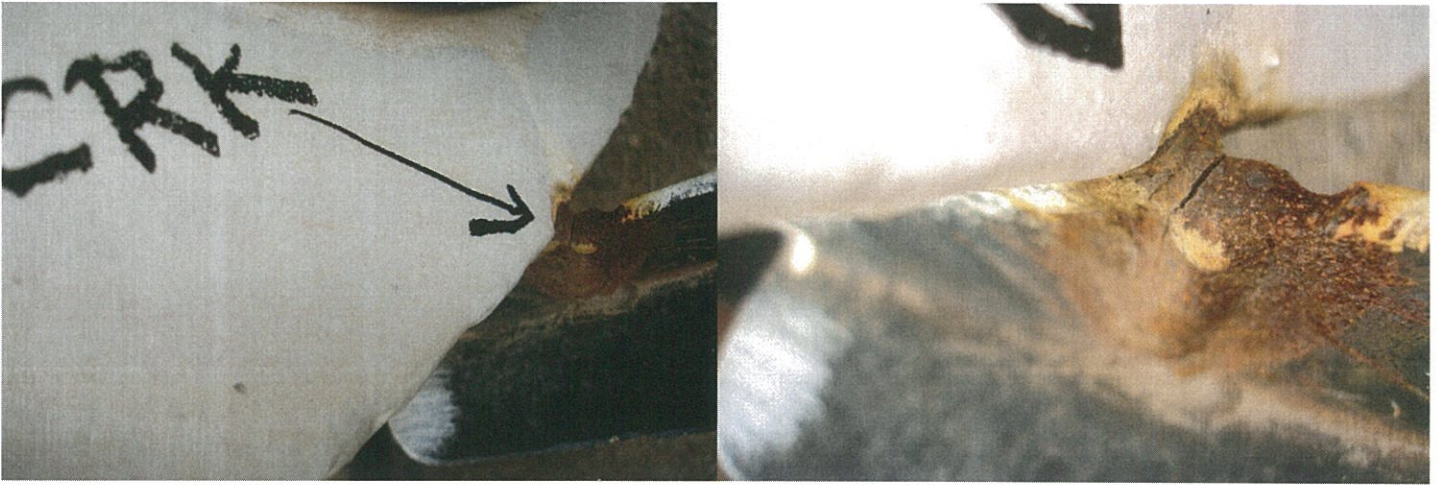
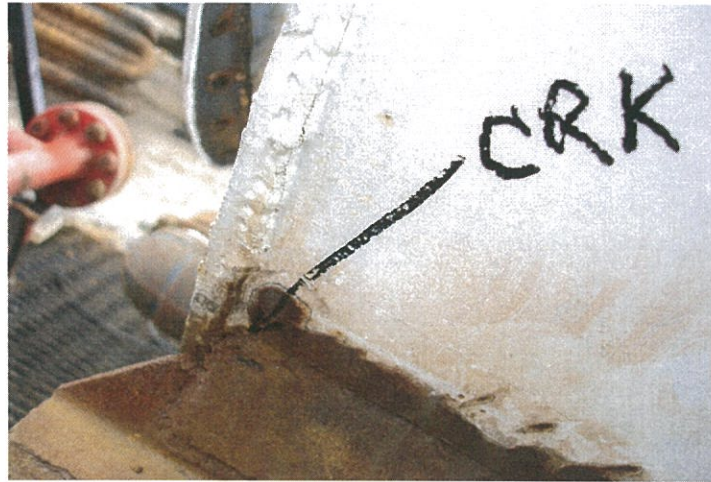
**Condition of Steel Supports, Saddles, and Bolting:** The (2) vertical supports have no distortion and light surface corrosion in localized areas. All support structural welds appear sound. The support saddle-to-shell attachment welds have no visual weld defects. Both angle iron bracket-to-heater shell attachment welds have cracks (brackets attach pipe stops for pipe rack).

Weld repair angle iron bracket-to-shell attachment welds on pipe stops (front and back). (Not a code repair.)

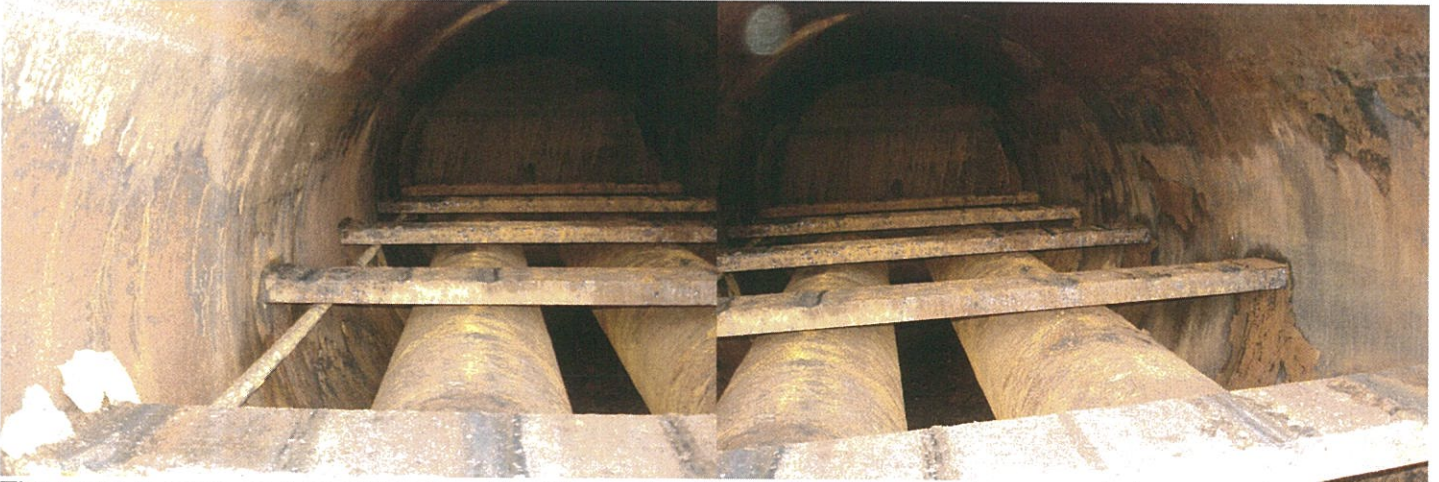
Heater Shell: The heater shell internal (as viewed through the cover place opening) has moderate scale.

☐ The scale is loose and no pitting is evident beneath. The horizontal supports appear to be securely attached to the heater shell and have no distortion.

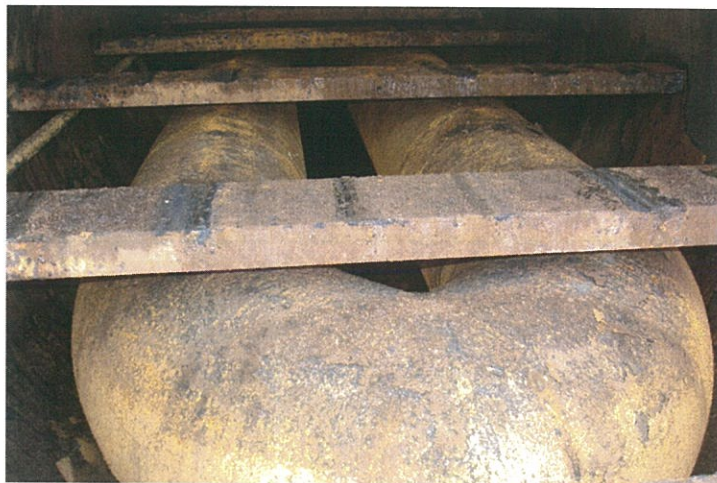
Fire tube: The fire tube has light to moderate scaling. No distortion noted to the fire tube.

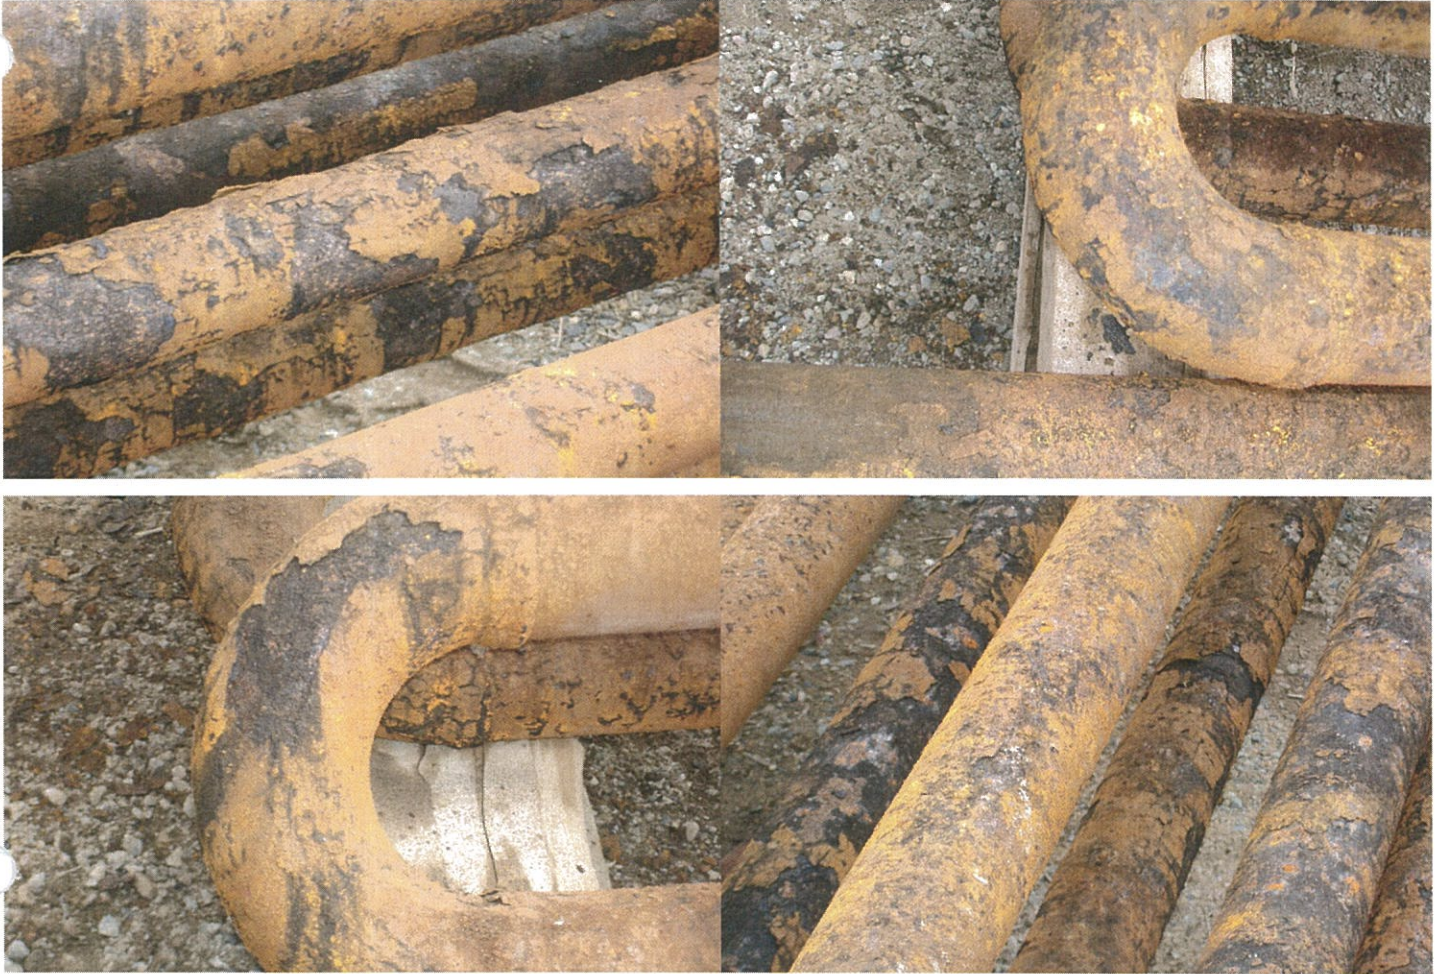
Coil Assemblies: (Coil 1 & 2). Inlet and outlet flanges are in acceptable condition. The tubes and 180° turns have light to moderate scale.

There is light (not measureable) pitting beneath the scale. The tubes have no distortion. Tube sheets have light corrosion and scale. Accessible tube-to-tube sheet welds appear sound.
